Concept Design Report

Trout Brook Watershed Improvements Afton Alps, Afton, Minnesota

South Washington Watershed District

August 9, 2012

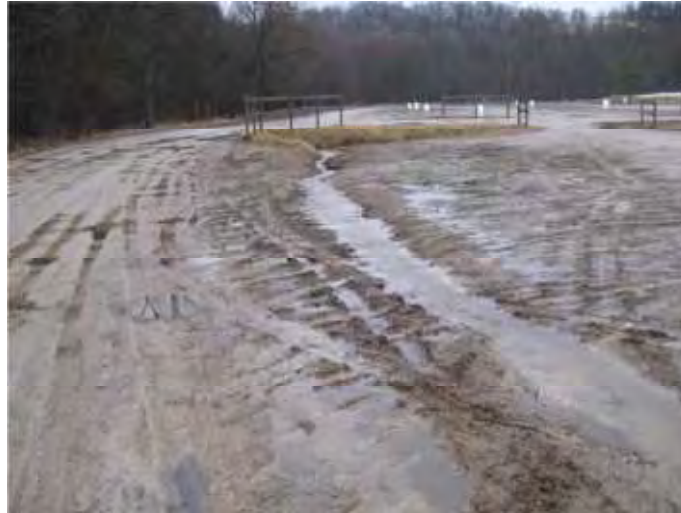
Within the Afton Alps property, the primary source of sediment loading to Trout Brook is runoff from the parking lots and roads. During heavy rain events and the spring melt, rapid runoff from the steep upland slopes flows over the gravel and mud surfaces and into the stream adjacent to the main road. Table 1 below indicates that the suspended solids concentration in Trout Brook at a sampling point just downstream from the Afton Alps property is highly correlated to discharge and storm events. Figure 1 below shows the condition of the existing parking lot and road during an early spring runoff event – there is a culvert inlet in the center of the photo at the base of the mud drainage swale, the culvert leads directly to Trout Brook.

Figure 1. Lower Parking Lot and Road During Runoff Event (Photo: HR Green)

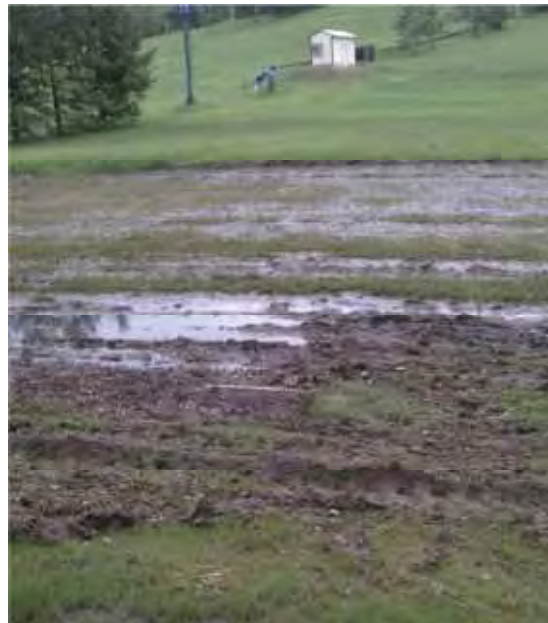
The Afton Alps property experiences land use problems due to this phenomenon and a lack of integrated groundwater management. The property owners have avoided paving the eastern road and parking areas due to high-water-table frost heave concerns. The dirt / gravel surface is also susceptible to frost heave and is therefore regularly re-graded to maintain a smooth surface. At other locations the flat plain at the base of the hill is very wet, muddy, and in poor condition due to maintenance vehicle traffic and overflow parking usage (see Figure 3). The end result is that the muddy plain, and continuously re-graded surfaces release large quantities of sediment during the spring thaw and subsequent rain events.

Figure 3. Typically Muddy Conditions at Base of Slope Due to High Water Table (Photo: HR Green)

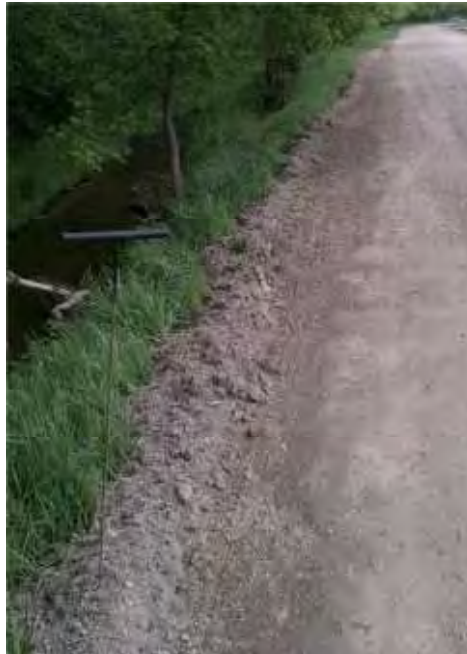
Figure 4. Grading spoil on creek bank (Photo: HR Green)

Due to the proximity of roads and parking lots to the creek, and the lack of an effective riparian barrier in many locations, special maintenance requirements exist on this property. Re-grading of roads and parking lots should be minimized as much as possible. When re-grading is absolutely necessary, care should be taken to avoid deposition of grading spoil near the creek banks or near surface drainage swales leading to the creek (see Figure 4). Spoil should be stockpiled in a location that is unlikely to create sediment laden runoff near the creek (see Figure 5). Any stockpiles remaining onsite and containing finely textured soil material should be located away from drainage paths, and encircled with silt-fencing or other appropriate measures to control sediment laden runoff.

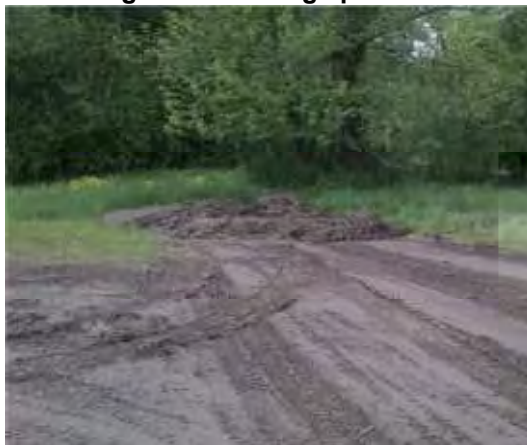
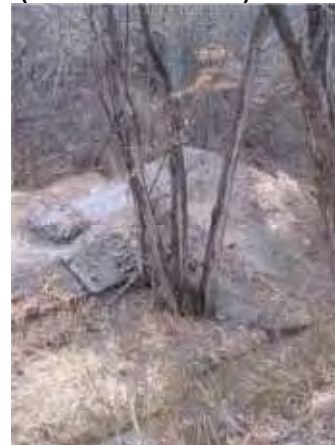
Figure 5. Approximately 8 tons of fine textured grading spoil deposited 30 feet from the creek bank (left); Approximately 50 tons of soil stockpiled immediately adjacent to creek near employee parking lot (right) (Photos: HR Green)

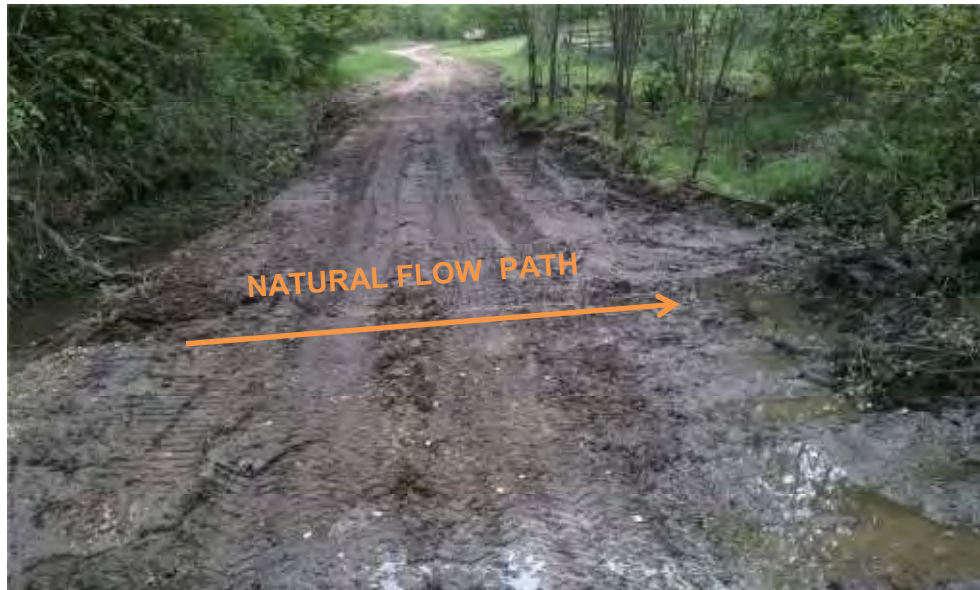
The access road on the far east side of the Afton Alps property requires frequent repair due to erosion of cross-flowing surface runoff. Both the erosion and the subsequent repairs with native gravel / soil mixtures are significant sources of runoff sediment. Some seasonal snow-melt runoff does flow down the road itself, so repairs to the road surface should include installation of larger aggregate material with minimal fines.

Runoff from the Afton Alps ski slopes crosses the access road in one concentrated location just north of the base of ski lift number 11 (see Figure 6). Additional runoff is distributed along the remaining ~500 feet of road between lift #11 and the Meadows parking lot. This section of road should be excavated and replaced with larger open-pore gravel (no fines). A culvert should be installed at the concentrated runoff location near lift #11. A small roadside swale should be installed along the west side of the road to deliver distributed runoff to the sand filter at the east end of the Meadows Chalet parking lot (see map and item #3 below). This design would improve runoff water quality and reduce the maintenance burden on the property owners.

Figure 6. Access road is routinely re-graded which stirs up sediment due to dirt / gravel surface; damage is due to seasonal cross drainage (Photo: HR Green)

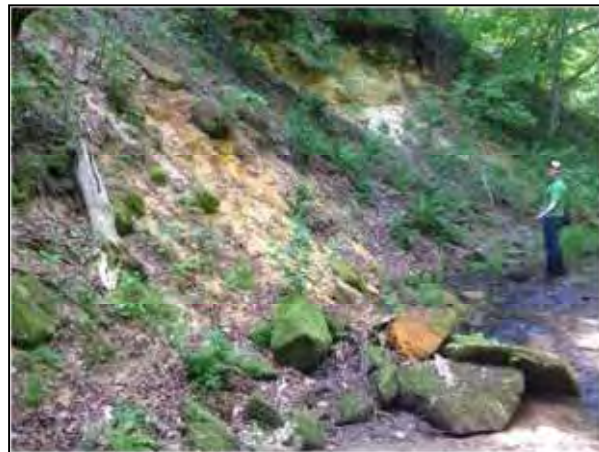
Figure 10. Exposed bedrock in higher gradient slope upstream of the Afton Alps Ski Area (Photo: Inter-Fluve).

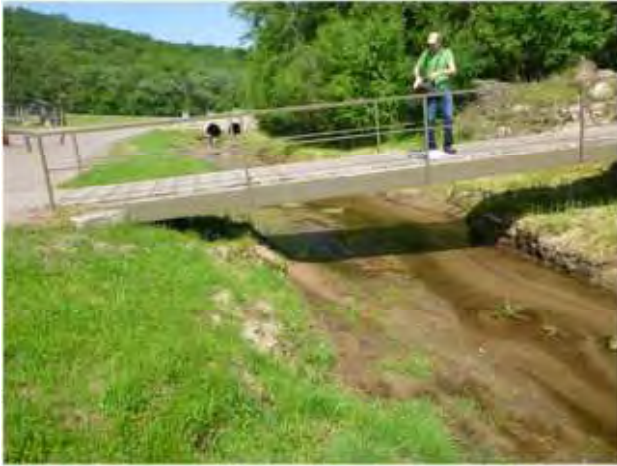
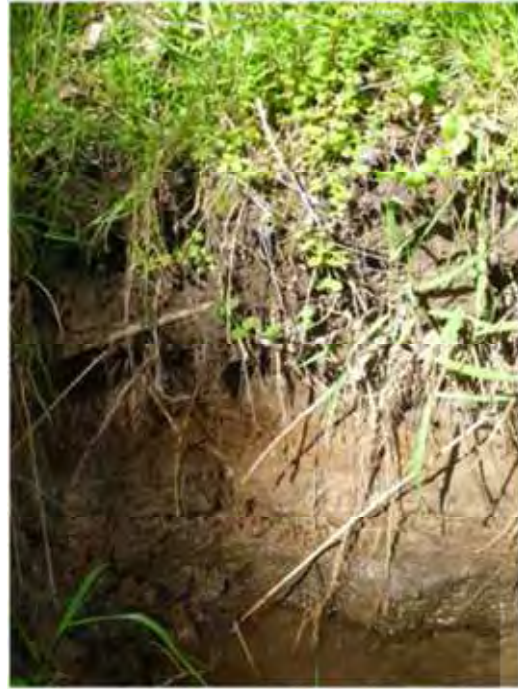
Figure 12. Sandy floodplain alluvium along Trout Brook in the study area (photos: Inter-Fluve).

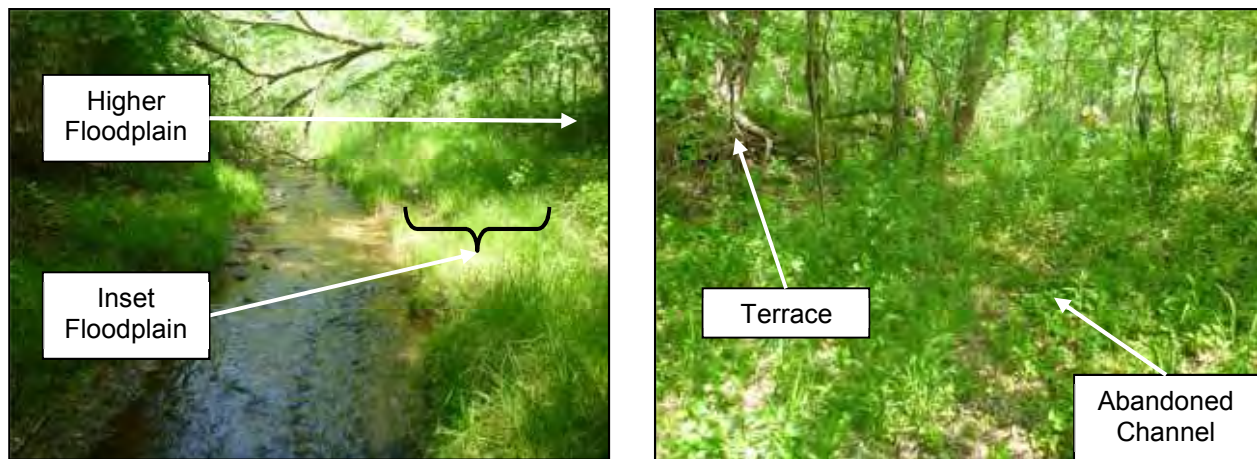
The air photo and map analysis was corroborated by observations made in the field while conducting the geomorphic assessment. Upstream of the Afton Alps Ski Area, the channel meanders through a narrow alluvial valley with multiple floodplain and terrace surfaces. The active low-flow channel has an approximately 5-8 ft wide top width and is 1 ft deep. Grasses grow along a floodplain that is 5-10 ft wide and inset into a higher floodplain (Figure 17). This higher floodplain is approximately 3-4 ft above the channel bed and contains ~30-50 yr old trees. The floodplain surface is 30-50 ft wide on either side of the stream and channel scars suggest that this surface was the elevation of the channel bed more than 30 years ago, corresponding with the 1953 and 1964 air photos. We also identified an abandoned terrace about 8 ft above the channel bed. This terrace sustains trees more than 50 years old and exposed roots indicate that a stream channel had eroded the banks at that location decades ago. This was likely the floodplain while the channel was aggraded during the mid-1900s due to excessive sediment loads.

Figure 17. Channel, floodplain, and terrace features upstream of the Afton Alps property showing the evolution over the last 150 years recent incision and creation of an inset floodplain (left) within a higher floodplain that used to be the channel bed due to excessive aggradation (Photos: Inter-Fluve)

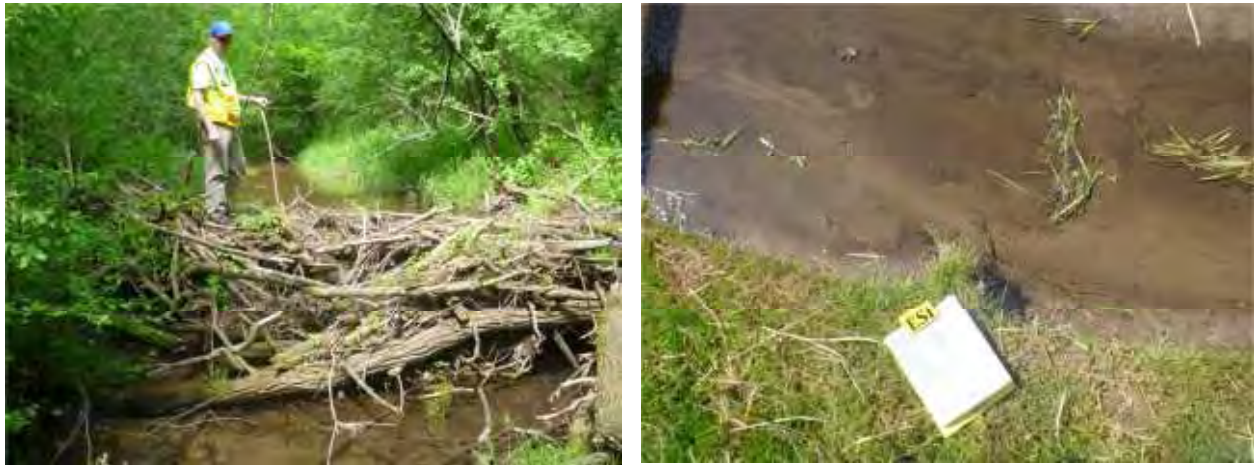
Channel bed, bank, and floodplain sediments were investigated to understand the sediment transport history of the site as well as the existing grain size distribution of the stream. Upstream of the Afton Alps Ski Area, sand continues to be transported from upstream sources, accumulating in pools and behind obstructions such as log jams or beaver dams (Figure 18). Small to large gravel were identified along riffles, while sand dominated the majority of the stream, which consisted of runs and shallow pools. The stream banks were primarily composed of sand and sandy loam as were the floodplain and terrace surfaces. Pits dug into the floodplain surface, which was the channel bed in the mid-1900s, revealed multiple feet of sand with occasional organic layers. Within the Afton Alps property, the channel bed grain size ranged from fine sand to gravel and cobble (Figure 19). Upstream of the eastern-most culvert near the ski lodge, the channel slope is relatively low-gradient and sand from upstream sources accumulates within the channel. Downstream in the straightened ditch, the channel maintains a steeper riffle-pool form. Sand from upstream sources as well as from runoff from parking lots and roads has generally filled in many of the pools that may exist otherwise. Small riffles and shallow pools were observed, but the stream was dominated by long, sandy runs.

Figure 18. Sand accumulates behind obstructions (left) as well as in the pools and runs through most of the length of the stream (right). (Photos: Inter-Fluve)

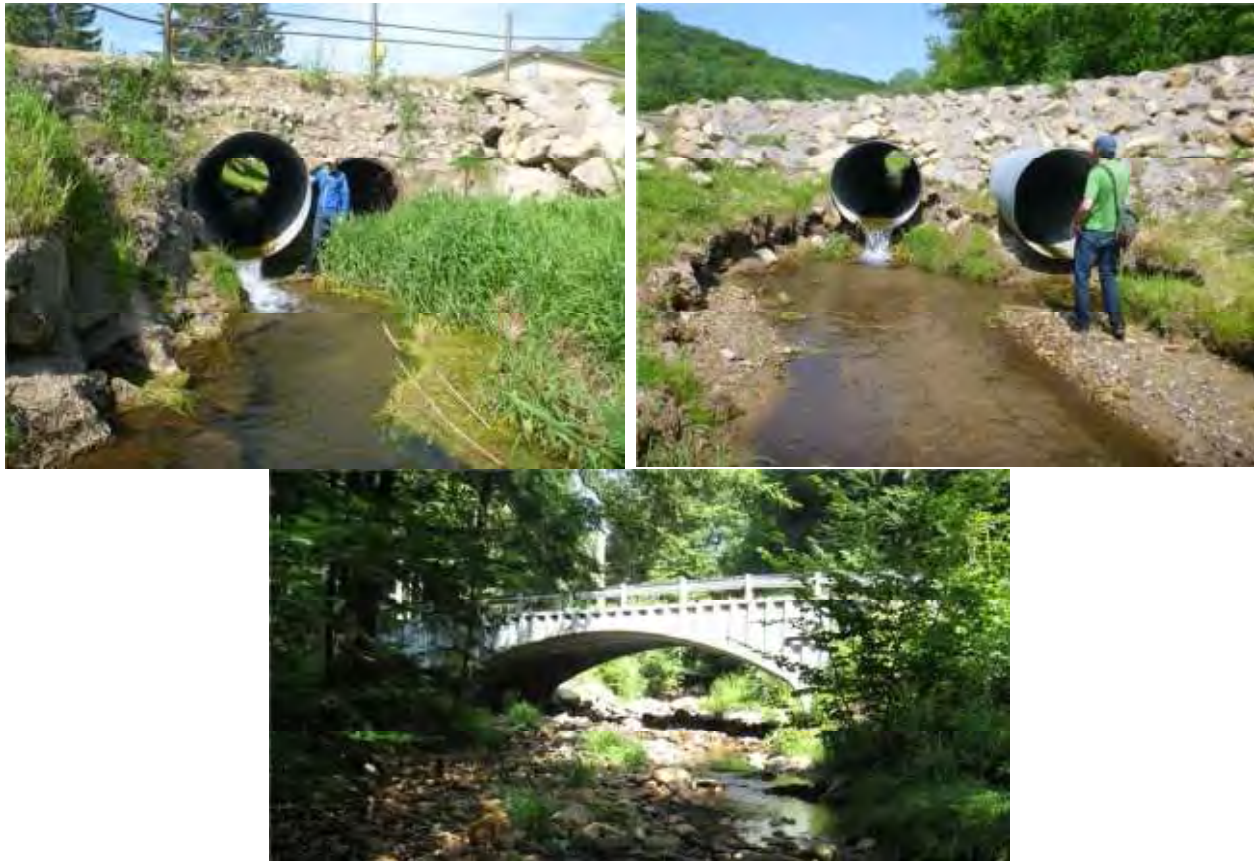
Culvert replacement - The culverts beneath the two road crossings near the ski lodge are undersized, which results in stream destabilization, degradation of aquatic habitat, and creation of a fish-passage barrier. We recommend replacing these culverts with bridge spans or bottomless arch culverts (Figure 21; see also Exhibit B2 in Appendix B). This would allow the flood flows to pass through without resulting in excessive erosion and would improve habitat and fish passage.

Figure 21. The culverts under both road crossings near the Afton Alps lodge are all perched and undersized, leading to erosion and ecological concerns (top photos). These can be replaced by bottomless arch culverts (left) or bridge spans for better stream flow. (Photos: Inter-Fluve)

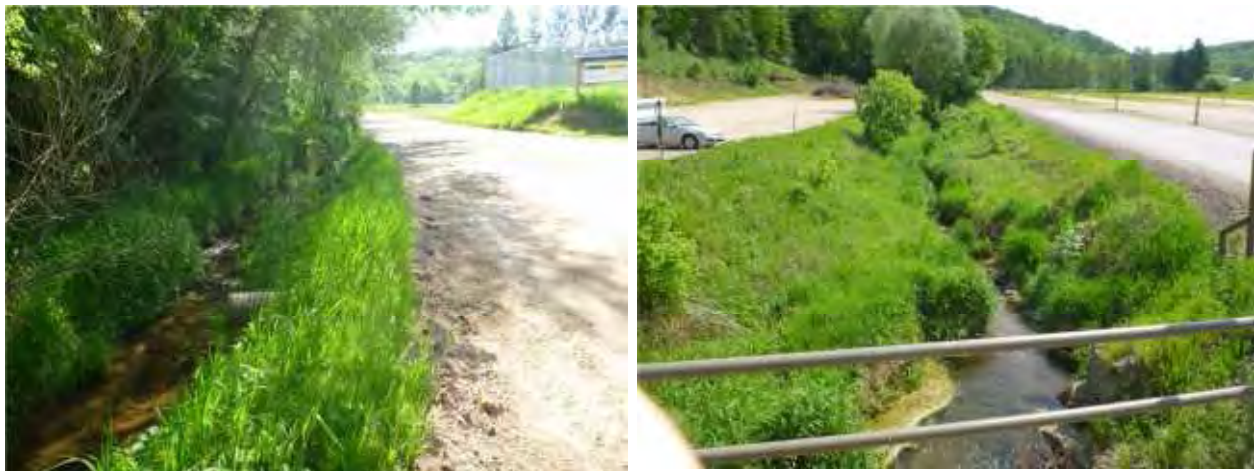
Buffers and re-vegetation - Through most of the stream length within the Afton Alps property, the buffer between roads, parking areas, and the stream is less than 5 ft (Figure 22). The lack of a sufficiently wide buffer results in excessive stormwater runoff, decreased bank stabilization, and decreased water quality due to lack of canopy cover, shade, and in-stream cover. We recommend increasing the buffer width to at least 15 ft and planting appropriate forbs, trees, and shrubs. Vegetation that meets the aesthetic goals of the ski area can be planted where appropriate.

Figure 22. Very little vegetative buffer exists between roads and parking lots and the stream channel. (Photos: Inter-Fluve)

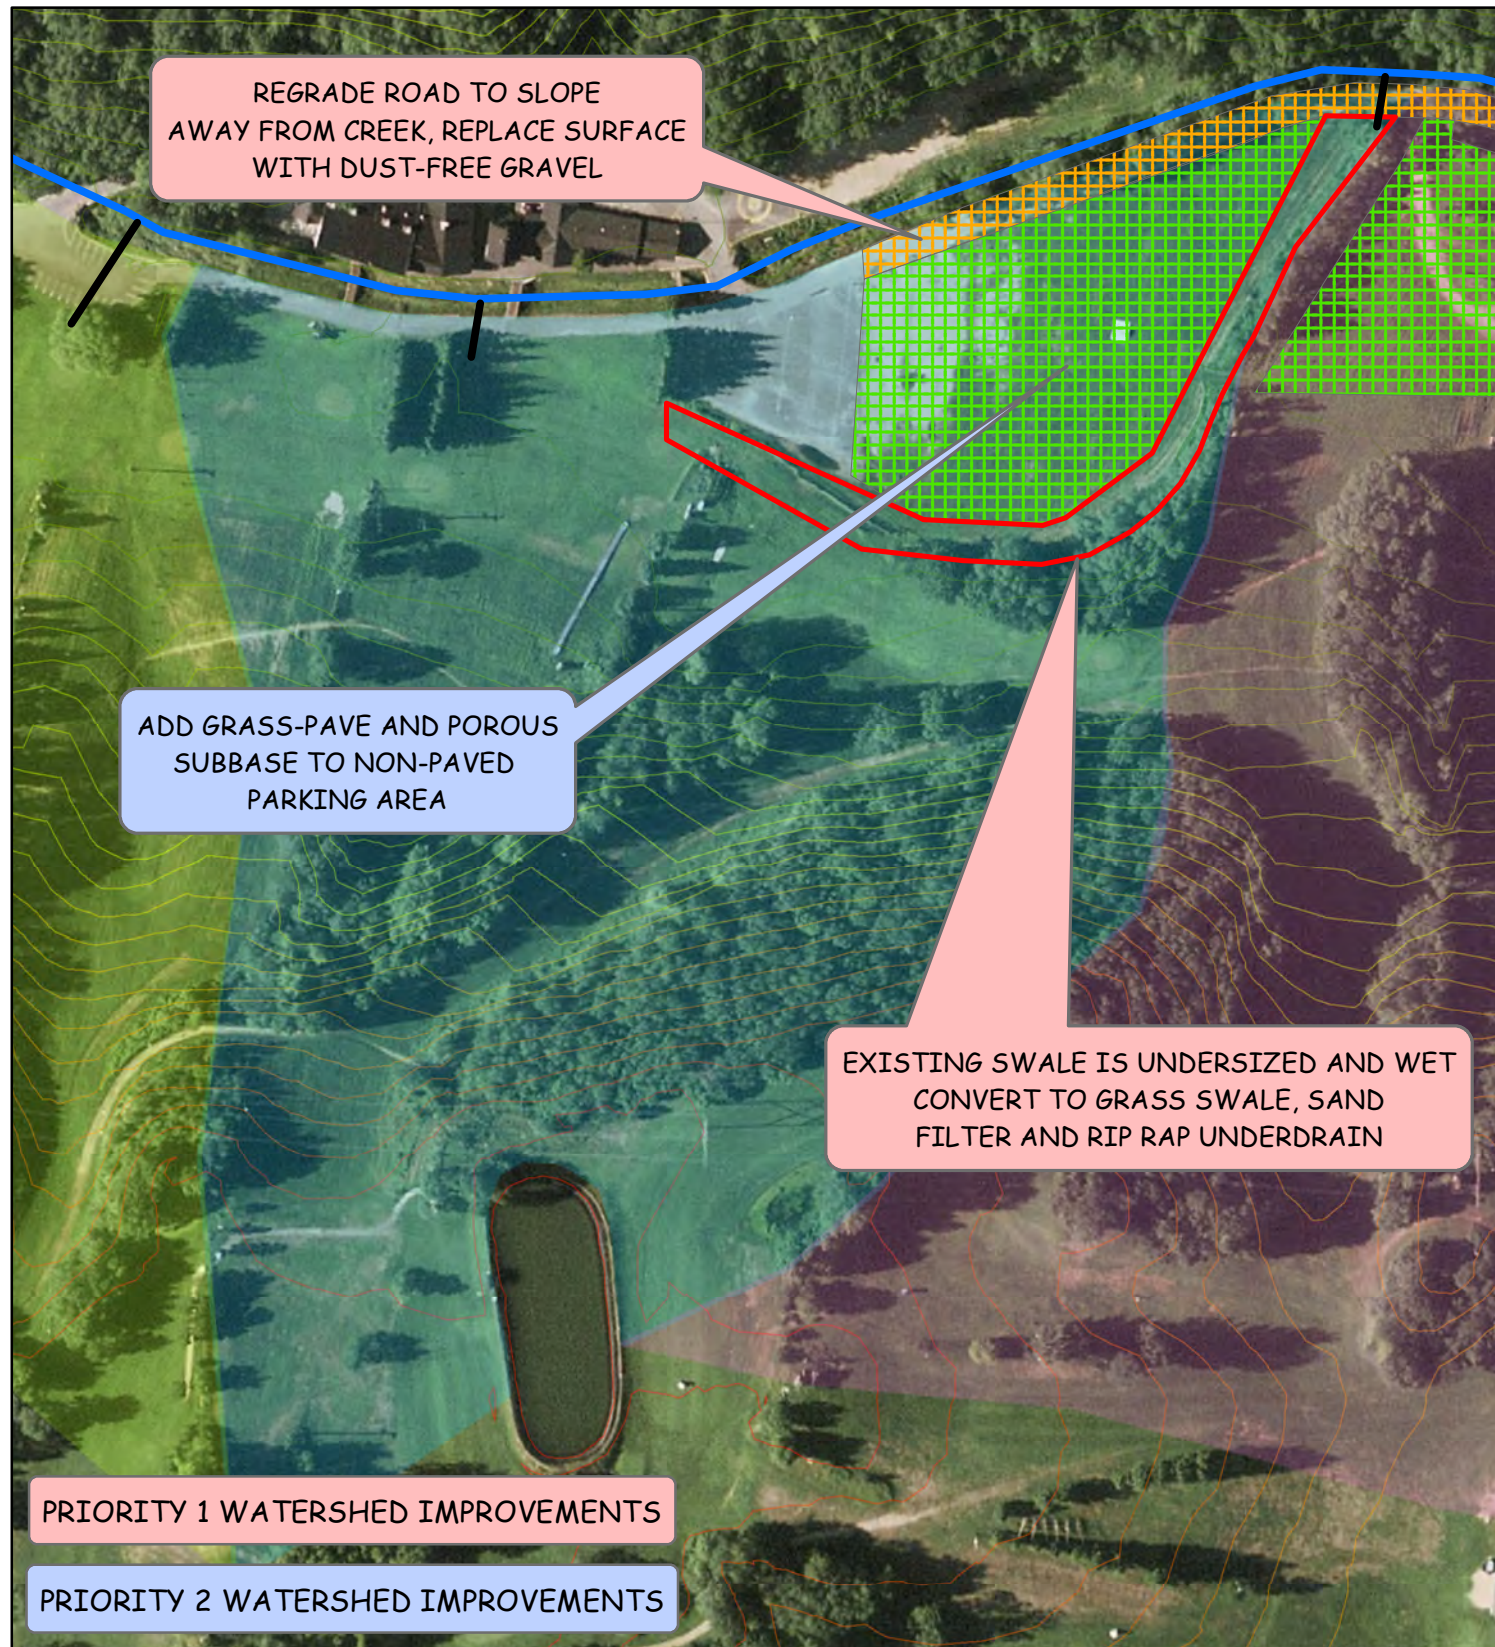
ANNIE'S DRAINAGE AREA

- Lower road and parking lot are unpaved (soil and gravel) and sloped eastward at 1.2%, no buffer exists to intercept sediment runoff
- Existing swale is undersized, eroded, and consistently wet
- Swale outfall (24" CMP) is perched 3' above ground on creek side creating a scour hole
- High water table makes hard-surface paving impractical and regular frost heave issues create need to re-grade road which exacerbates sediment runoff

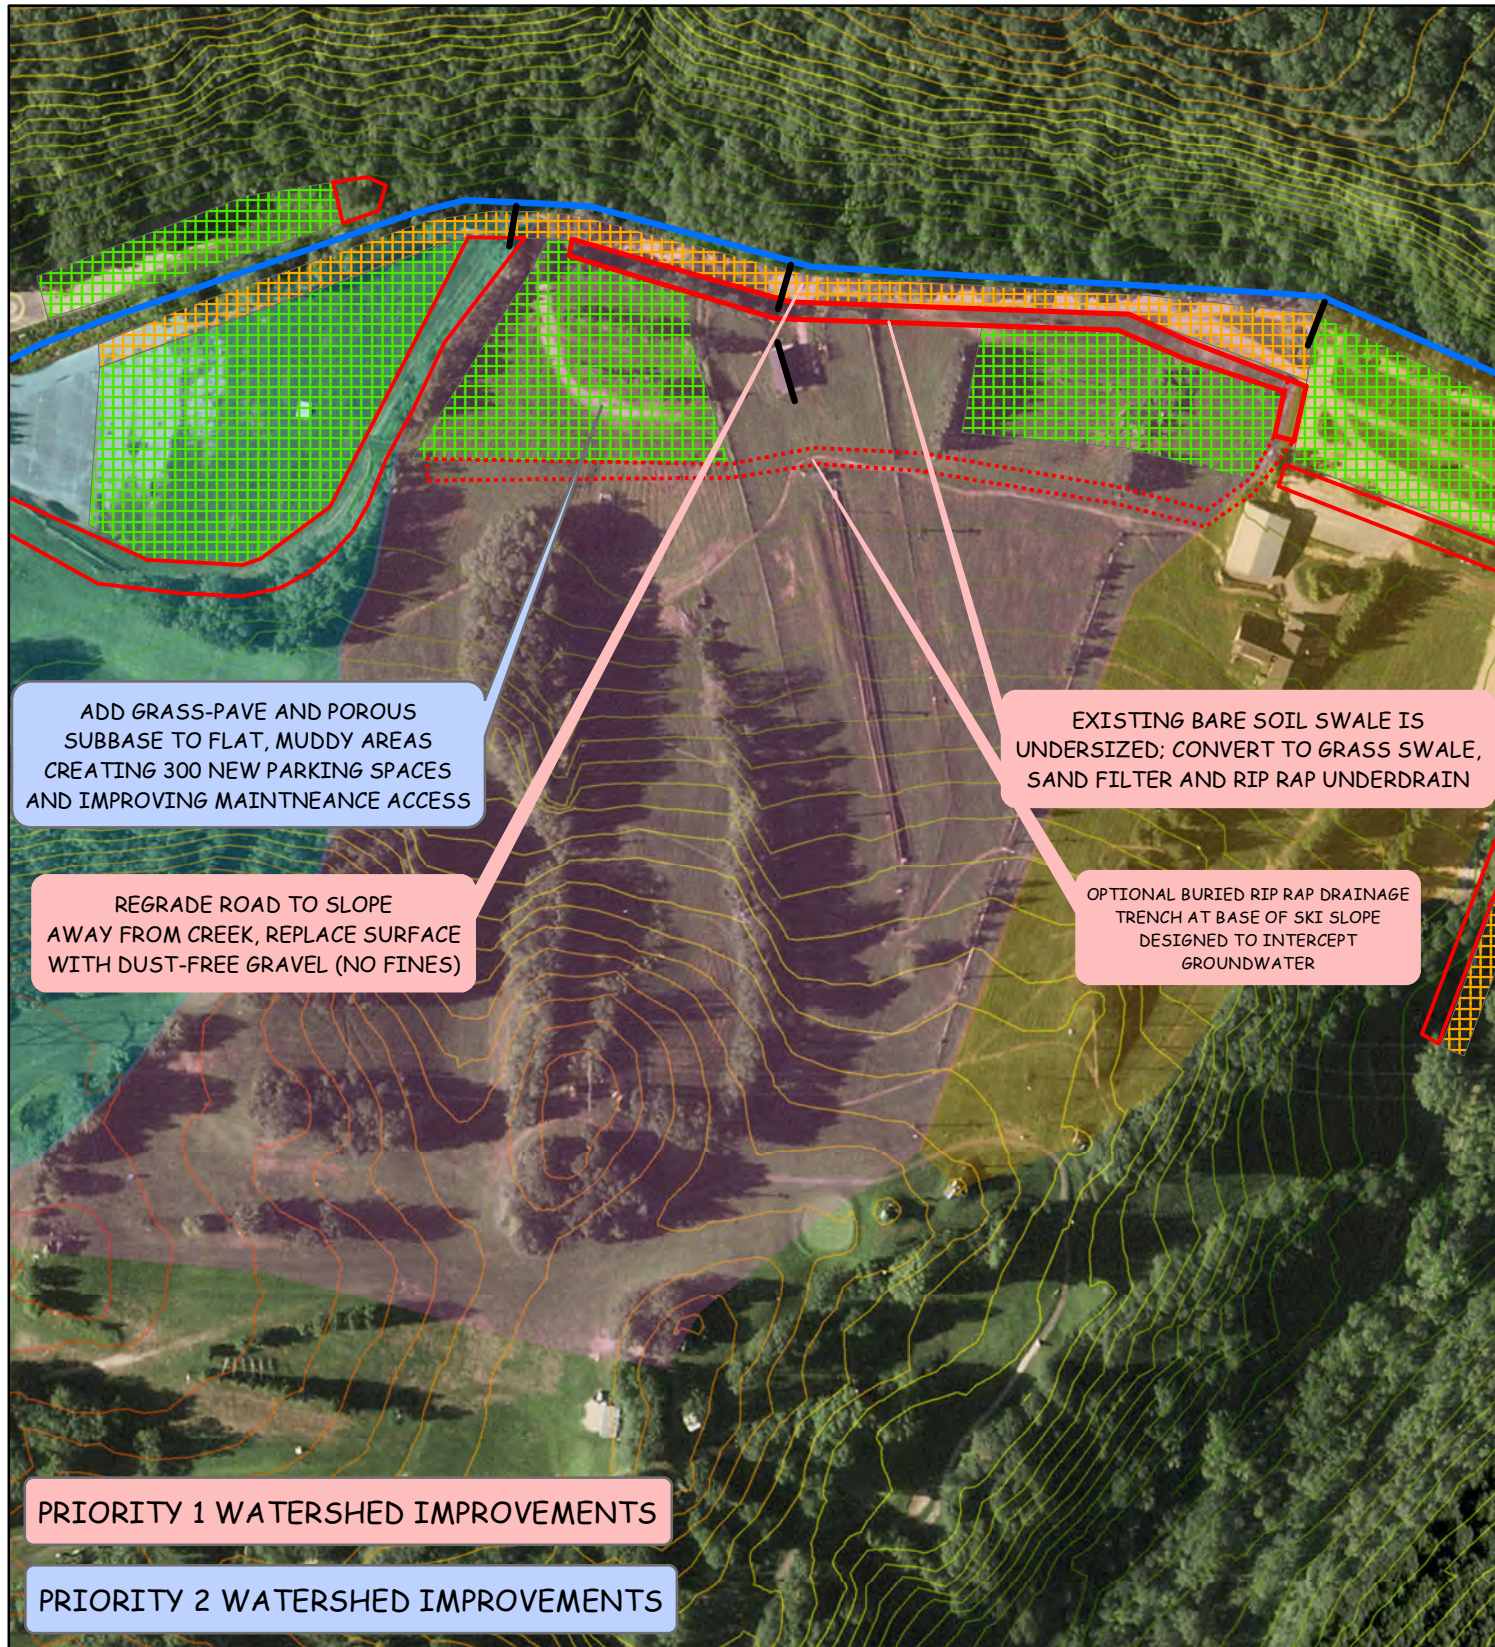
SONJA'S DRAINAGE AREA

- Road is unpaved (soil and gravel), no buffer exists to intercept sediment runoff
- Area between road and ski slope is flat, muddy, and torn up from vehicular traffic.
- Surface drainage is currently routed along south road edge in a bare soil swale
- CMP outfalls are undersized and deliver high TSS runoff directly to creek
- High water table makes hard-surface paving impractical and regular frost heave issues create need to re-grade road which exacerbates sediment runoff

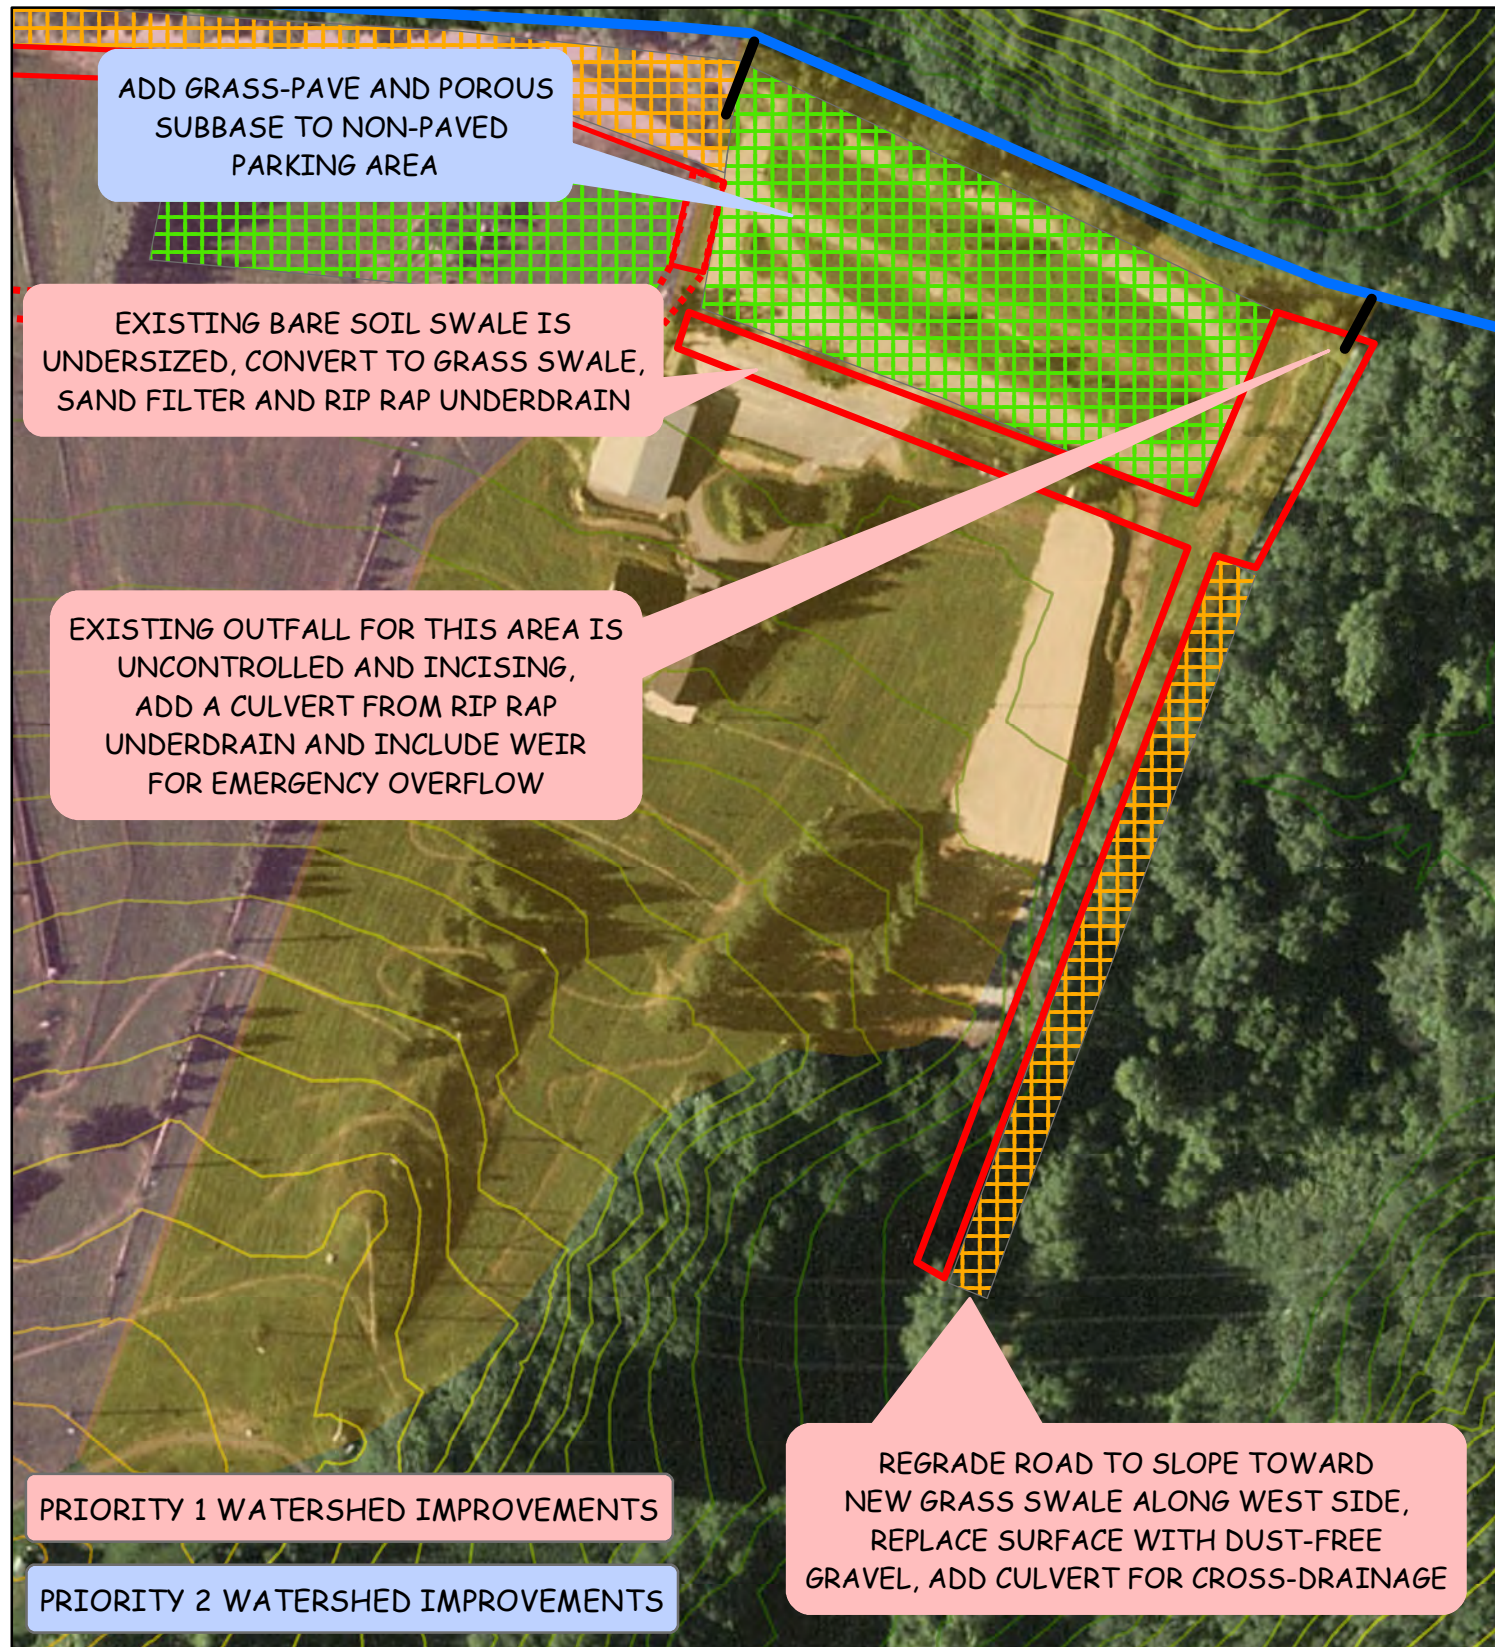
MEADOWS DRAINAGE AREA

- Parking lot and east road are unpaved and in poor condition (loose soil and gravel), no buffer exists to intercept sediment runoff
- Drainage across east road surface produces sediment runoff and creates a recurring maintenance issue
- Surface drainage is currently routed to east edge of property in a bare soil swale, outfall to creek is uncontrolled and eroding
- High water table makes hard-surface paving impractical and regular frost heave issues create need to re-grade which exacerbates sediment runoff

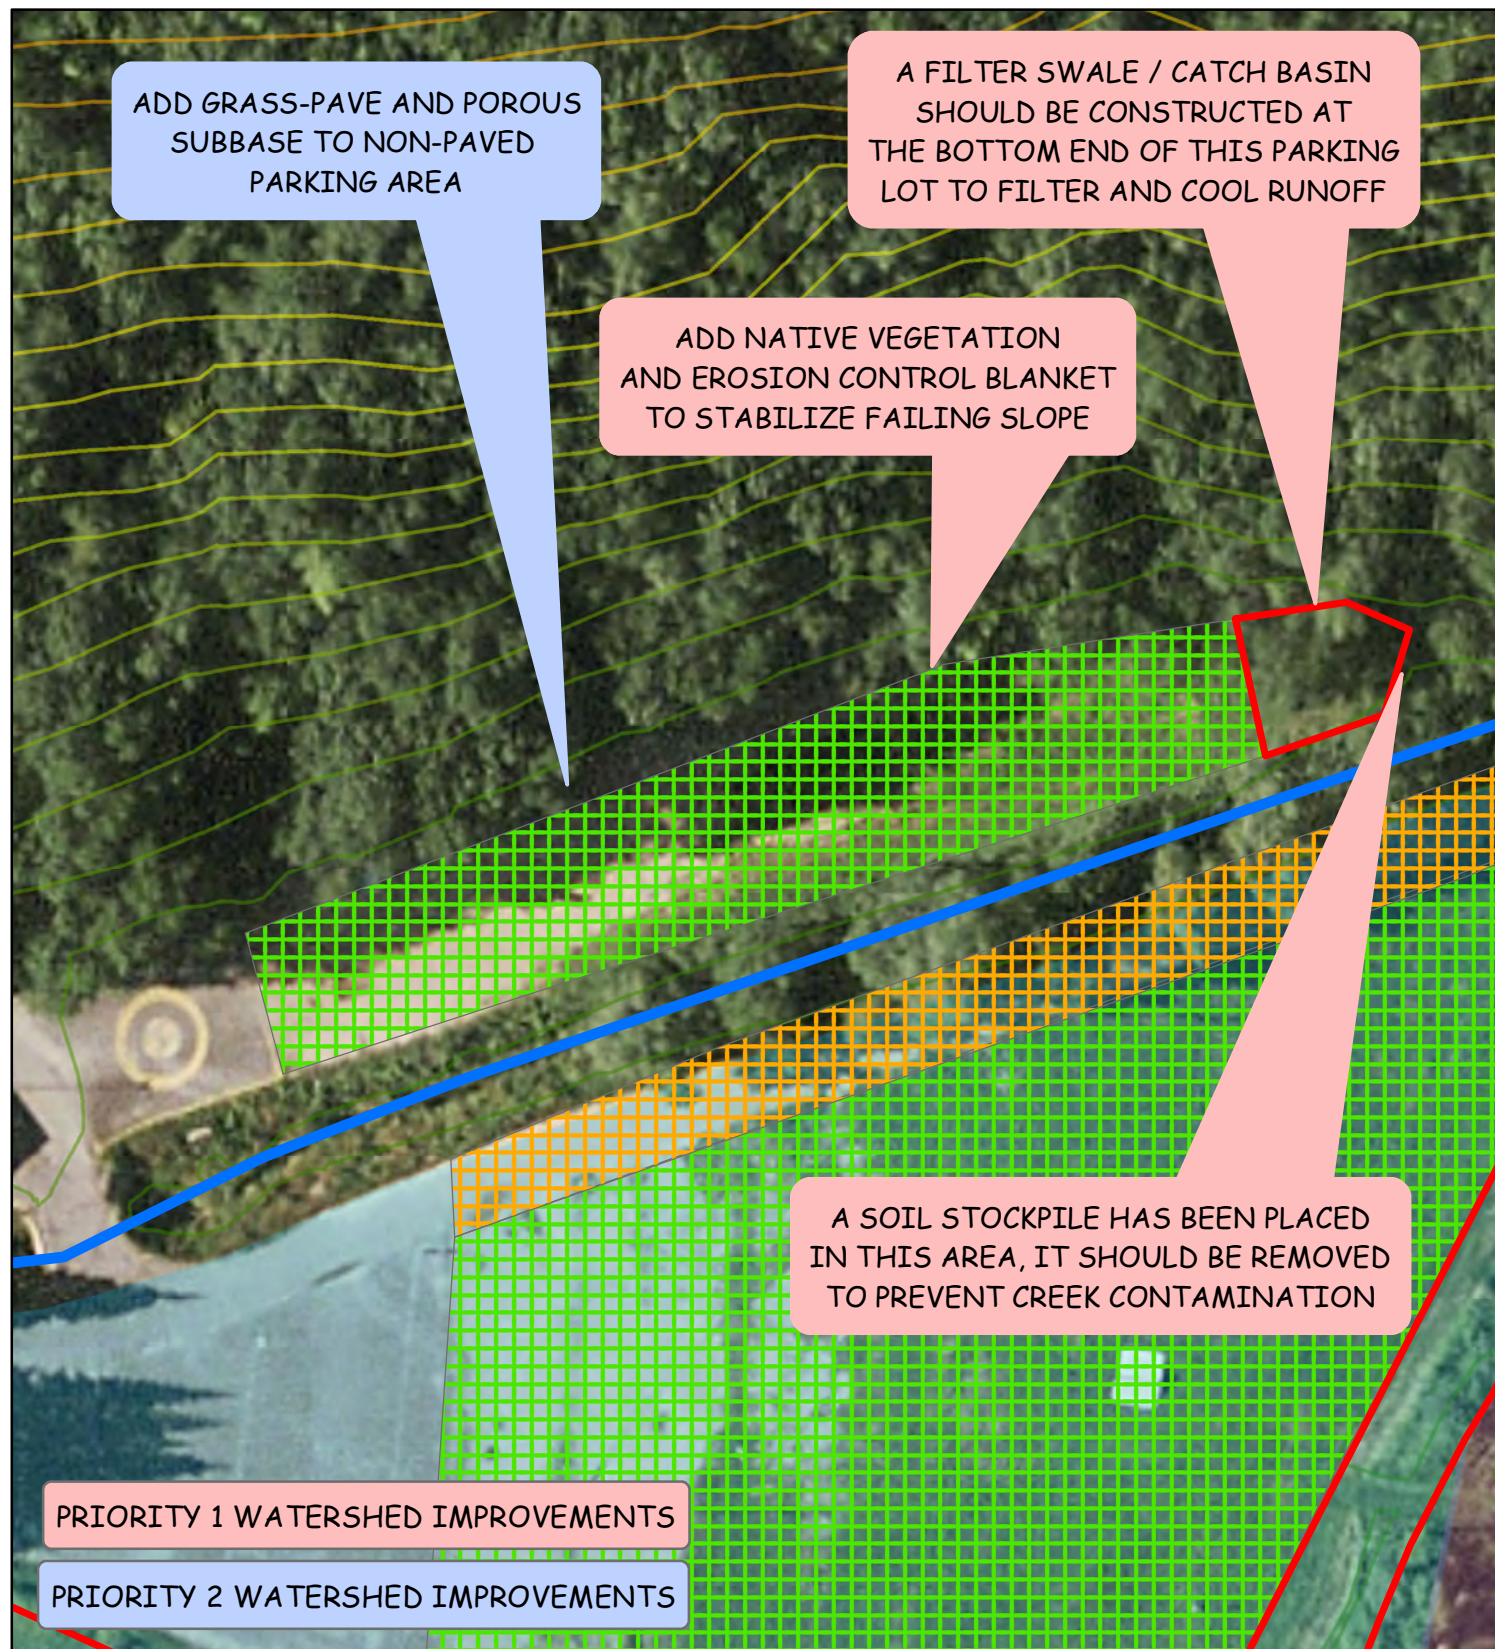
EMPLOYEE PARKING LOT

- Parking lot is unpaved (soil and gravel), no buffer exists to intercept sediment runoff
- Cut hillside is bare soil, eroding and in danger of failing
- Loose soil is being stockpiled at bottom end of parking lot and adjacent to creek bank (directly in runoff flow path)
- High water table makes hard-surface paving impractical and regular frost heave issues create need to re-grade which exacerbates sediment runoff

- Add vegetation to failing hillside, preferably native, deep-rooted grasses; add biodegradable erosion control blanket for temporary stabilization
- Remove soil stockpile and re-vegetate area
- Install runoff catch basin at east end to intercept, filter, and cool runoff (native grass basin with underlying sand filter and rip rap underdrain wrapped in geotex fabric, similar to modified swale filters prescribed elsewhere)
- Install culvert outfall at creek flow line, connect south end to rip rap swale filter underdrains, also include overflow weir for swale surface flow
- Install grass-pave parking lot surface to eliminate sediment source and improve filtration
