2011 Monitoring Report; Markgrafs Lake

DNR ID #82-0089	Municipality: Woodbury
Surface Area: 46 Acres	Watershed Area: 436 Acres
Mean Depth: 5 feet	Maximum Depth: 8 feet
SWWD Maximum Allowable Phosphorus Load: 0.61 lbs/ac/yr	
SWWD Trophic State Index (TSI) Goal: 66-70

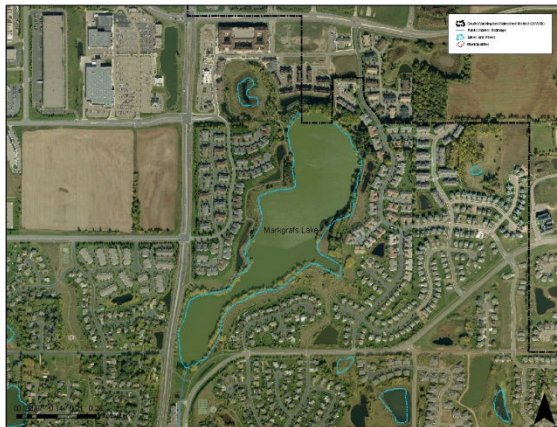
Map 1: Markgrafs Lake

Markgrafs Lake is approximately 46 acres in surface area and has a contributing watershed of 413 acres. Along with Armstrong Lake, Markgrafs makes up the headwaters of SWWD's Northern Watershed (NWS).

The Markgrafs Lake watershed is completely built out. The upper part of the watershed is dominated by commercial land use while the remainder is made of dense residential neighborhoods. Water from Markgrafs Lake drains to the south basin of Wilmes Lake via Woodbury's storm sewer network.
