2003 INFILTRATION MONITORING PROGRAM

FINAL REPORT

February 2, 2004

Emmons and Olivier Resources, Inc.
651 Hale Avenue North
Oakdale, MN 55082

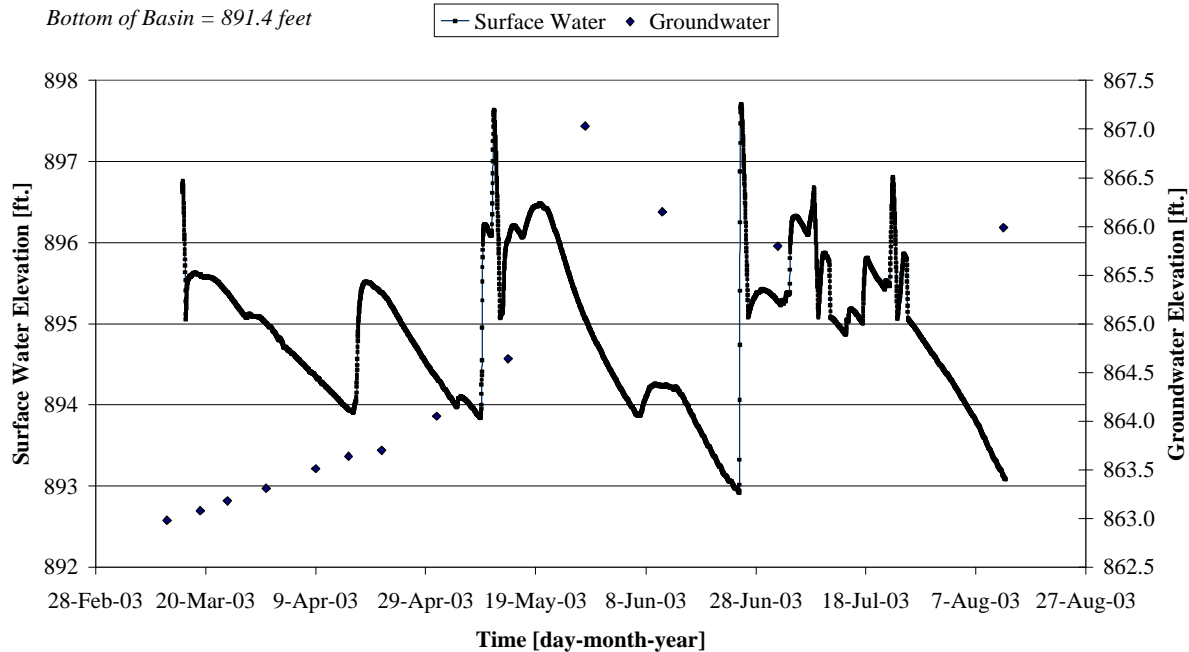
Figure II-1. Water Fluctuations at CD-P50

Groundwater levels at CD-P50 fluctuated throughout the infiltration events at the basin. Figure II-2 summarizes the 2003 groundwater level data. A response was measured in the water table as a result of recharge following the peak water levels in the basin. Using a static water elevation equal to 860.0, the highest measured water table mound height of 7.0 feet, corresponding to an elevation of 867.0 was recorded on May 28, 2003. This elevation is

approximately 25 feet below the bottom of the basin. The water table remained above the normal static groundwater elevation for the duration of the summer.

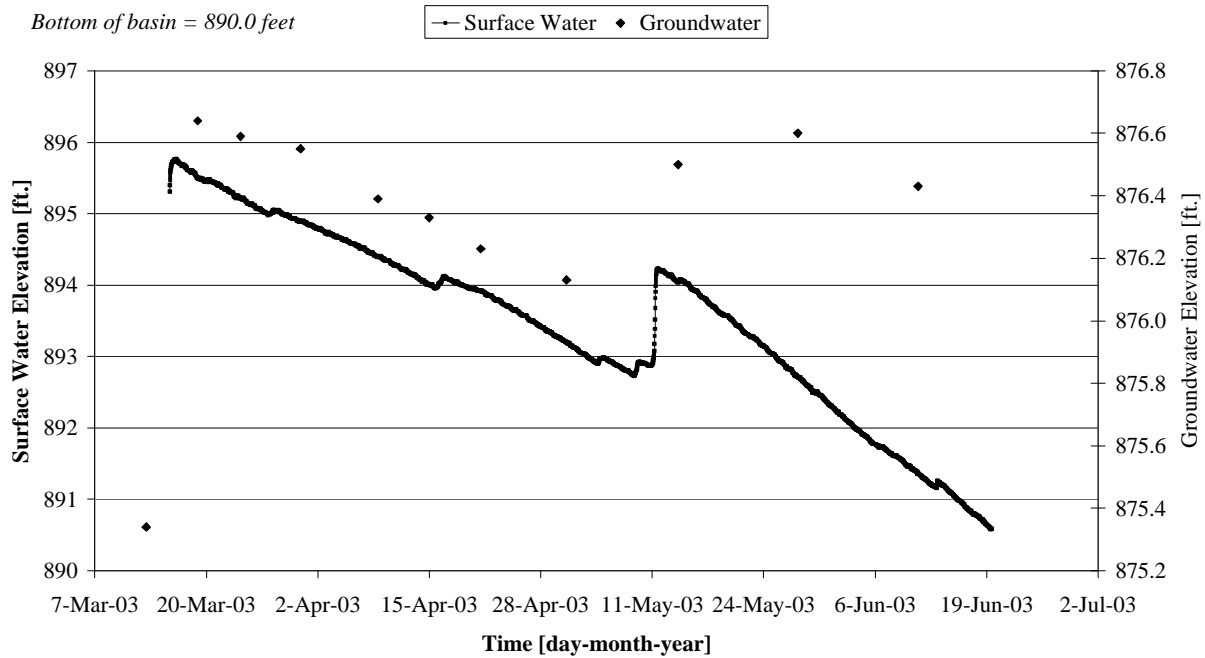
Figure II-2. Water Fluctuations at CD-P82

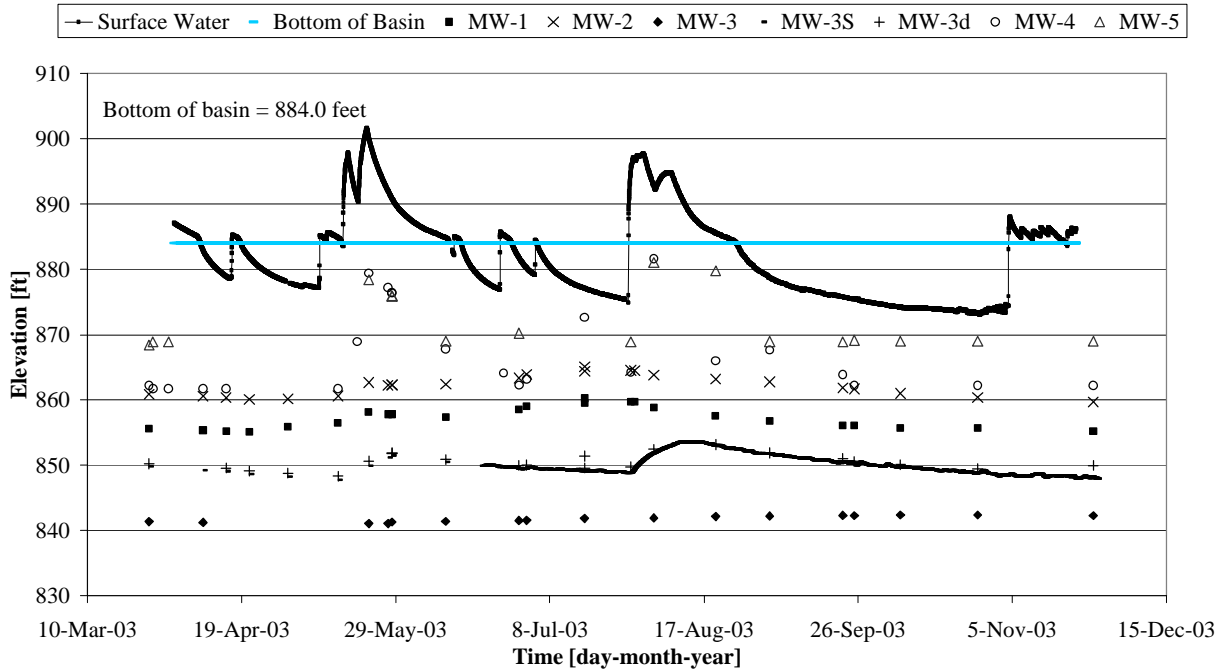
Figure II-3. Water Fluctuations at CD-P85

Measured groundwater levels at CD-P85 are summarized in Figure II-5. The rise and fall of the water table tracked the surface water levels in the basin at monitored wells near CD-P85. The groundwater mound produced by infiltrating water at CD-P85 and South Bailey Lake extends to MW-1 and may extend as far as MW-3. The rise in groundwater levels at MW-3 could also be the result of climatic fluctuations alone.

The measured groundwater mound reached a peak height of 31.52 feet on August 4 corresponding to an elevation of 881.04 in MW-4 and 881.64 in MW-5. The static water level was determined to be equal to 850.12 and was derived from pre-pumping water table elevations measured in MW-3s. Measured groundwater levels in MW-4 and MW-5 did not intersect the bottom of this basin, although water table elevations did intersect the infiltration trench at times between May 22 and June 11, and August 4 and September 9. A minimum of 2 feet of unsaturated soils below the basin was maintained throughout the infiltration events, although the rate of water level decline in the infiltration trenches is being limited by the saturated hydraulic conductivity of the underlying sediments during these time intervals.

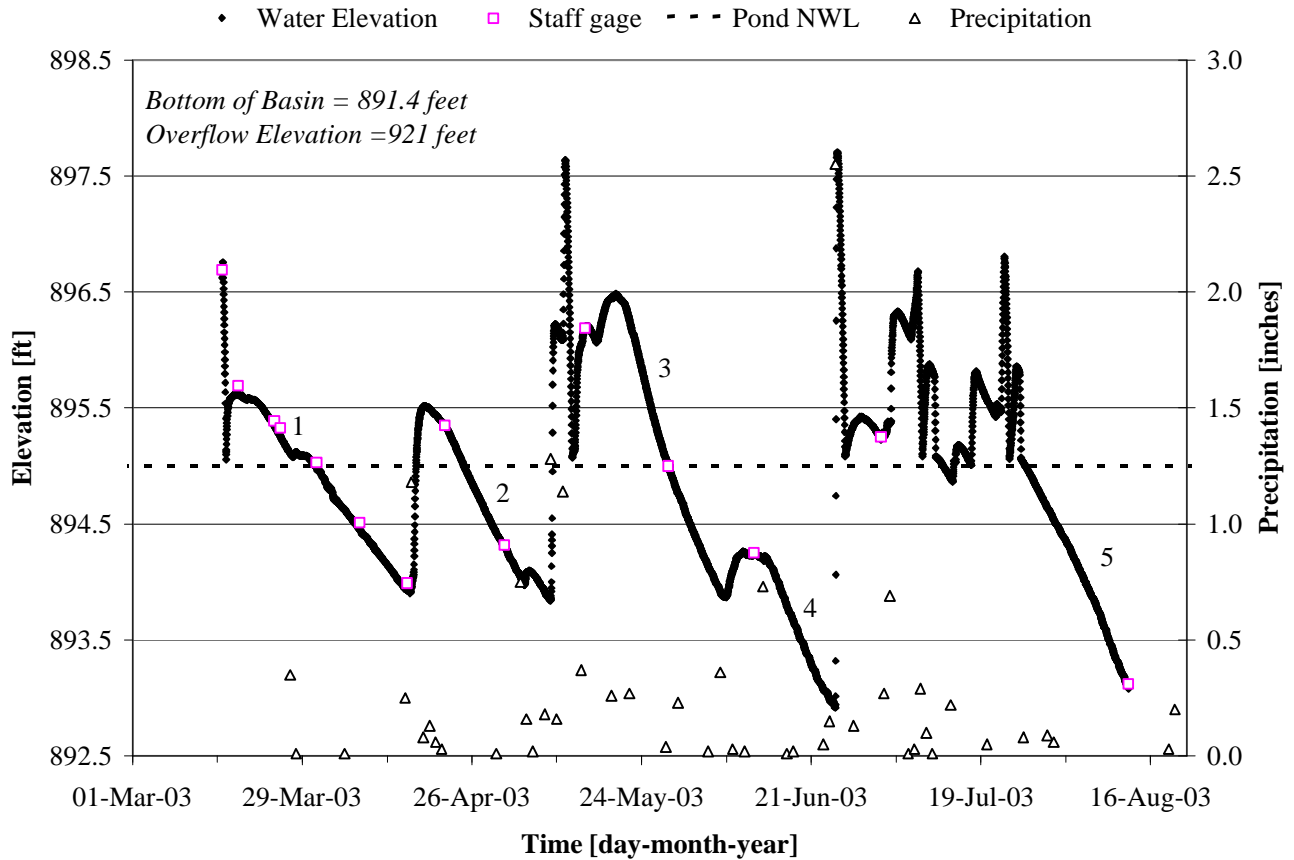
Figure III-2. CD-P50 Water Elevation vs. Time. Numbers refer to drawdown events.

Figure III-2 illustrates the water elevation in CD-P50 over time. During the spring infiltration event (Drawdown 1, March 21 through April 15), there was a short period of time during which the infiltration rate leveled off just above the normal water level for the pond. These data points were not used in the infiltration rate calculations for that event. This change in infiltration rate (slope) in the middle of the event was likely due to precipitation.

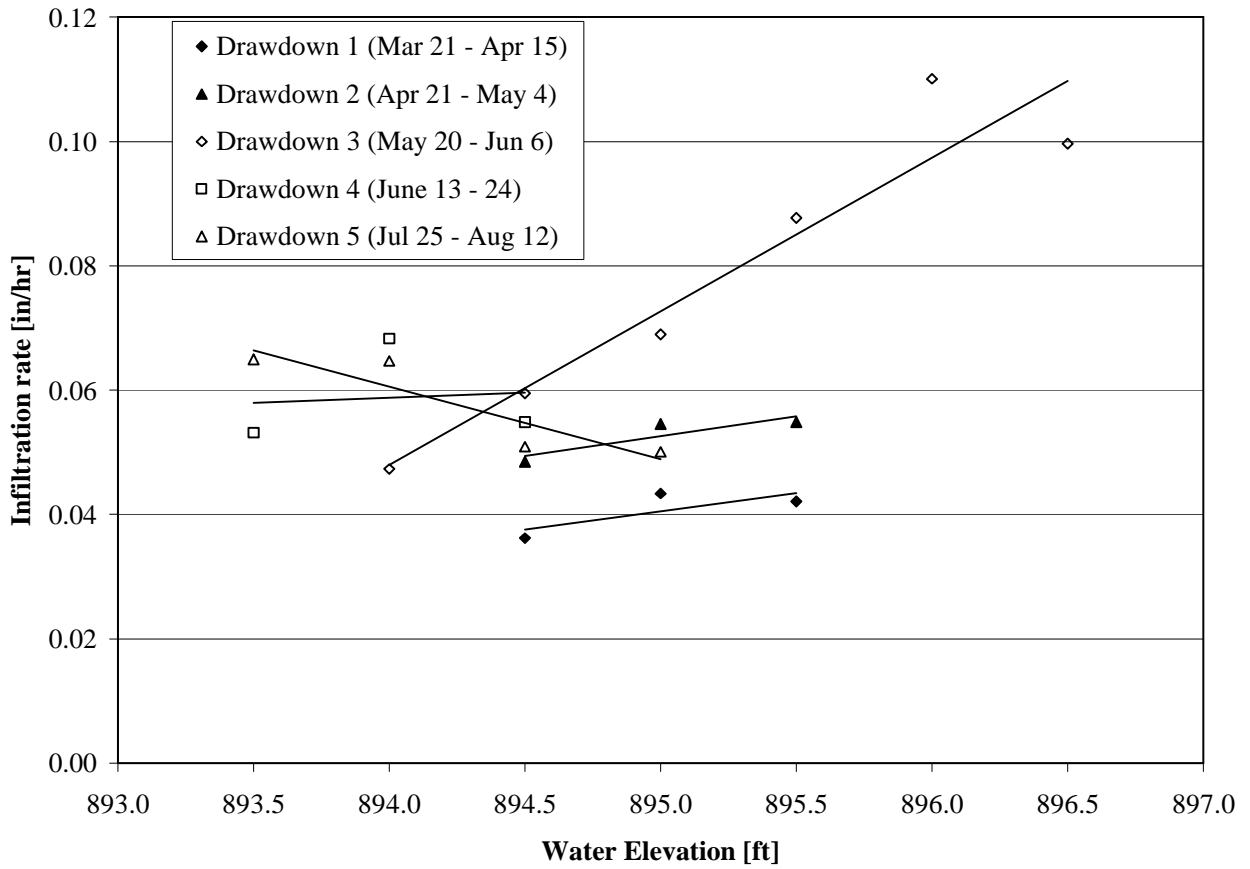
Figure III-3. CD-P50 Infiltration Rate Curves, 2003

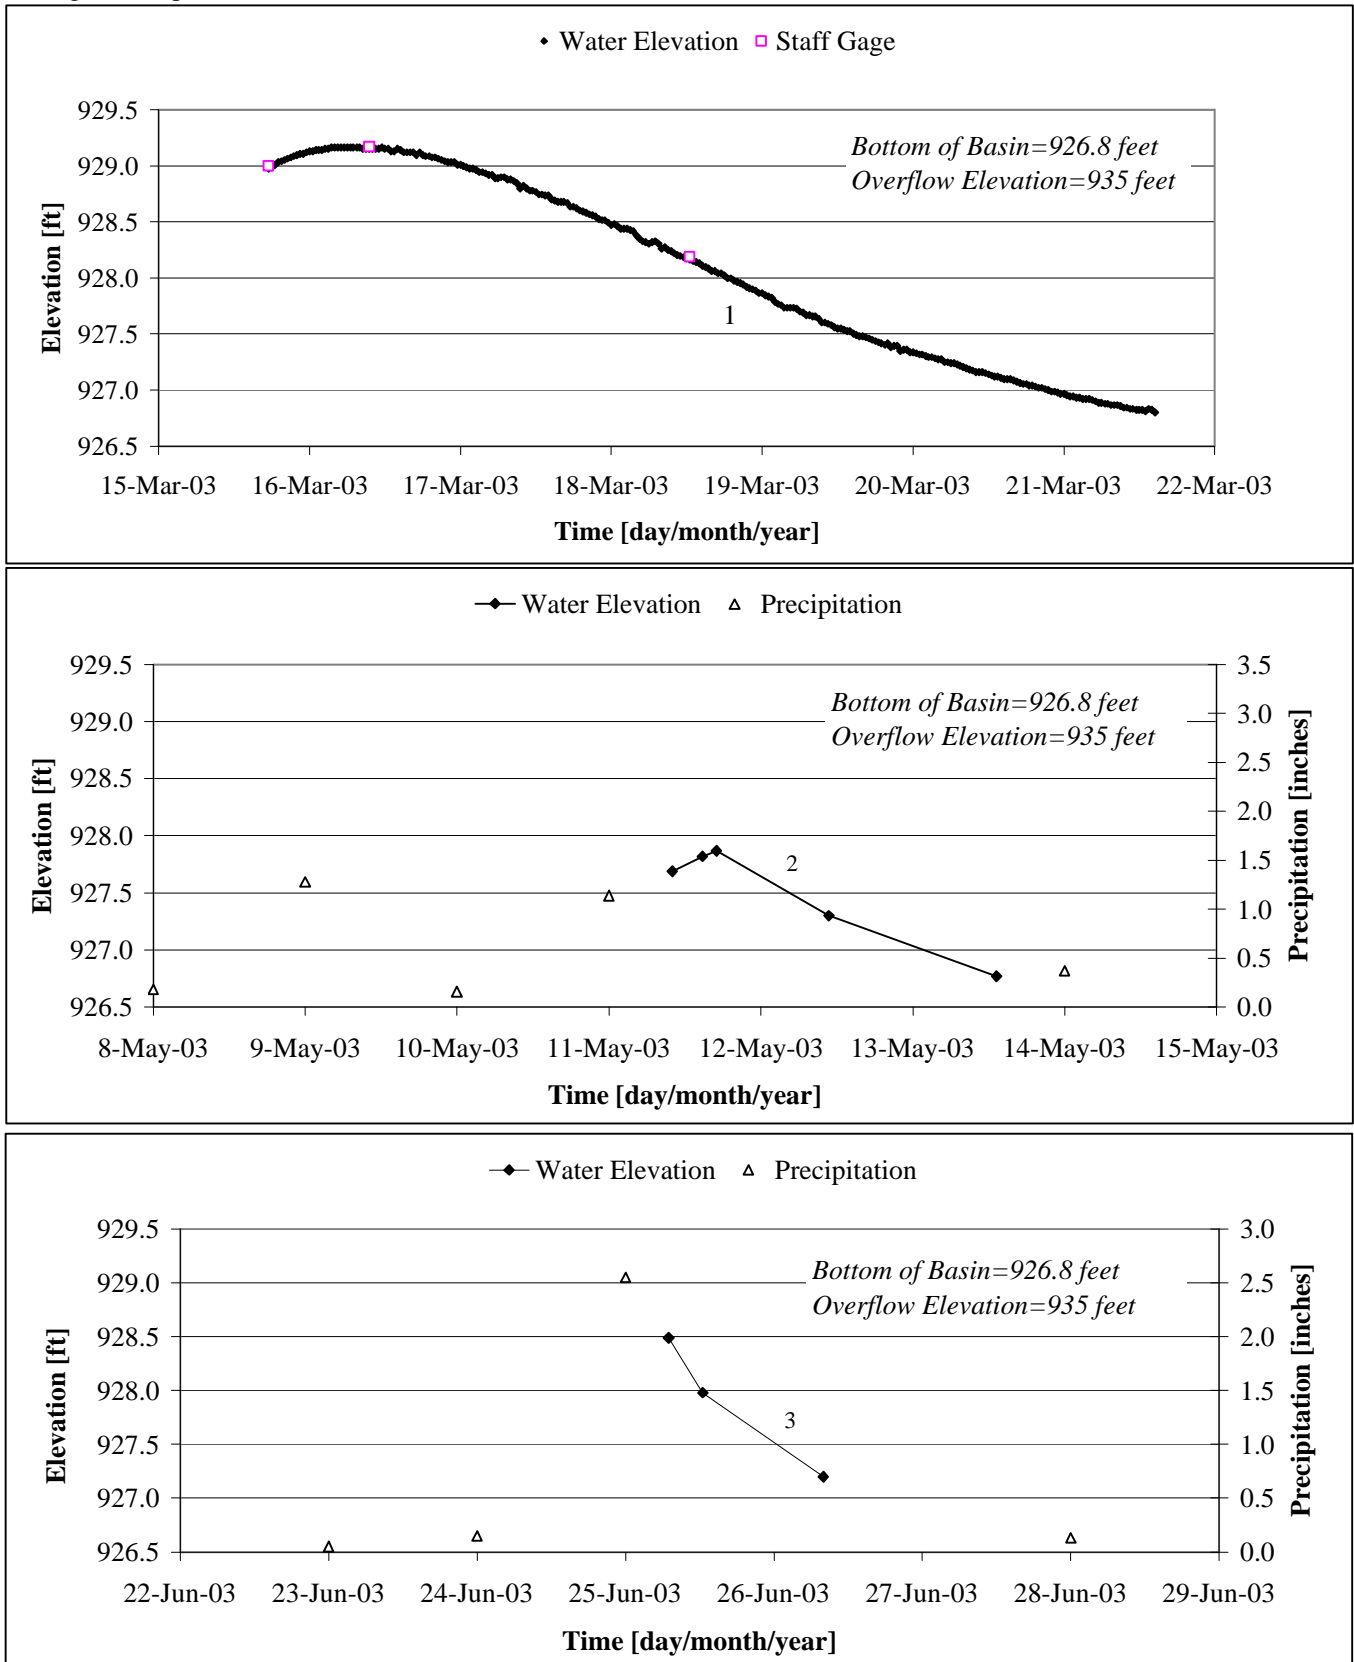
Figure III-6. CD-P76 Water Elevation Versus Time. Numbers refer to drawdown events. The three figures are plotted on the same scale.

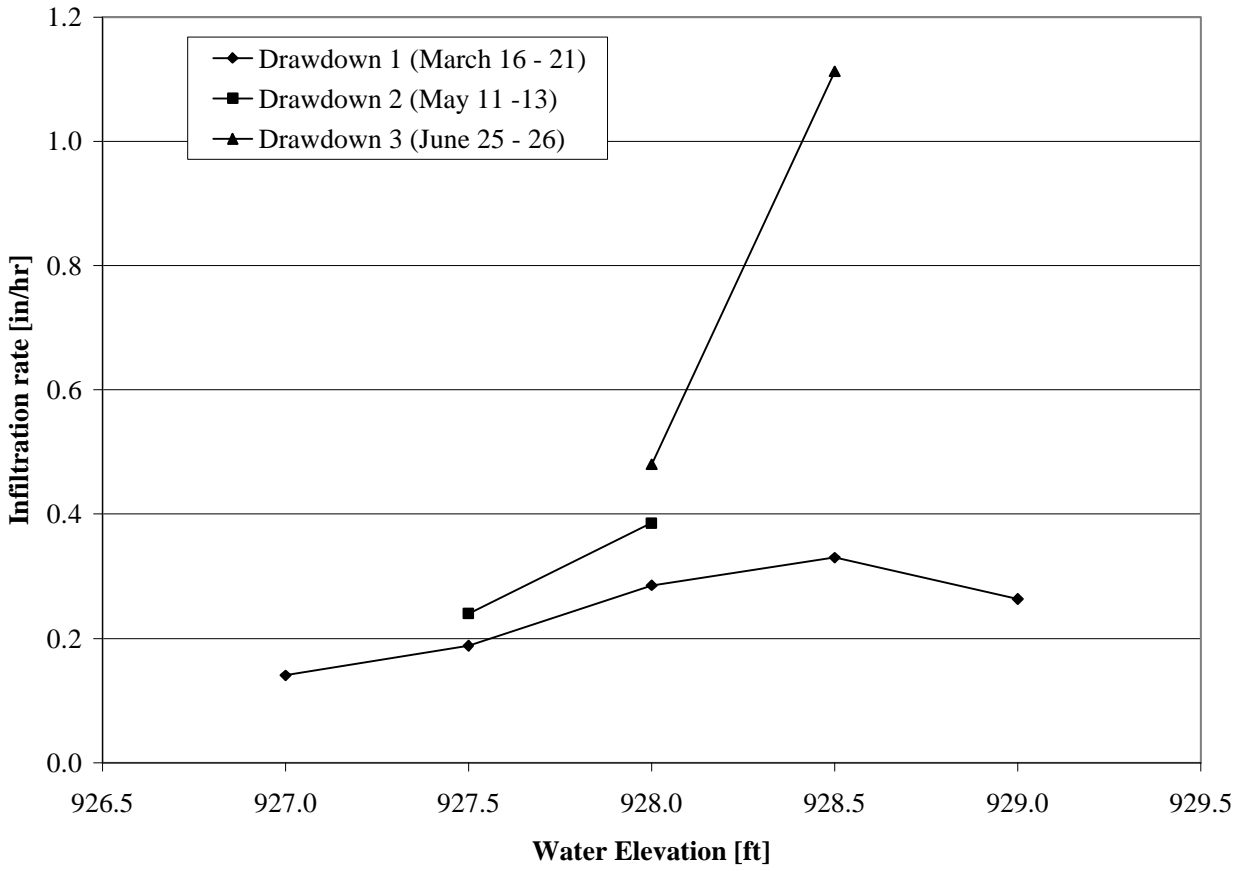
Figure III-7. CD-P76 Infiltration Rate Curves, 2003

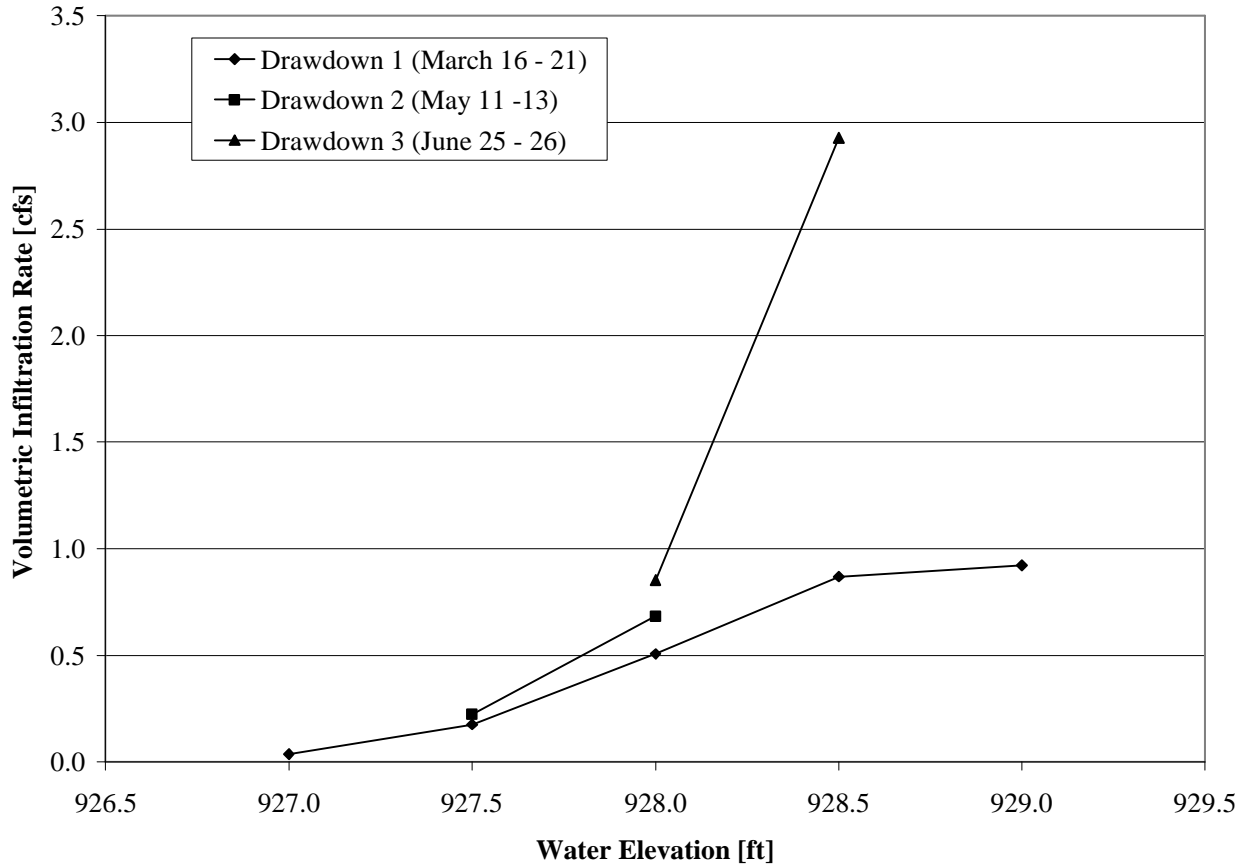
Figure III-8. CD-P76 Volumetric Infiltration Rate Curves, 2003

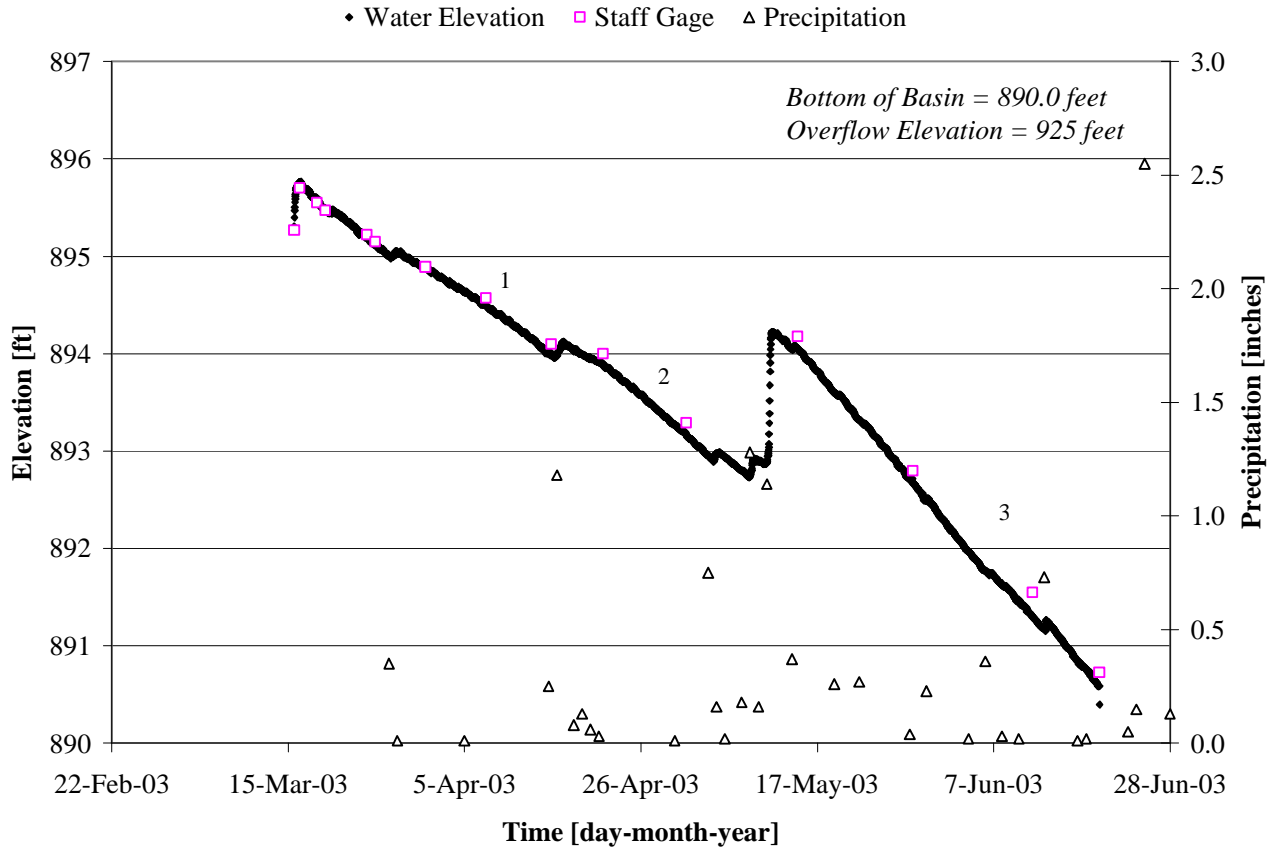
Figure III-10. CD-P82 Water Elevation vs. Time. Numbers refer to drawdown events.

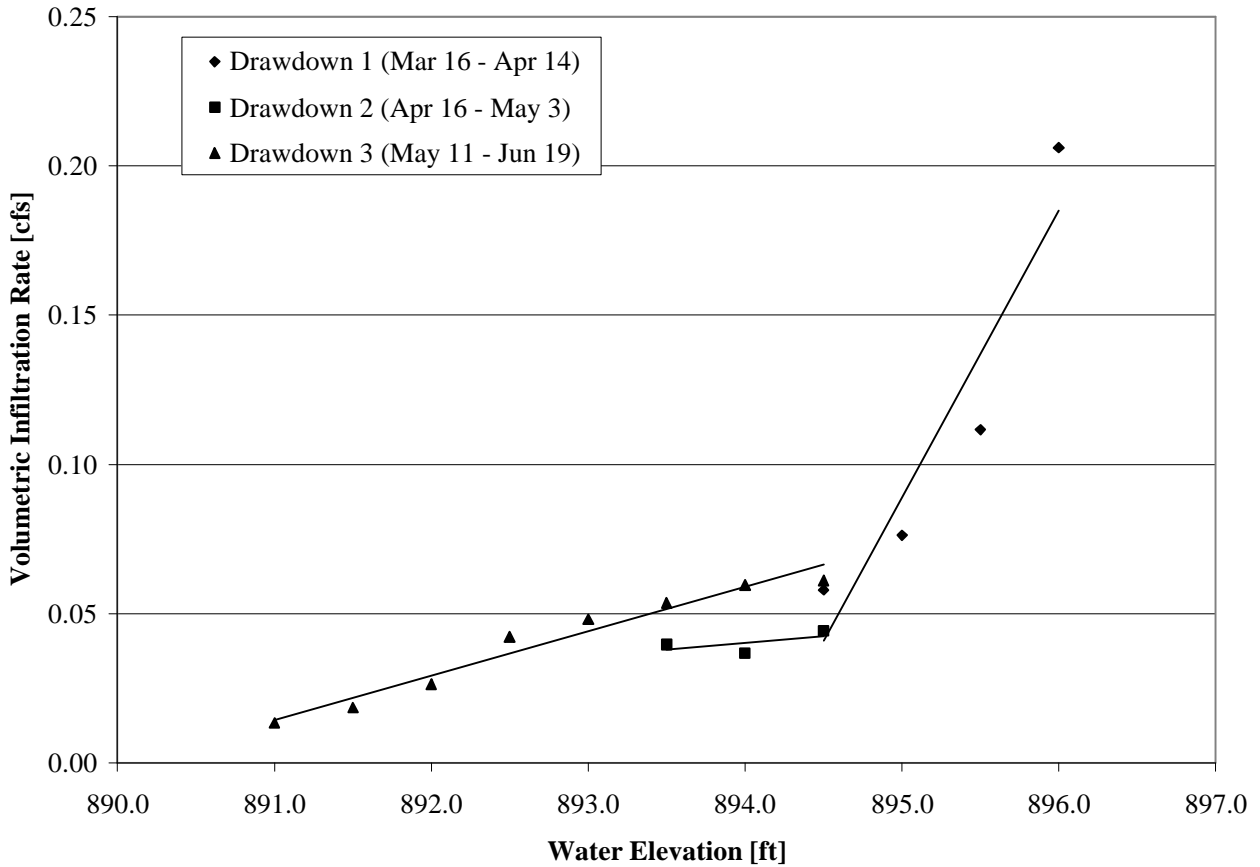
Figure III-12. CD-P82 Volumetric Infiltration Rate Curves, 2003

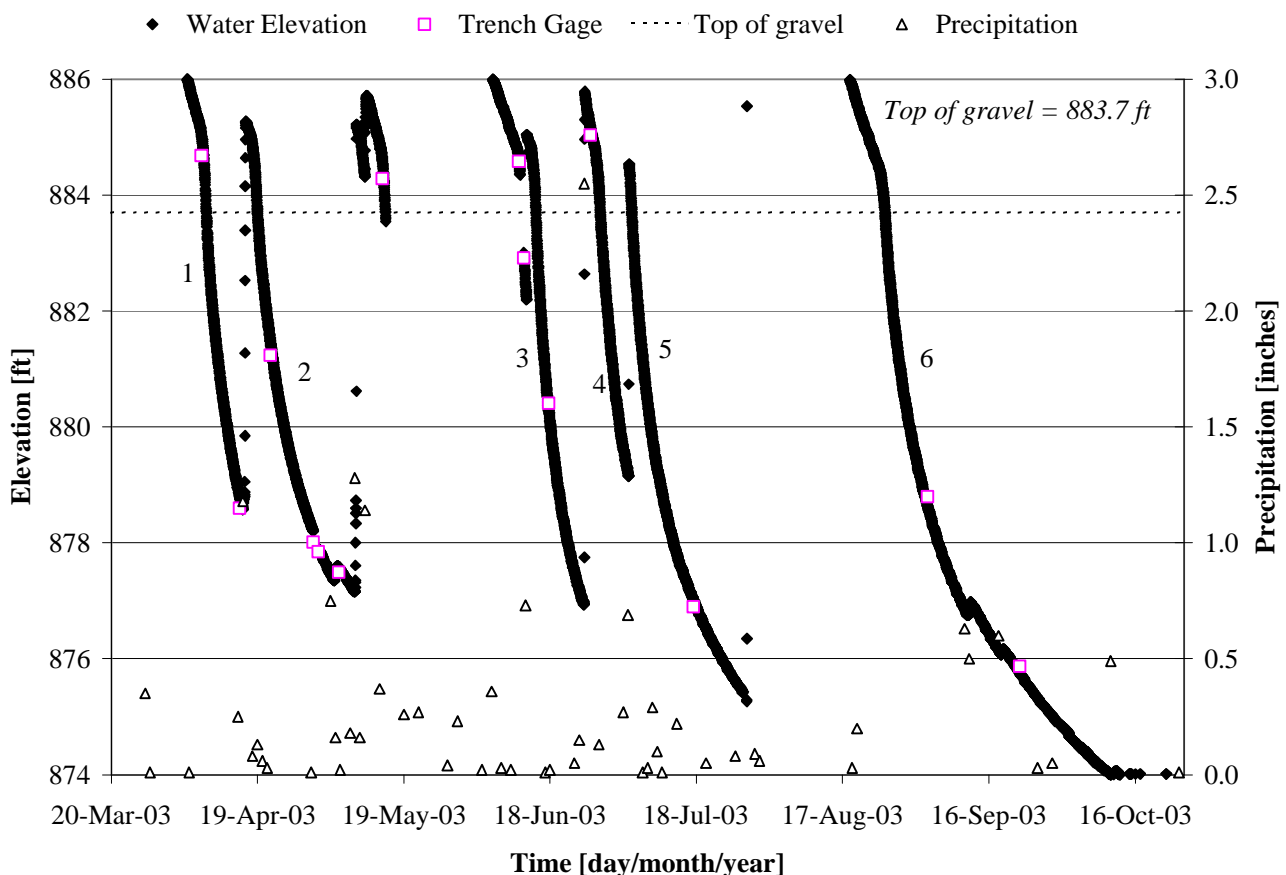
Figure III-14. CD-P85 Trench Water Depth vs. Time, 2003. Numbers refer to drawdown events.

Figure III-12 illustrates the depth of water in the CD-P85 infiltration trench over time. Table III-8 presents the infiltration rates observed for two of the drawdown events, representing the infiltration envelope for this trench. A discussion regarding the infiltration envelopes can be found in section VI.A. Figure III-13 compares the infiltration rates from different events to one another, plotted with respect to water depth. Either a linear or a polynomial curve was fit to each drawdown event in Figure III-13, depending on which relationship explained more of the variation in the rate of water decline. Where the relationship is polynomial, this indicates that the rate of water decline was relatively higher at greater depths of water, compared to if the relationship had been linear.

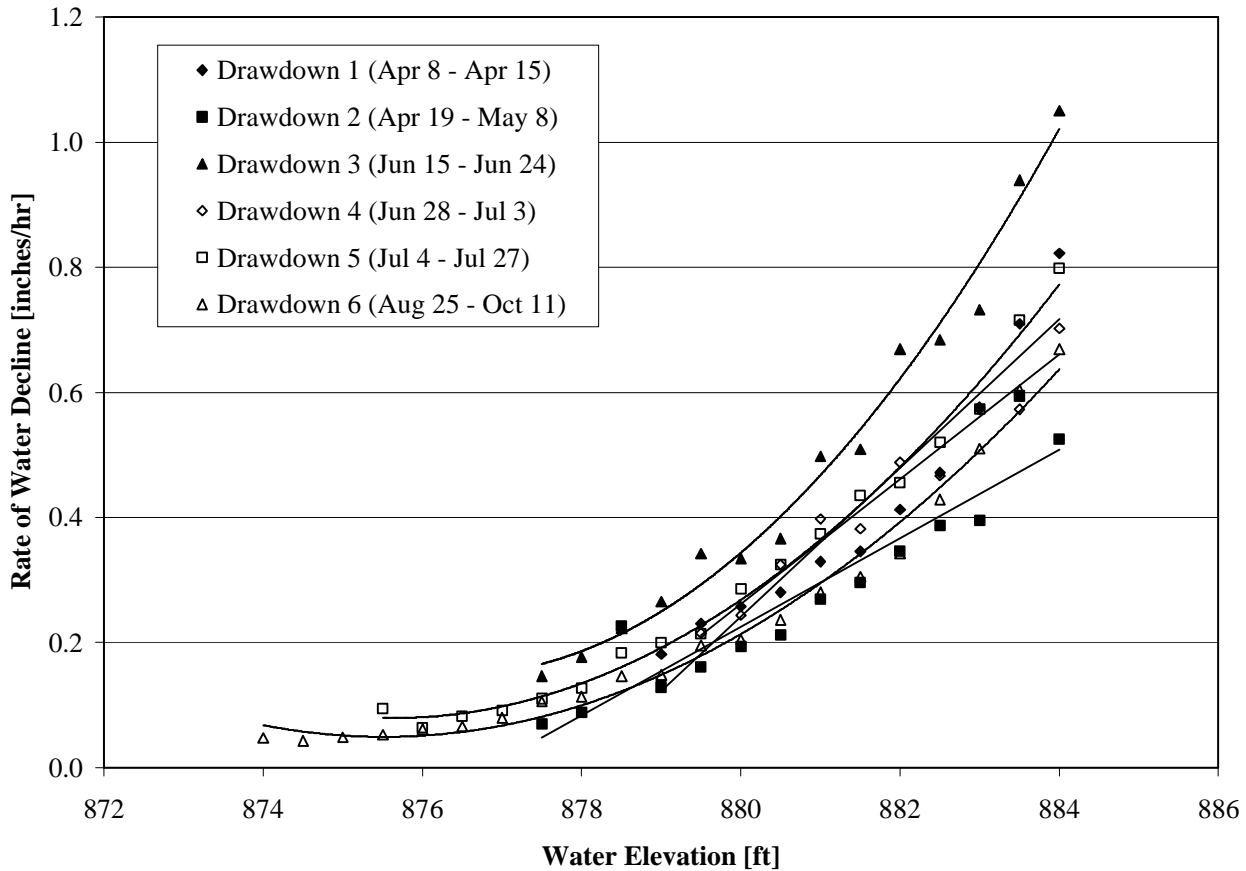
Figure III-15. CD-P85 Trench Rates of Water Decline, 2003

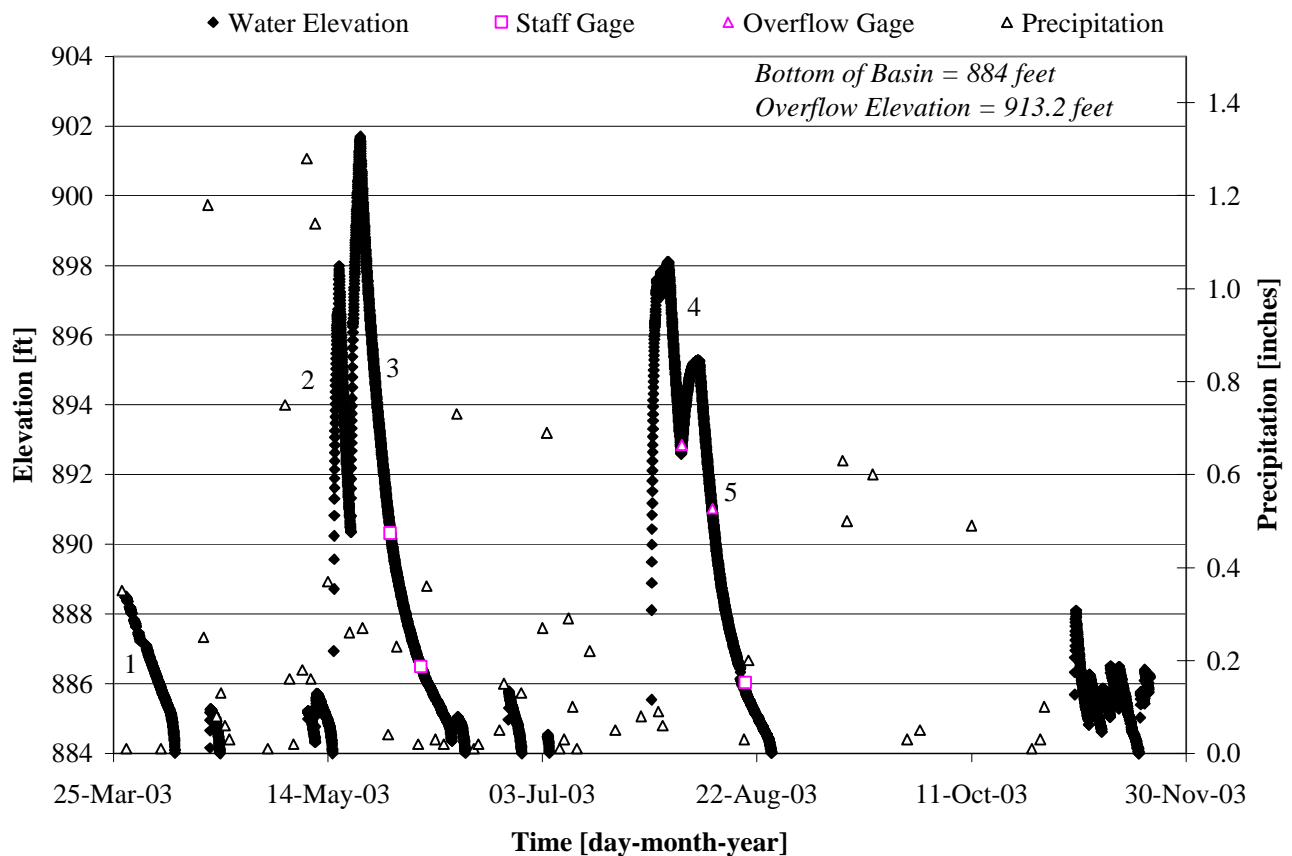
Figure III-16. CD-P85 Water Elevation vs. Time, 2003. Numbers refer to drawdown events.

During the fall and winter of 2002, a thick layer of ice formed at the bottom of the basin. Drawdown 1 (March 27 – April 4) is a result of this ice melting within the basin and direct drainage in the subwatershed. The City of Woodbury began a series of water pumping events beginning on May 9, 2003 from South Bailey Lake into regional infiltration basin CD-P85. Three separate pumping events occurred at CD-P85 in May, August and November.

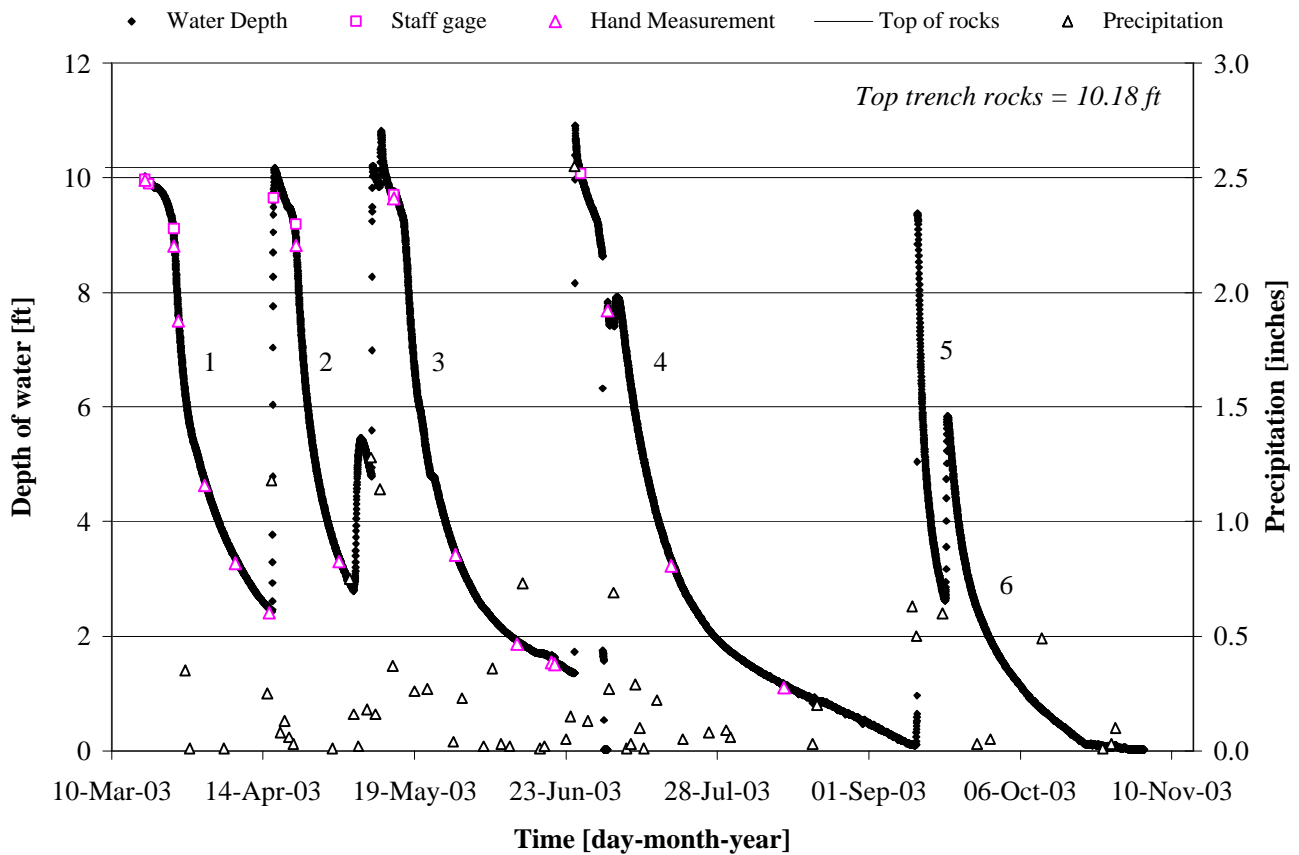
Figure III-19. MSA Depth vs Time and Precipitation, 2003. Numbers refer to drawdown events.

Figure III-19 illustrates the depth of water in the MSA trench over time. Water level data are presented as depth of water in the infiltration trench, as opposed to water elevation. In the MSA trench, the elevation of the surface water is not as relevant as in the other trench (in CD-P85), since the infiltration trench operates alone, and not in conjunction with an infiltration basin. Table III-10 presents the infiltration rates observed for two of the drawdown events, representing the infiltration envelope for the MSA trench. A discussion regarding the infiltration envelopes can be found in section VI-A. Figure III-20 compares the infiltration rates from different events to one another, plotted with respect to elevation.

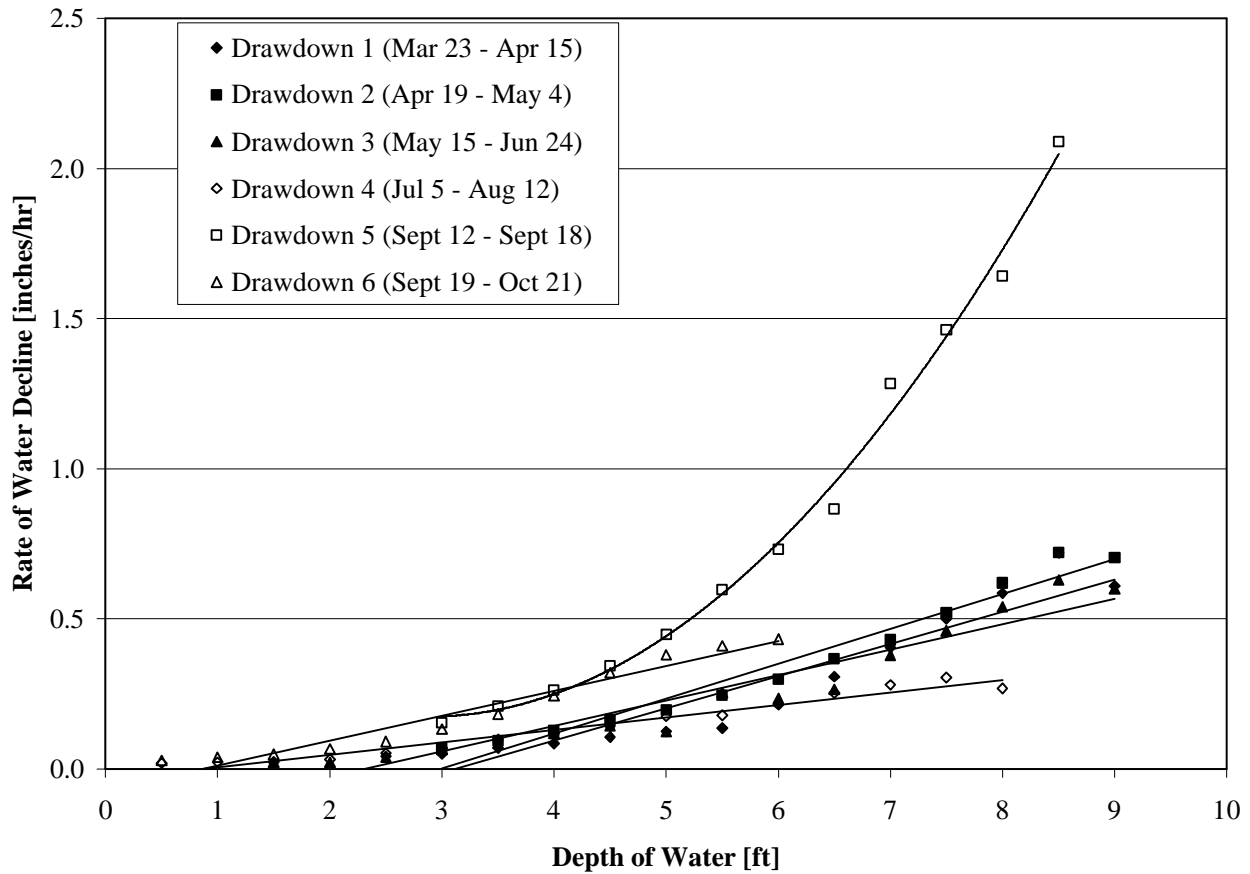
Figure III-20. MSA Trench Infiltration Rate Curves, 2003

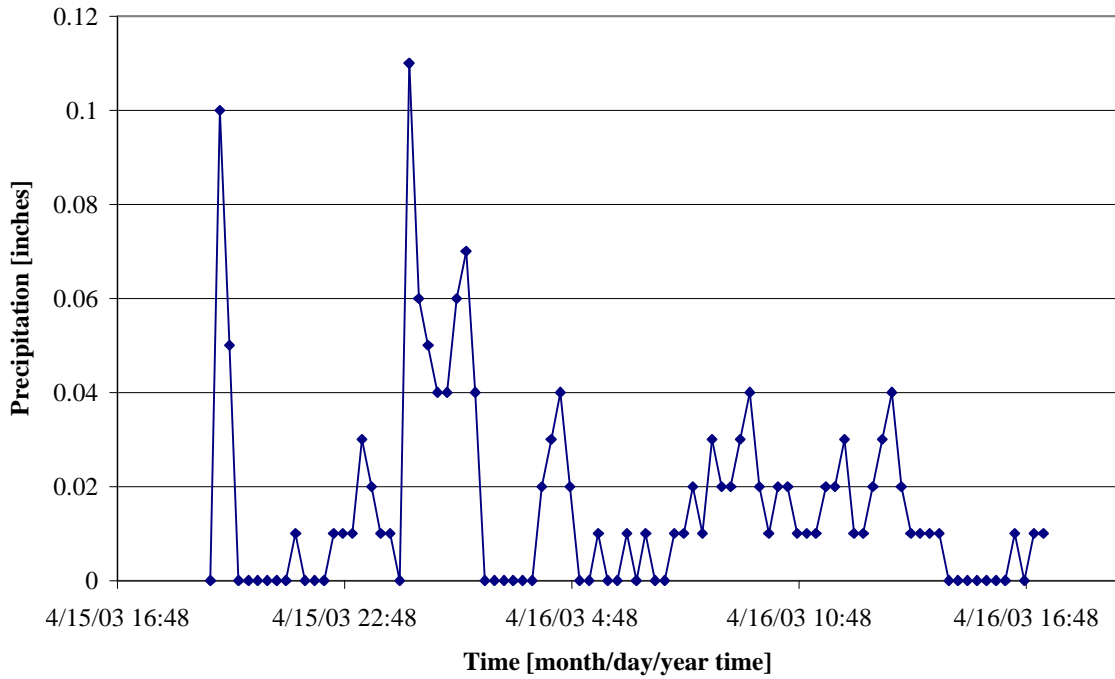
Figure IV-1. April 15 through 16 Rainfall Distribution

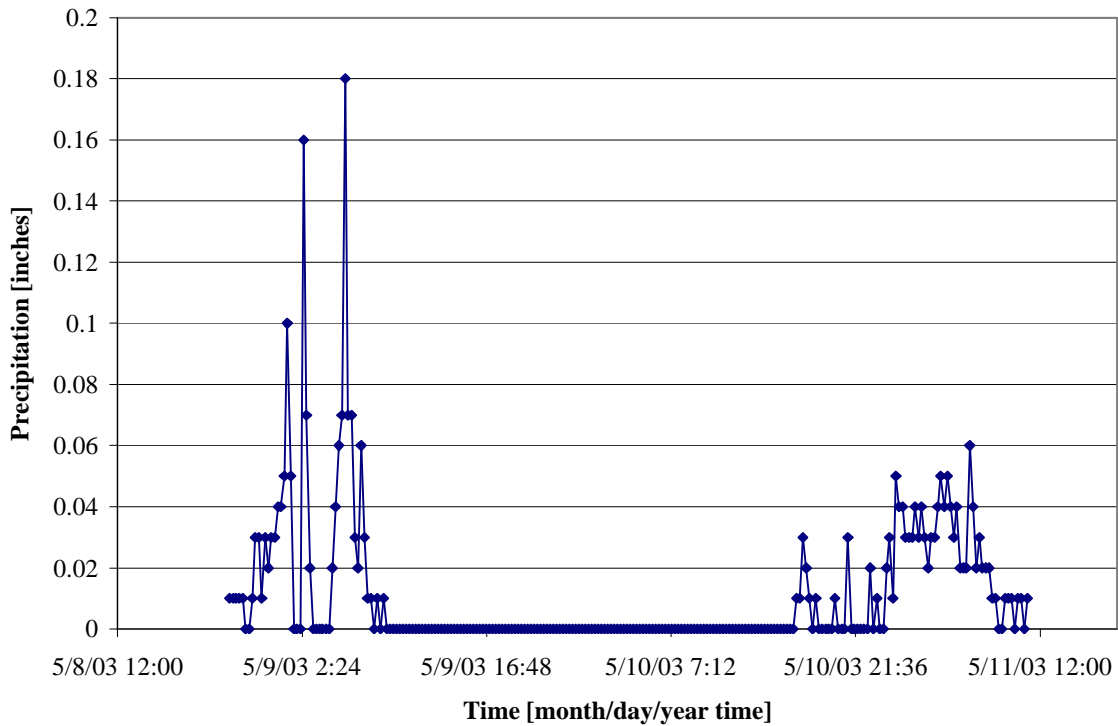
Figure IV-2. May 9-11 Rainfall Distribution

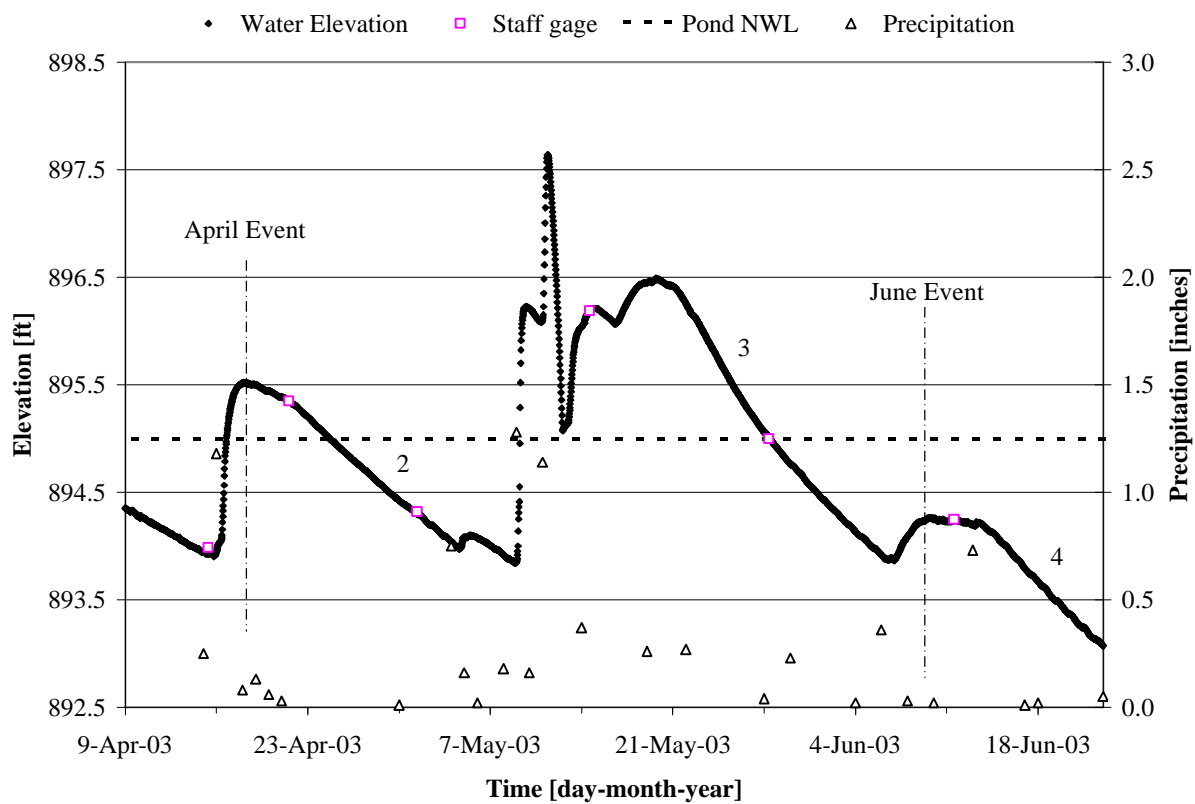
Figure IV-5. CD-P50 Surface Water Elevations and Ponding Events

Water levels at each basin and identified ponding events included in the CN analysis are presented in Figures IV-5 through Figure IV-7. Additional information on stage storage relationships, measured infiltration rates, and basin monitoring are summarized in Chapters II and III. The maximum height of ponded water within each basin during each precipitation event was used to calculate the volume of runoff delivered. The actual volume of runoff generated is likely higher than the volume used in this analysis due to infiltration occurring in the basins while the basin is filling. This will result in calculating lower than actual CN values.

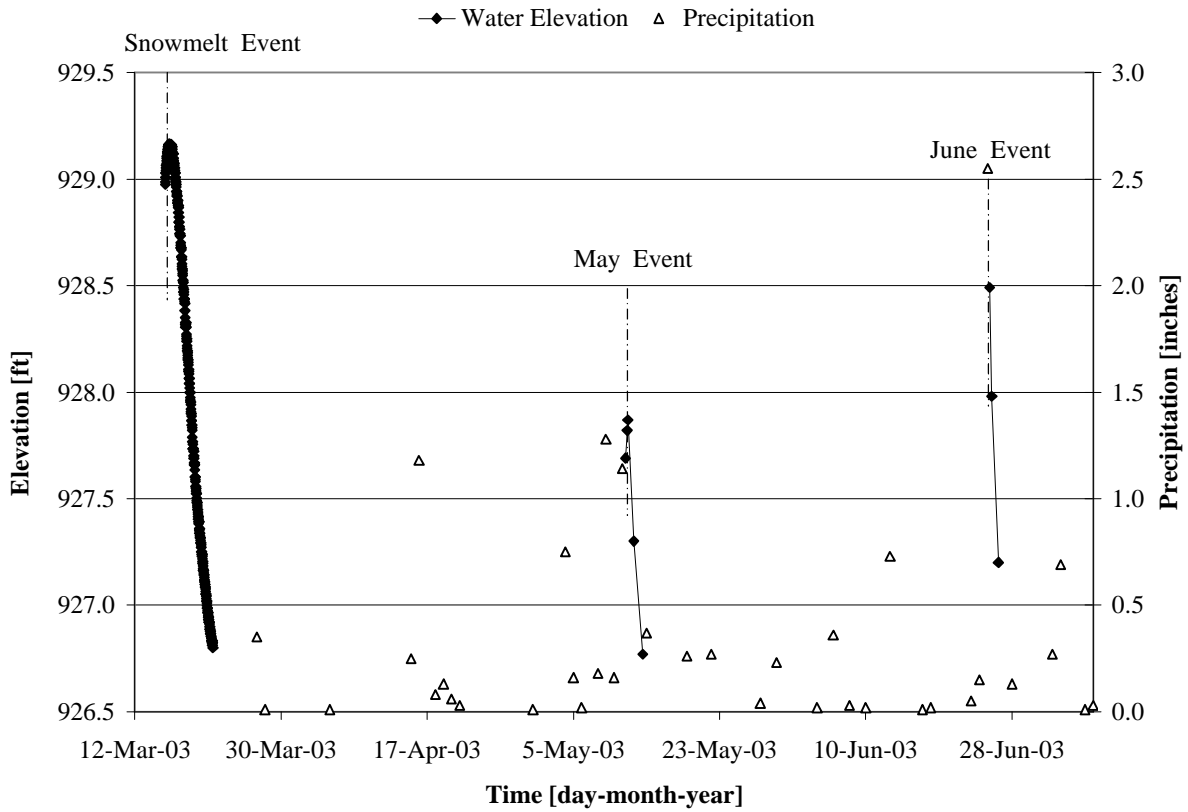
Figure IV-6. CD-P76 Surface Water Elevations and Ponding Events

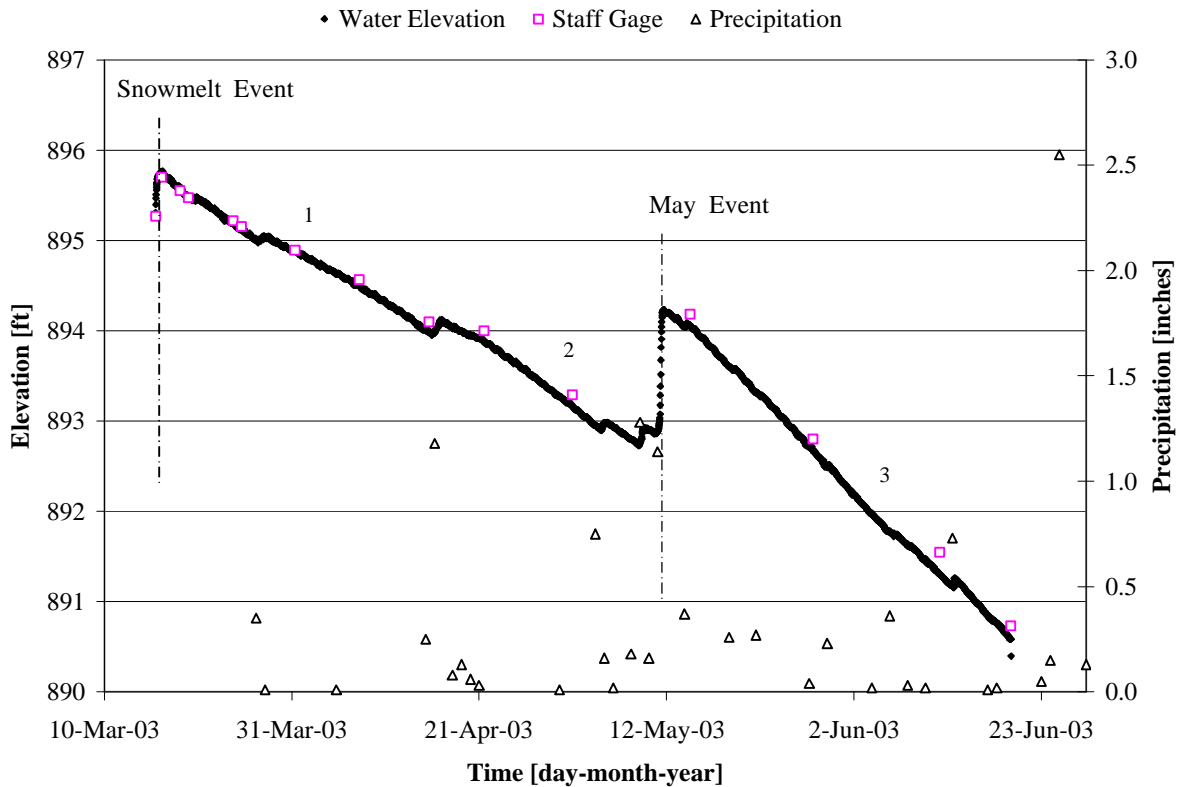
Figure IV-7. CD-P82 Surface Water Elevations and Ponding Events
