2003 INFILTRATION MONITORING PROGRAM

FINAL REPORT

February 2, 2004

Emmons and Olivier Resources, Inc.
651 Hale Avenue North
Oakdale, MN 55082

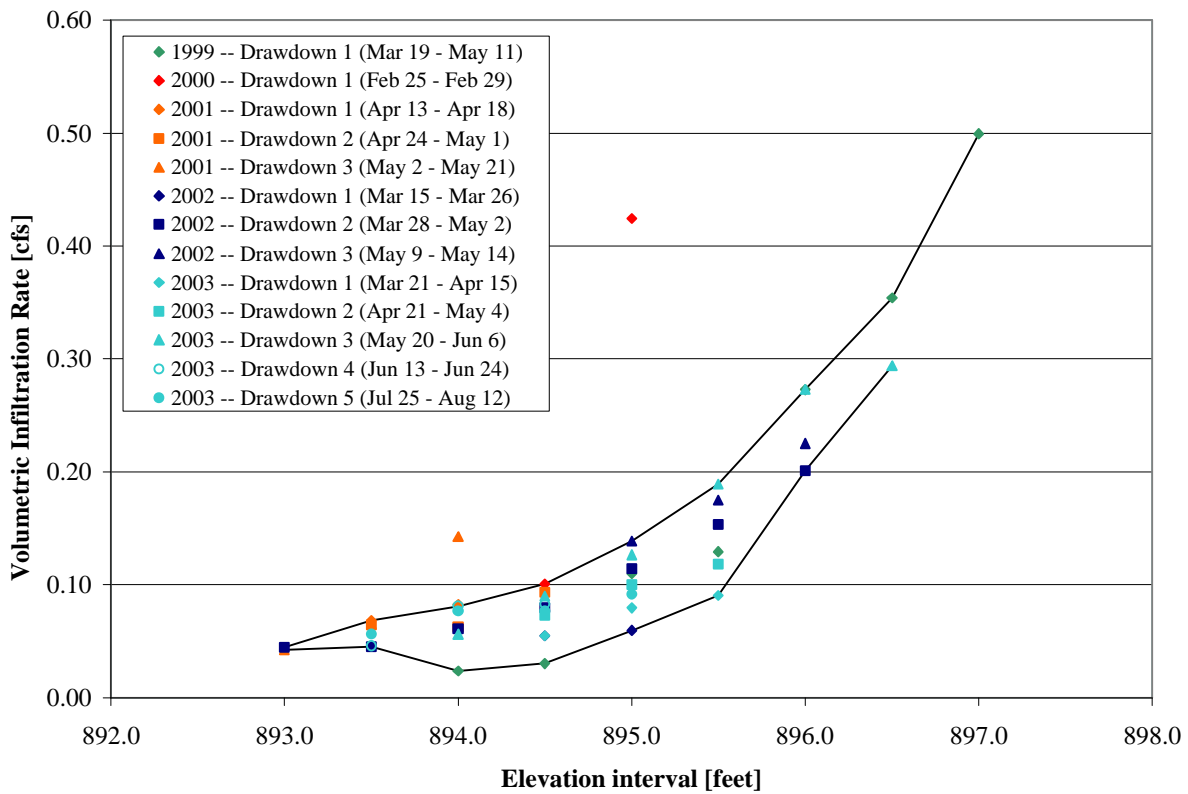
Figure VI-2. Volumetric Infiltration Rate vs. Elevation for CD-P50 1999-2003 and Infiltration Envelope

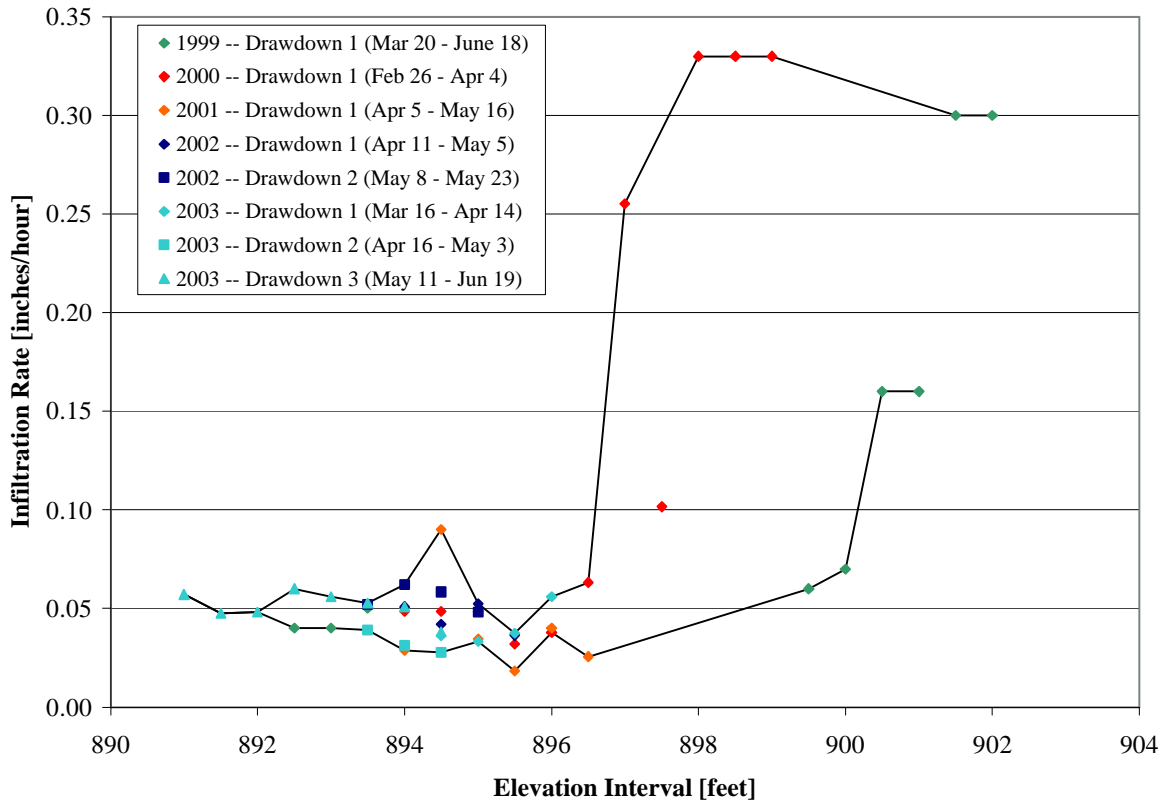
Figure VI-5. Infiltration Rate vs. Elevation for CD-P82 1999-2003 and Infiltration Envelope
