Comprehensive Lake Management Plan for Ravine Lake, Washington County, Minnesota

Prepared for
**Matt Moore, Administrator & the Managers of the
South Washington Watershed District**

Prepared by
**Steve McComas
Blue Water Science
St. Paul, MN
651.690.9602**

January 2003

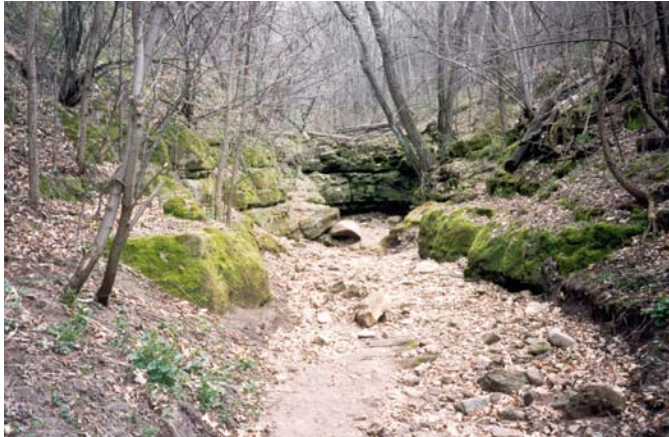
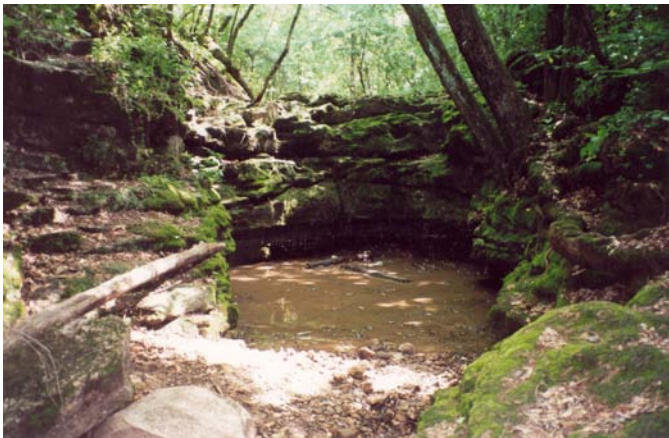
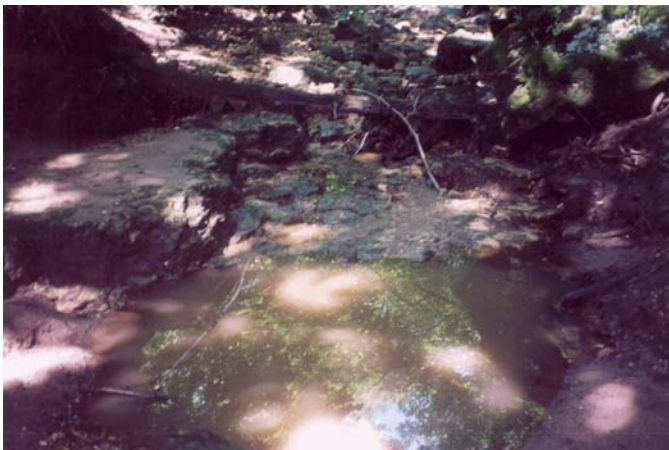
Figure 9. All three pictures are stream channels in a steep gradient on the northeast side of Ravine Lake and are in subwatershed RL-1, the active watershed.

No perennial streams flow into Ravine Lake, but there is interesting evidence of ephemeral stream flow that has probably been occurring for thousands of years.

The stream channel has cut through bedrock indicating that at times, flow must have been substantial.

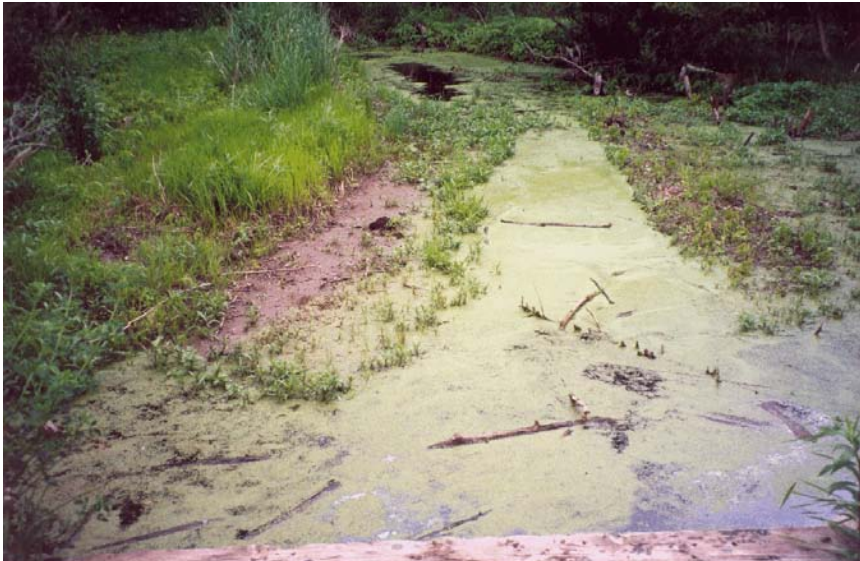
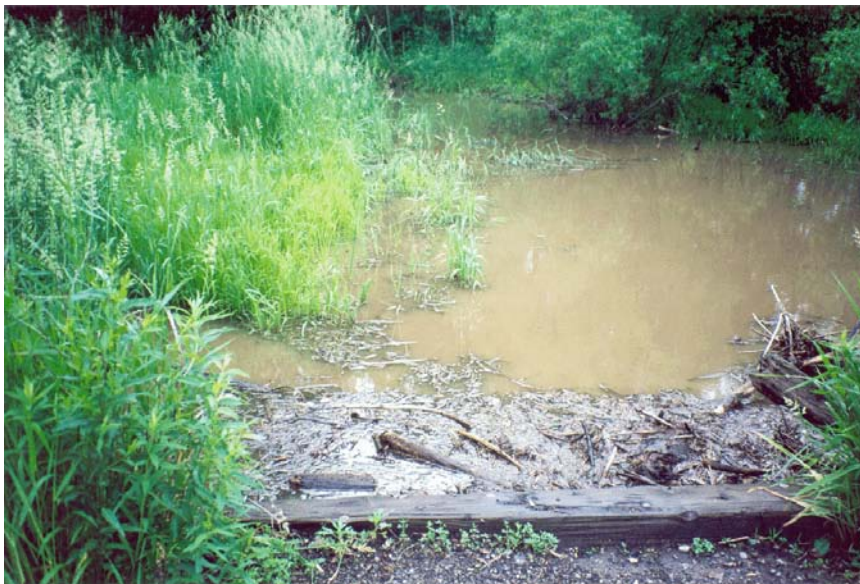
Figure 10. Stream channel leading into Ravine Lake referred to as the lake inlet area in Table 6. Both pictures are in a low gradient setting at the bottom of the ravine. The top picture is in June 2000 and the bottom picture is from June 2001.

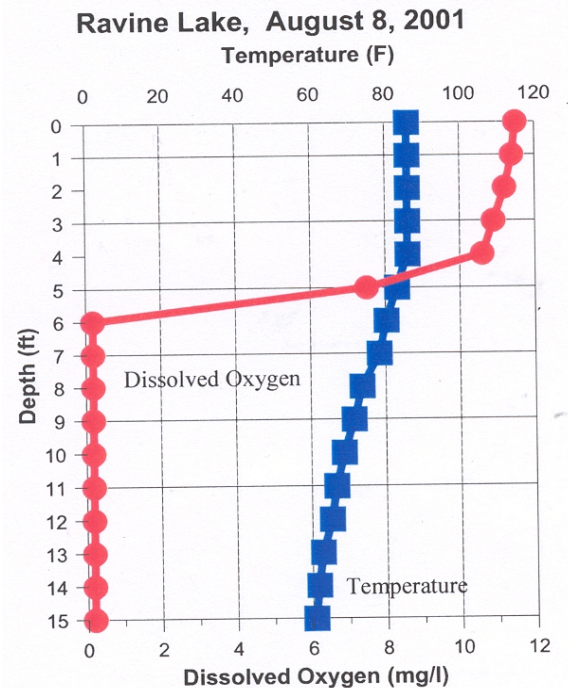
Figure 13. Dissolved oxygen/temperature profile for Ravine Lake, collected August 8, 2001.

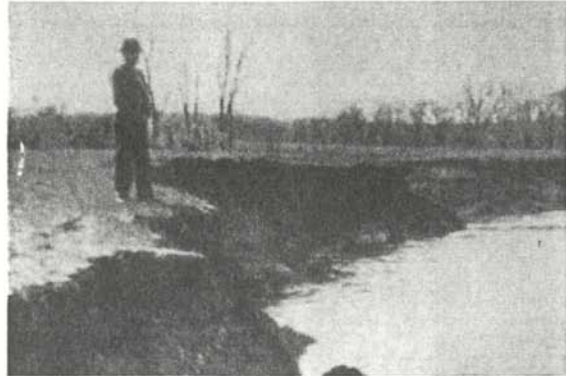
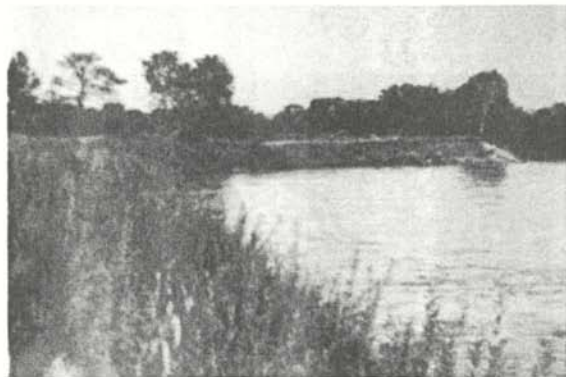
“Streambank erosion control project: (top) Existing conditions in 1937. (bottom) Same bank in 1938. Improvements included protecting toe of slope with riprap, reshaping the bank, brushmatted and planted with willows.” (From Edminster et al., 1949.)

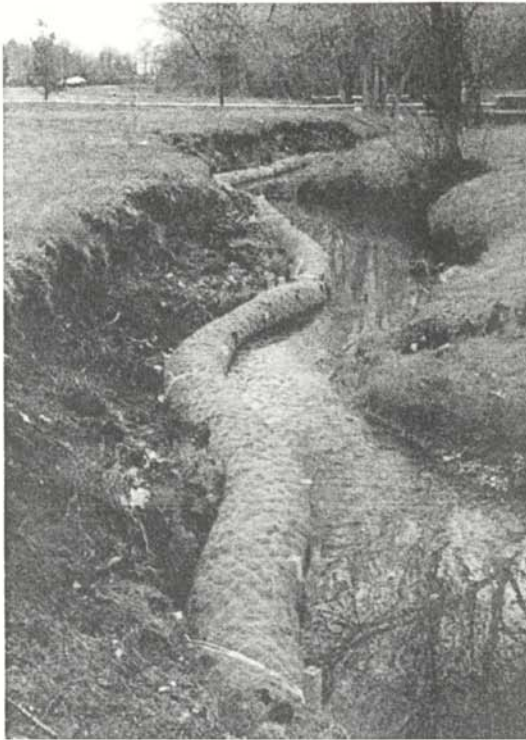
Coir fiber rolls can be used to stabilize the toe of a streambank. Bank reshaping and reseeding will complete the stabilization project. Coir fiber rolls are composed of loose coconut fiber from coconut husks, held together with coir fiber netting. In higher energy environments, rock is used. (From Don Knezick, Pinelands Nursery, Columbus, NJ. With permission.)

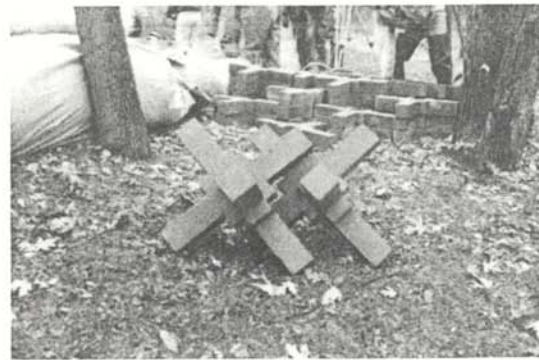
Another type of structural toe protection is the use of A-jacks. They are a good energy dissipater. As with rock riprap, they are permanent.

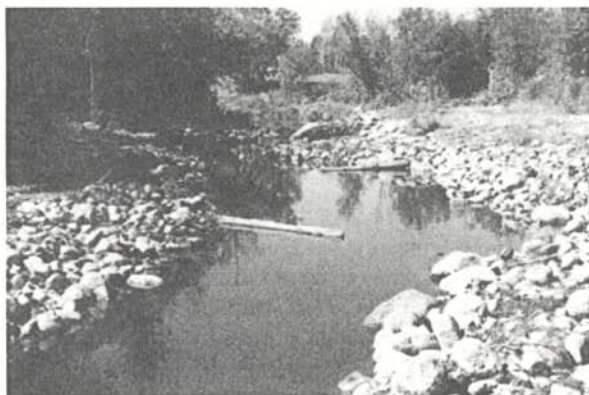
Rock can be used to stabilize the toe of a streambank where there are high flows.

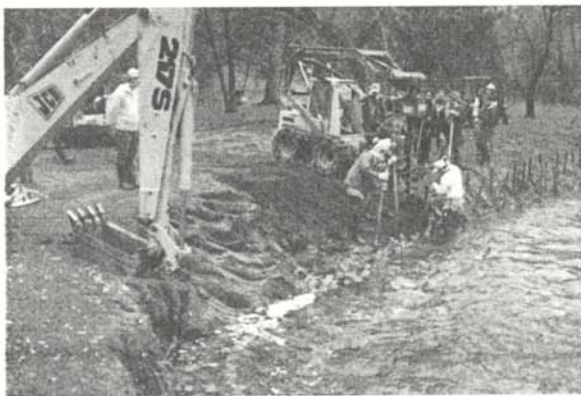
Reshaping the bank can be done by hand or with equipment. In this case, a backhoe is reshaping the streambank, followed by the placement of willow posts. An auger on the end of a bobcat drills holes for the willow posts.

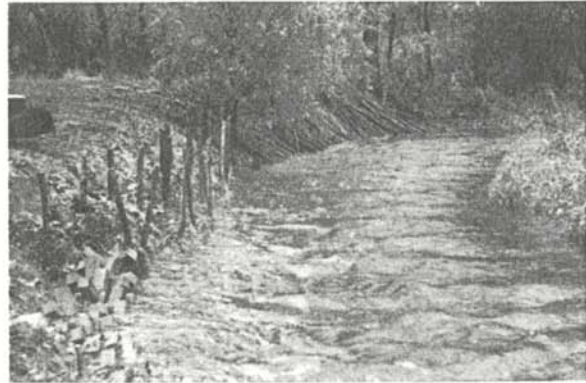
Willow posts and willow stakes are used to help stabilize streambanks. Their root systems stabilize the soil. Willows are often acquired from river floodplain areas. They are left soaking in water until they are used. They should be cut and inserted into the ground as soon as possible.

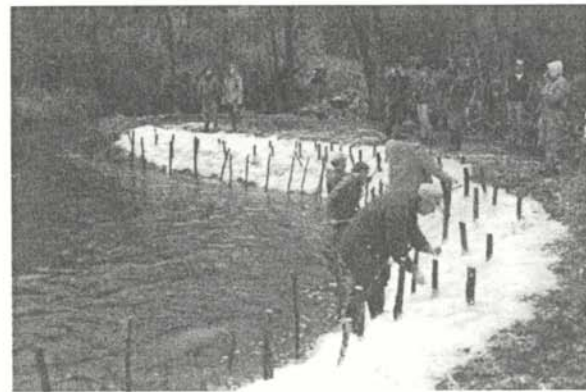
After inserting the willow posts, they can be cut off at 1 to 2 feet above the ground. Erosion control matting is laid down on the reshaped banks to reduce erosion.

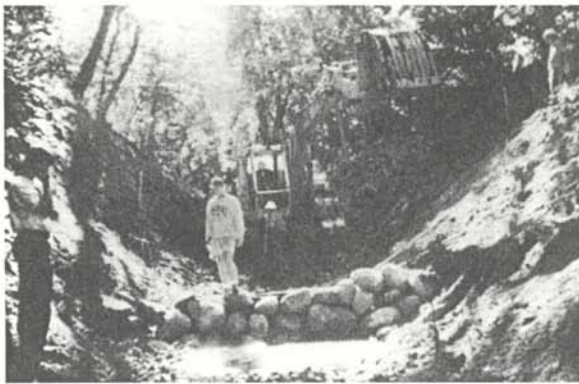
Reducing the gradient in gullies or ravines reduces the erosive force of the water flows. Grade control structures such as this rock weir reduce flow velocities and allow a streambank to reestablish vegetation and stabilize. The rock weir is constructed in the shape of an arc with the high point oriented upstream.

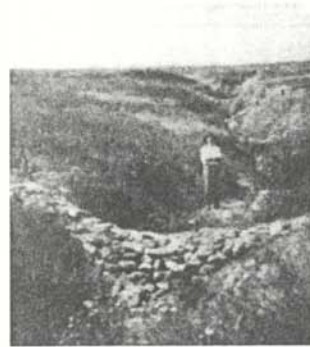
"Series of loose rock dams in a farm gully." (From Ayres, Q.C., Soil and Erosion Control, McGraw-Hill, New York, 1936.)

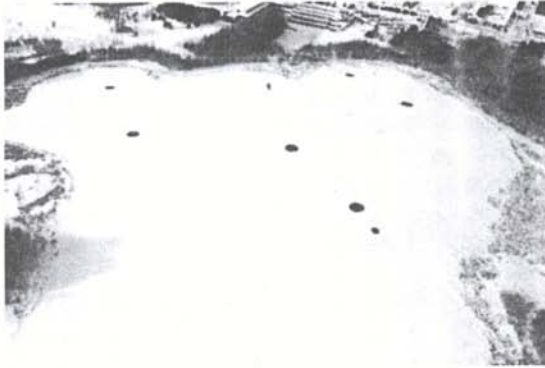
Winter diffuser aeration system operating on a 75-acre lake. An aerial view shows seven diffuser heads spread around the lake with the intent of aerating small pockets in the lake. (From H.B. Huller, Company Nature Reserve, Vadnais Heights, MN.)

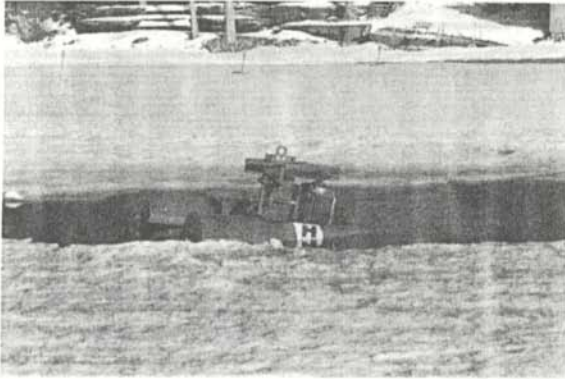
Another style of pump-and baffle-system uses an intake mounted on a floating platform. The hydraulic pump delivers low oxygenated lake water to the baffle component.

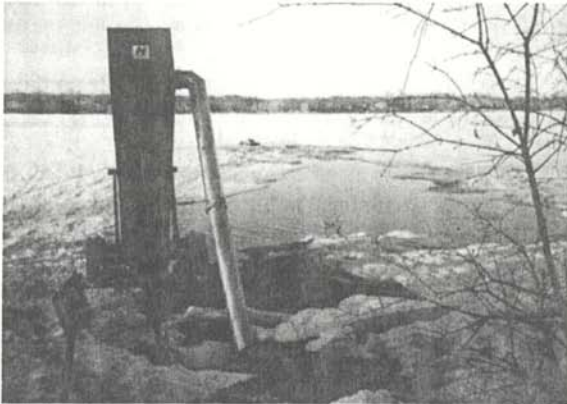
Lake water goes in at the top of the baffle and cascades back into the lake. (From City of Lakeville, Minnesota.)

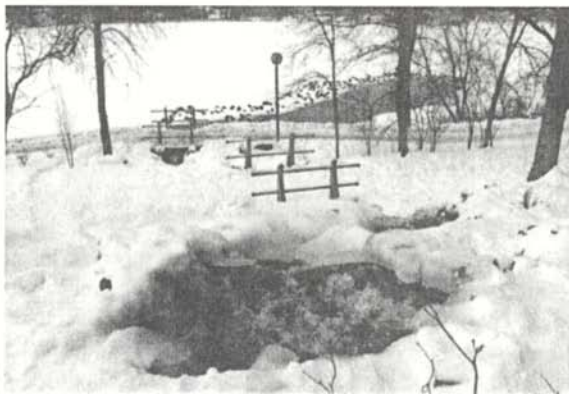
When the pump-and-baffle system is built into a hillside and uses natural rock for baffles, it mimics a bubbling brook. It looks natural and is a permanent setup, but can cost \$30,000 or more.

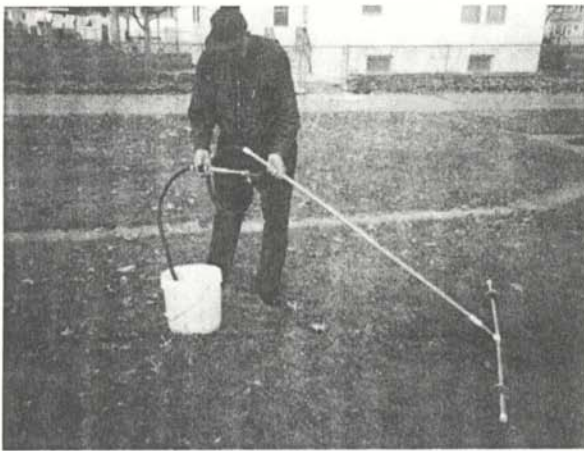
For small lakes or ponds, a distribution system for a buffered alum application can be constructed from PVC pipe. The buffered alum is mixed into a slurry in a pail and pumped through the manifold into the lake.

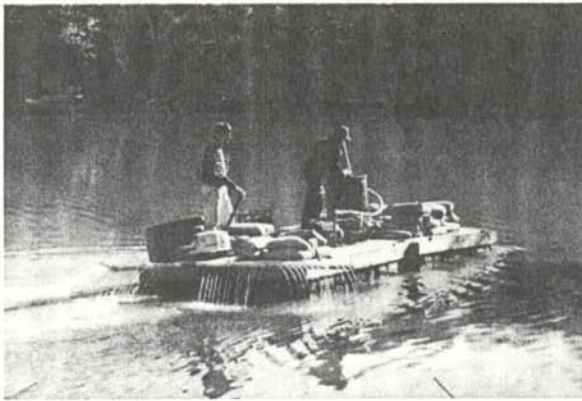
For alum applications in ponds over 4 acres in size, a scaled-up delivery system will be more efficient. Here, a commercial applicator mixes dry alum with lake water to make a slurry that is then pumped through a manifold in the rear of the alum barge.
