# O'Conner's Stream and Lake Management Plan

Final Report

Prepared for the Lower St. Croix Watershed Management Organization

Emmons and Olivier Resources, Inc.  
651 Hale Avenue North  
Oakdale, MN 55128

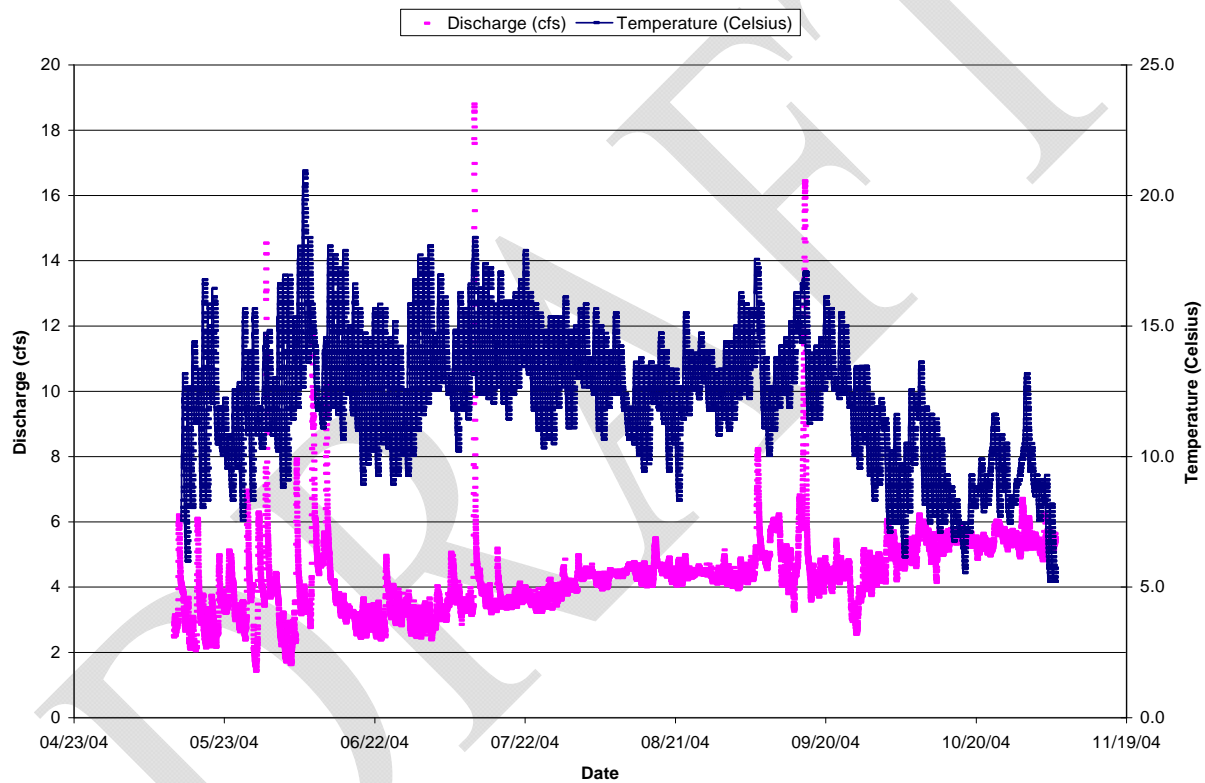
**Figure 9: O’Conner’s Stream Temperature and Discharge, April-November 2004.**

O’Conner’s Stream is continuously fed by the seepage of groundwater which in the region varies from 8° Celsius to 12°Celsius. Water temperature collected in the creek varies seasonally outside of the groundwater temperature range. The shift in stream temperature outside of the groundwater range is due to the seasonal ambient air temperature influence on stream temperature. Temperature data collected in 2004 by the WCD at County Road 21 illustrate the fluctuation of temperature through time (Figure 9). The maximum stream temperature recorded in 2004 was on June 7<sup>th</sup> and measured 20.9° Celsius (86°F). The minimum stream temperature recorded in 2004 was on November 4<sup>th</sup> and measured 5.2° Celsius (41°F).

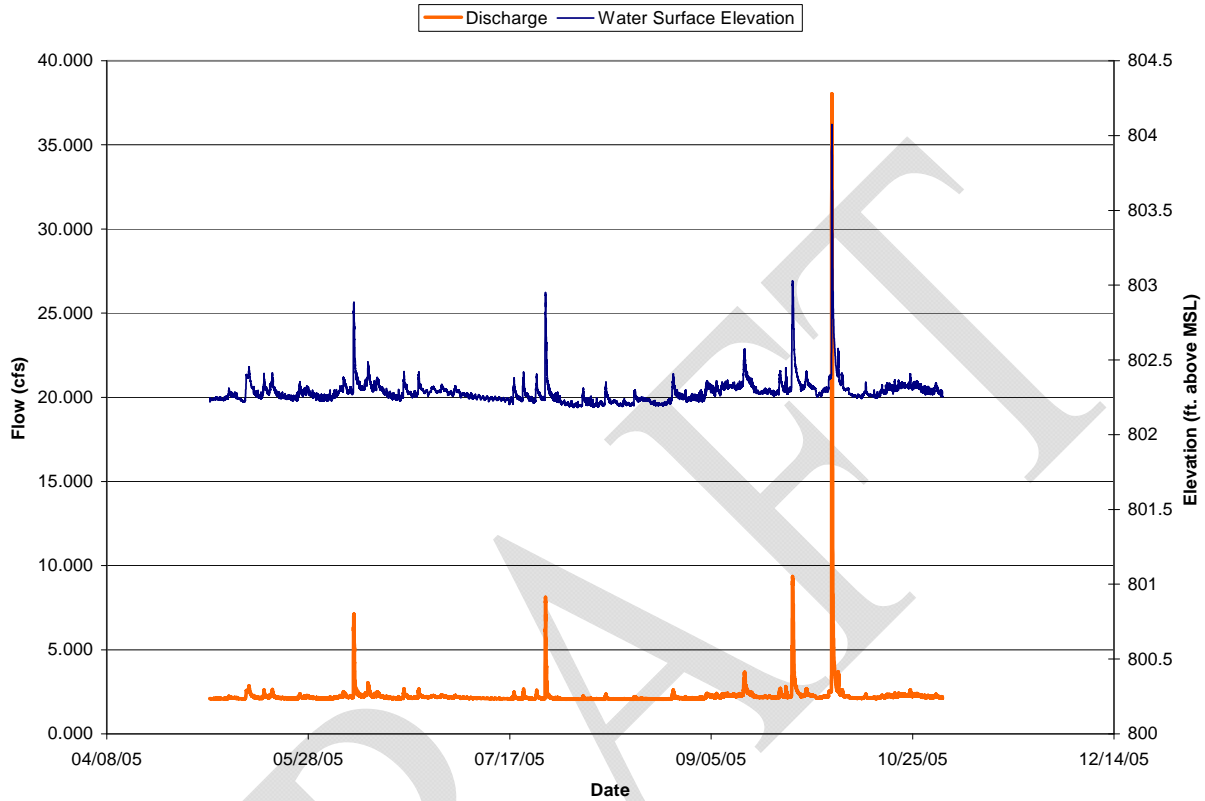
**Figure 10: Washington Conservation District Flow/Stage Data, 2005.**

Stream flow data were collected in 2005 near the inlet to O'Conner's Lake on the west side of the County Road 21 Bridge. Equipment was set and data were collected and calibrated by the Washington Conservation District (WCD). Creek stage data were collected and converted to discharge from a rating curve developed by the WCD. Discharge data from the WCD indicate that creek baseflow is very close to 2 cfs for the months May through October.

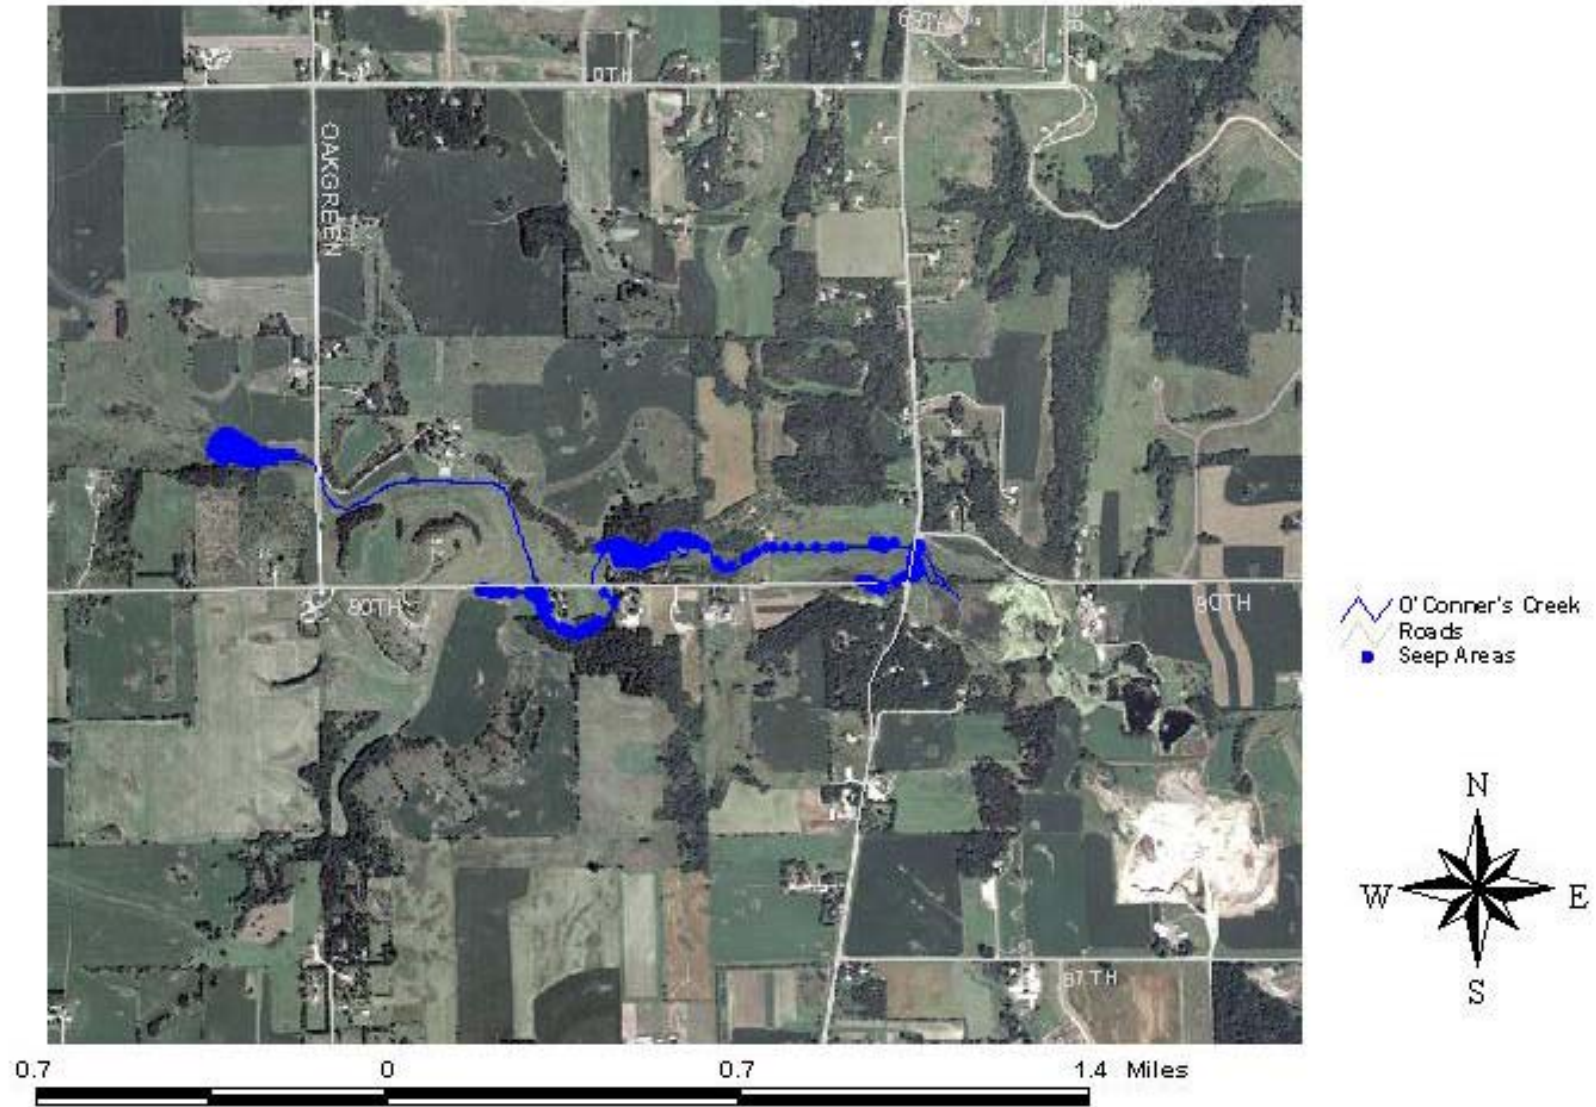
**Figure 11: Groundwater Discharge Regions**

An extensive spring inventory was conducted May 5, 2005 to identify recharge areas along O’Conner’s Stream. The majority of groundwater resurging along the stream is through slow seep recharge. Many of the seepage areas are identifiable by a reddish iron precipitate visible at the surface. Notable recharge areas along the stream include the wetland region west of Oakgreen Avenue South where the perennial stream begins, north of 80<sup>th</sup> Street South along the south side of the bluff, and east of County Road 21 (Figure 11). Two small springs were identified along the creek, one located south of the 80th Street South bridge and the other located on the west side of the bluff located north of 80<sup>th</sup> Street South. Figure 12 depicts a seep region located east of County Road 21. Note the orange iron precipitate visible at surface.
