Comprehensive Lake Management Plan for Ravine Lake, Washington County, Minnesota

Prepared for
**Matt Moore, Administrator & the Managers of the
South Washington Watershed District**

Prepared by
**Steve McComas
Blue Water Science
St. Paul, MN
651.690.9602**

January 2003

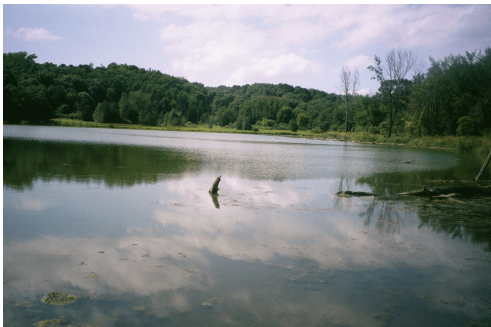
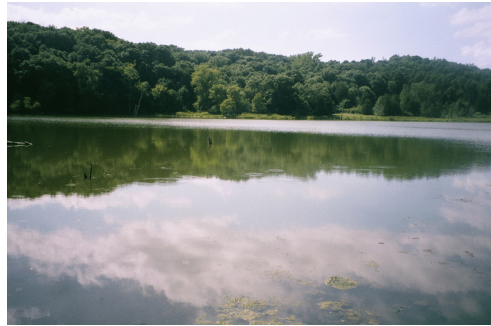
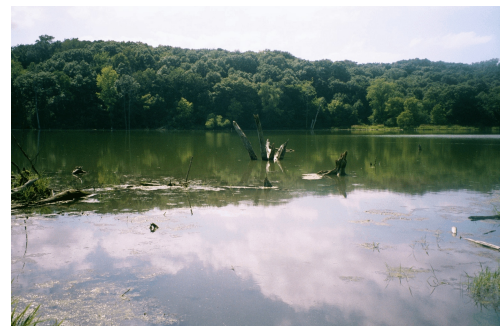
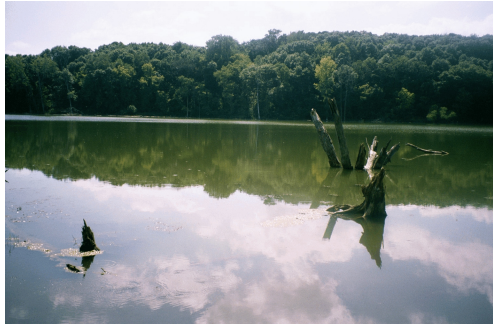
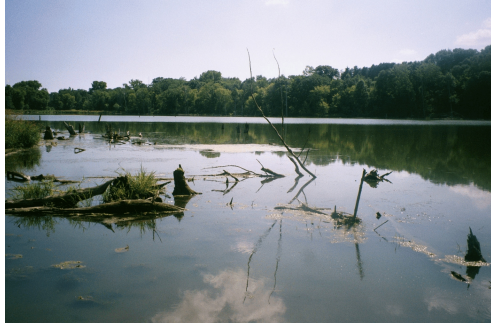
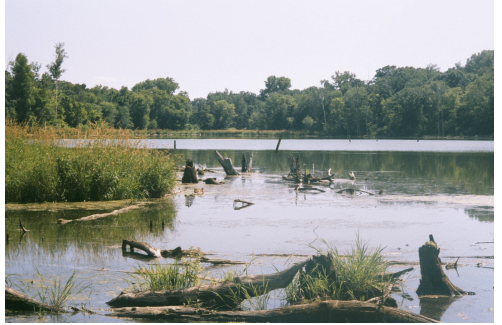
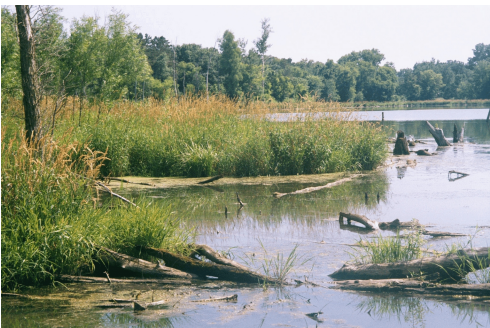
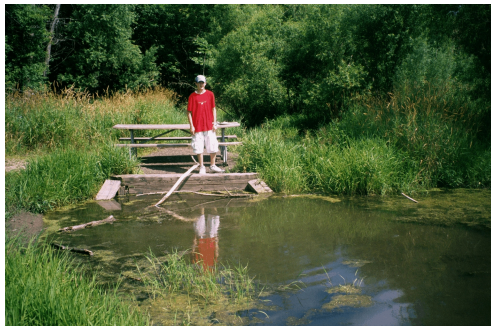
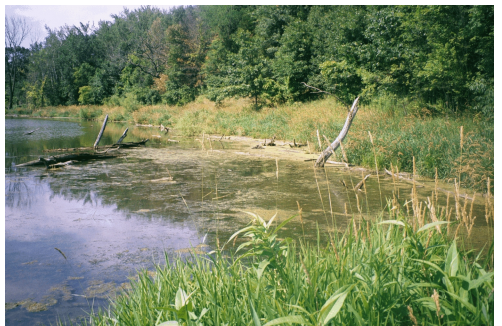
Key to shoreland photo parcels for Ravine Lake, July 19, 2001.

The shoreland area encompasses three components: the upland fringe, the shoreline, and shallow water area by the shore. A photographic inventory of the 0.9 mile Ravine Lake shoreline was conducted on July 19, 2001. The objectives of the survey were to characterize existing shoreland conditions which will serve as a benchmark for future comparisons.

For each photograph we looked at the shoreline and the upland condition. Our criteria for natural conditions were the presence of 50% native vegetation in the understory and at least 50% natural vegetation along the shoreline in a strip at least 15 feet deep. We evaluated shorelands and uplands at the 75% natural level as well.

Table 3. Summary of shoreland conditions for the 0.9 miles of shoreline around Ravine Lake. Nine photographs were used.

ID #	Natural Upland Condition		Natural Shoreline Condition		Shoreline Erosion		Shoreline Structure			Comments
	>50%	>75%	>50%	>75%	No	Yes*	No	Yes riprap	wall	
1	X	X	X	X	X		X			
2	X	X	X	X	X		X			
3	X	X	X	X	X		X			
4	X	X	X	X	X		X			
5	X	X	X	X	X		X			
6	X	X	X	X	X		X			
7	X	X	X	X	X		X			
8	X	X	X	X	X				X	Inlet area.
9	X	X	X	X	X		X			
TOTALS	9/9 (100%)	9/9 (100%)	9/9 (100%)	9/9 (100%)	9/9 (100%)		8/9 (89%)	0/9 (0%)	1/9 (11%)

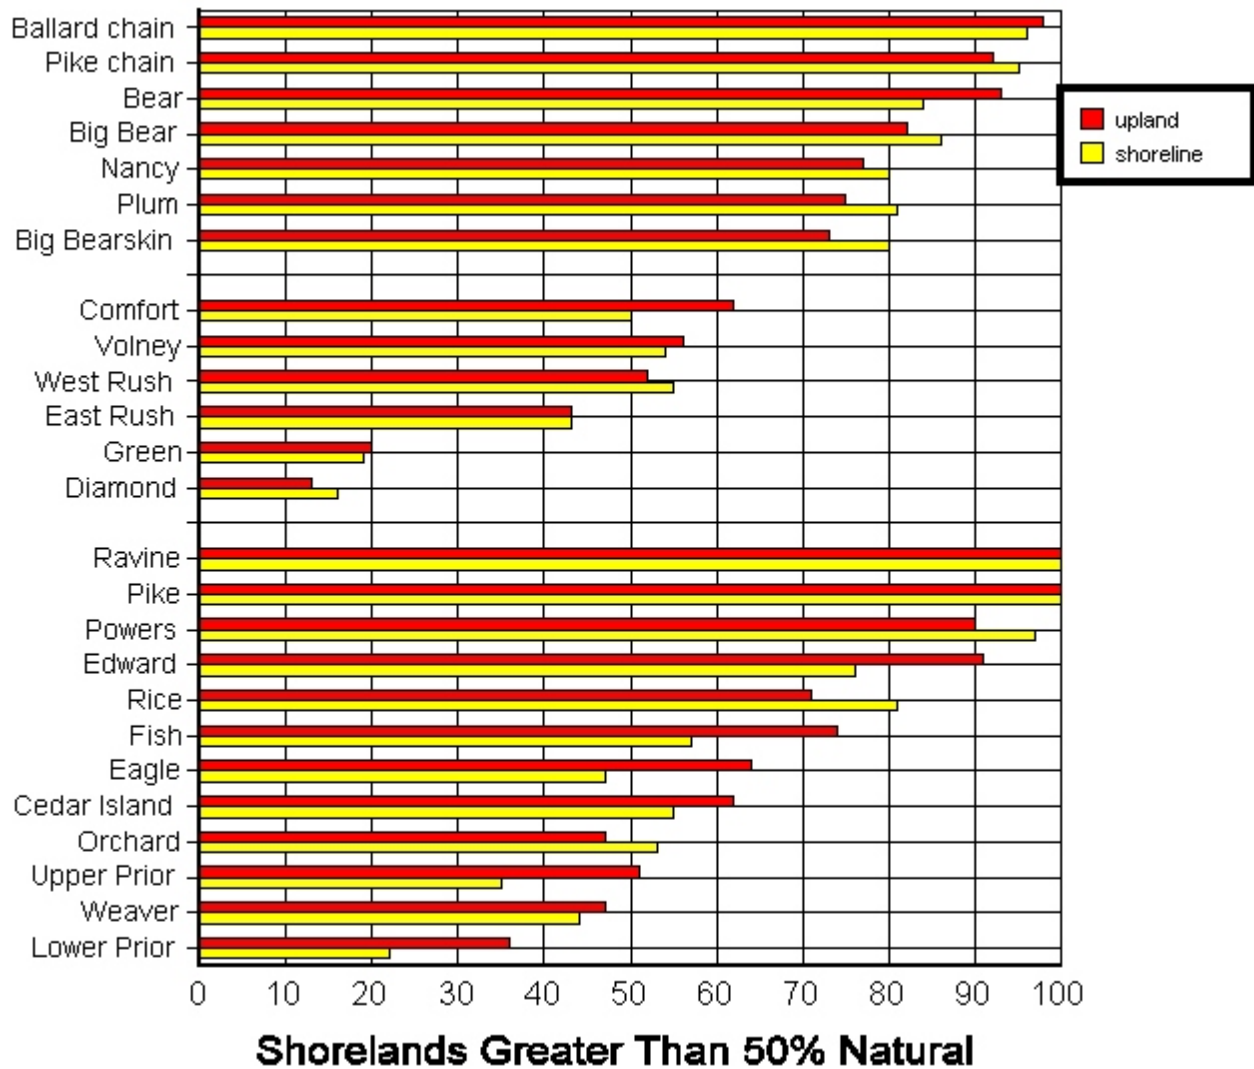
Figure 7. A summary of shoreland inventory results for lakes using an evaluation based on shoreland photographs. For each lake the percentage of shoreline and upland conditions with greater than 50% natural conditions is shown. The first tier of lakes are located in northern Wisconsin. The lower tier of lakes are in the Twin City Metropolitan area and are considered urban lakes. Although several lakes are “urban” lakes most of the shoreland is owned by the city and there is a high percentage of natural conditions. The middle tier of lakes are about an hour’s drive from the Twin Cities, and are not considered to be urban lakes, they are “country” lakes.

A comparison of Ravine Lake conditions to other lakes in Minnesota and Wisconsin is shown in Table 4 and Figure 7.

Ravine Lake is a Twin City Metropolitan lake. It’s natural shoreland conditions are above average compared to the other metropolitan lakes.

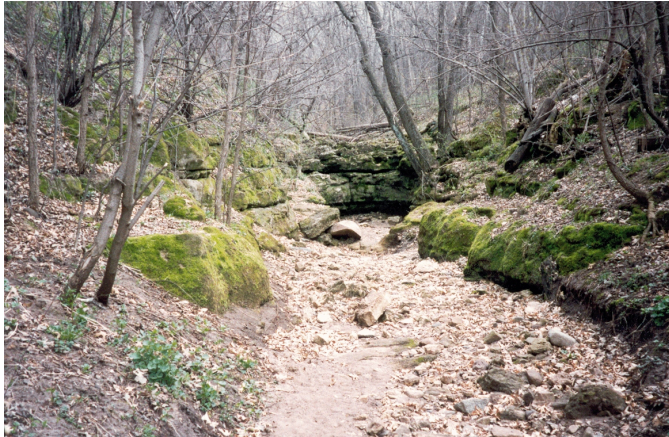
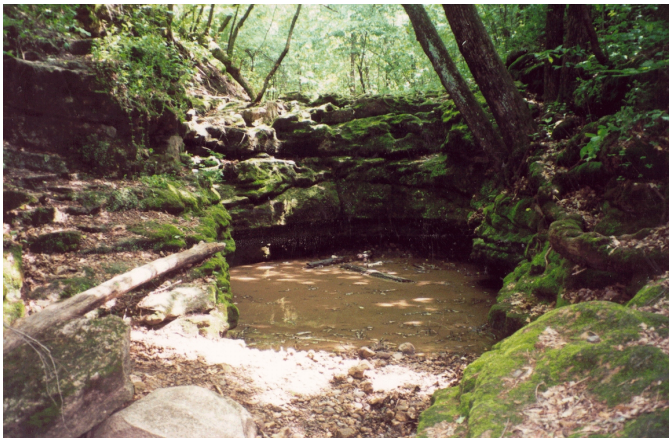
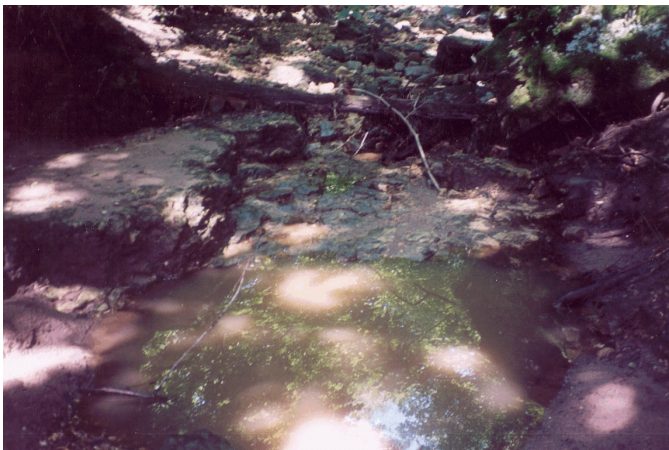
No perennial streams flow into Ravine Lake, but there is interesting evidence of ephemeral stream flow that has probably been occurring for thousands of years.

The stream channel has cut through bedrock indicating that at times, flow must have been substantial.

Figure 9. All three pictures are stream channels in a steep gradient on the northeast side of Ravine Lake and are in subwatershed RL-1, the active watershed.

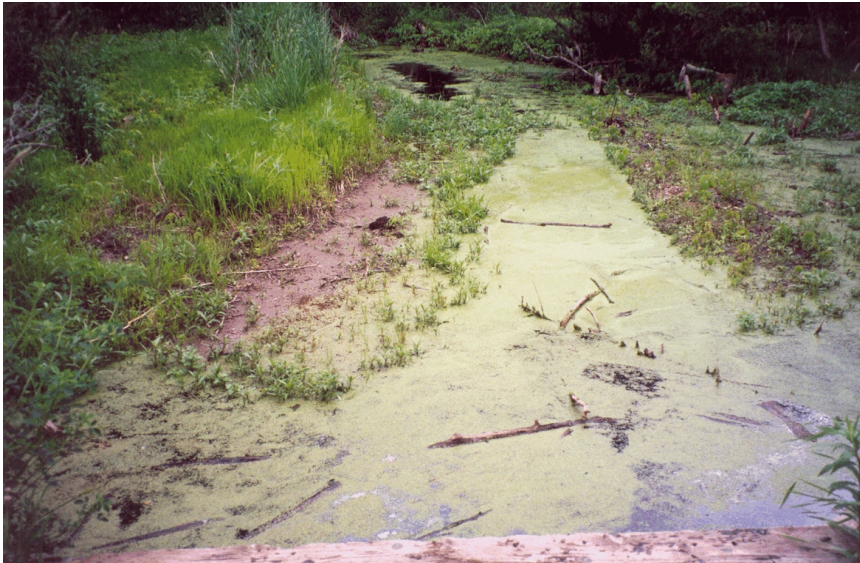
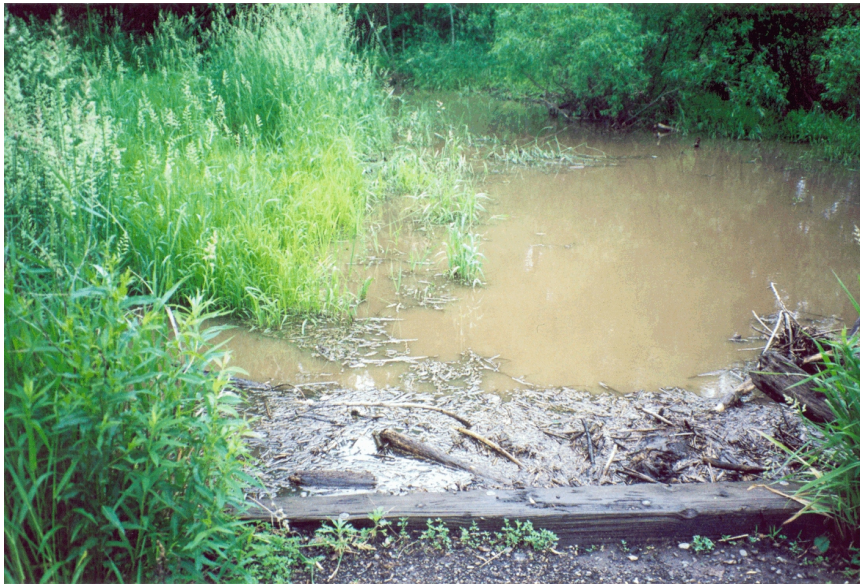
Figure 10. Stream channel leading into Ravine Lake referred to as the lake inlet area in Table 6. Both pictures are in a low gradient setting at the bottom of the ravine. The top picture is in June 2000 and the bottom picture is from June 2001.

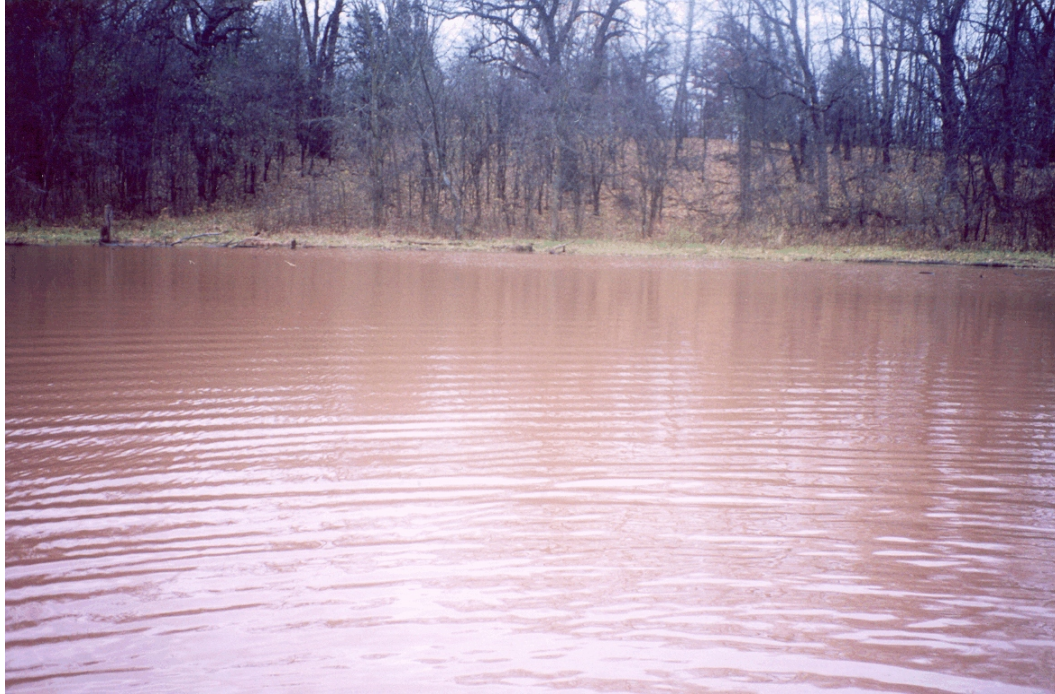
Figure 11. [top] A small pond about 100 meters from Ravine Lake had a brownish color. [bottom] Particles observed under a microscope at 625x. They appear to be soil particles.

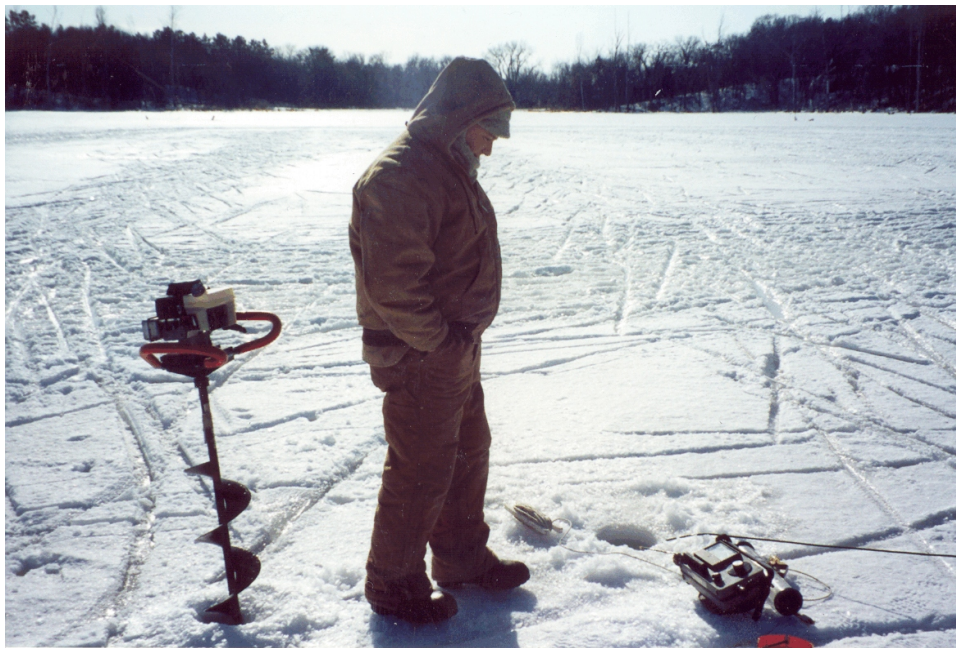
Figure 15. Matt Moore, Watershed Administrator, checks dissolved oxygen levels in Ravine Lake on February 1, 2001.

February 1, 2001	March 22, 2001
Transparency (Ft)	13.8	--
Dissolved oxygen - top (ppb)	0.5	2.2
- bottom	0	0.4
Total Phosphorus (ug/l)	36	440
Ammonia-nitrogen (ug/l)	--	1,200
Nitrate-nitrogen (ug/l)	--	1,380
Total Kjeldahl nitrogen (ug/l)	--	1,500
Chlorophyll a (ug/l)	1.4	--

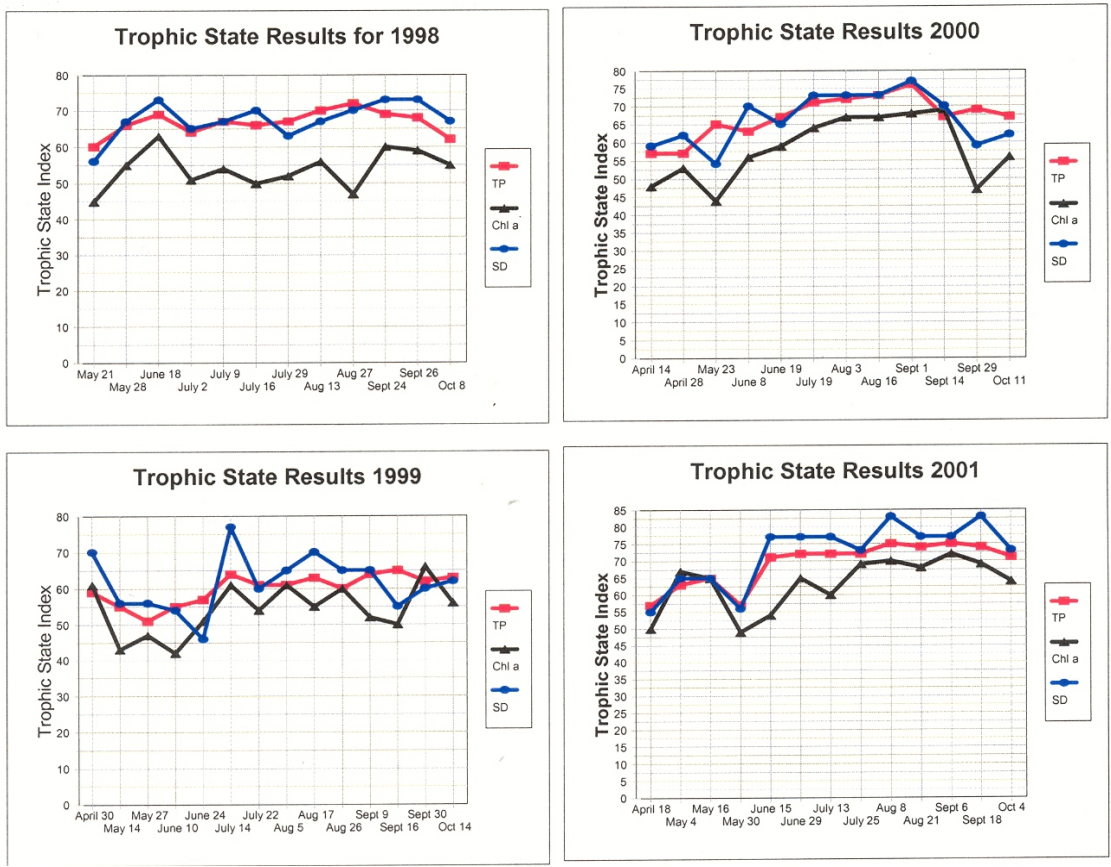
Figure 16. Water quality data from the 1998 through 2001 CAMP program were converted to Trophic State Index values and graphed. Chlorophyll (chl a) has been lower than expected compared to total phosphorus (TP) and secchi disc (SD) values.

Three water quality parameters, secchi disc transparency, phosphorus, and chlorophyll, are referred to as trophic indicators. They are used to classify a lake as eutrophic (fertile), mesotrophic, or oligotrophic (infertile). In addition, all three parameters are closely correlated. If transparency is high, phosphorus and chlorophyll are low. If transparency is low, phosphorus and chlorophyll are high. Mathematical equations are used to convert water quality data into a *Trophic State Index*. Low trophic state index (TSI) numbers indicate oligotrophic conditions and TSI numbers over 50 indicate eutrophic conditions. Water quality data for 1998, 1999, 2000, and 2001 has been converted to TSI numbers (Table 14). The TSI results show Ravine Lake is eutrophic.

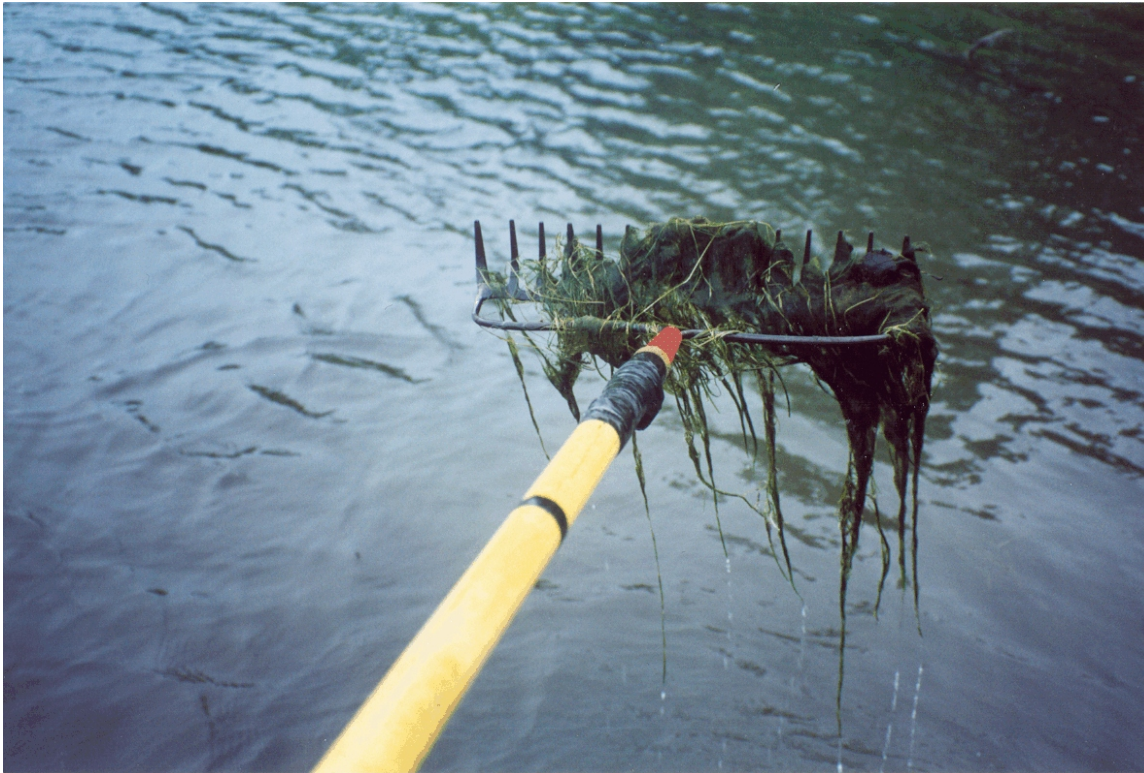
Figure 20. Stringy pondweed and filamentous algae sampled from Transect 1 during the aquatic plant survey on Ravine Lake.

Example of the type of aquatic plants found in Ravine Lake is shown in Figure 20. Stringy pondweed, elodea, and sago pondweed were the most common plant species.

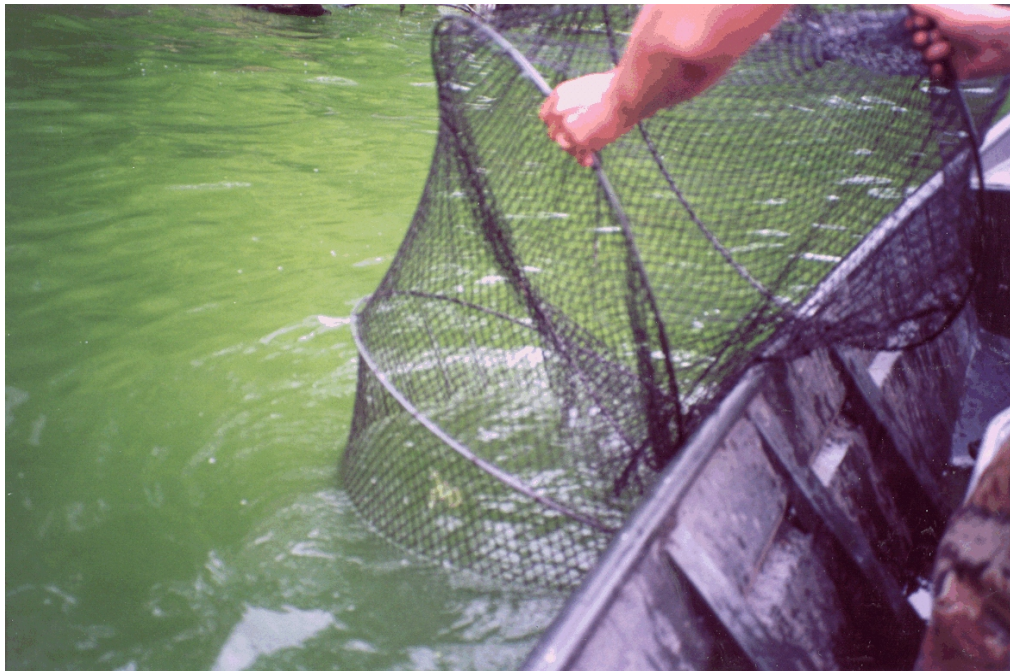
Figure 22. Standard MnDNR trapnet being hauled into a boat. Fish are measured, weighed, and returned to the lake.

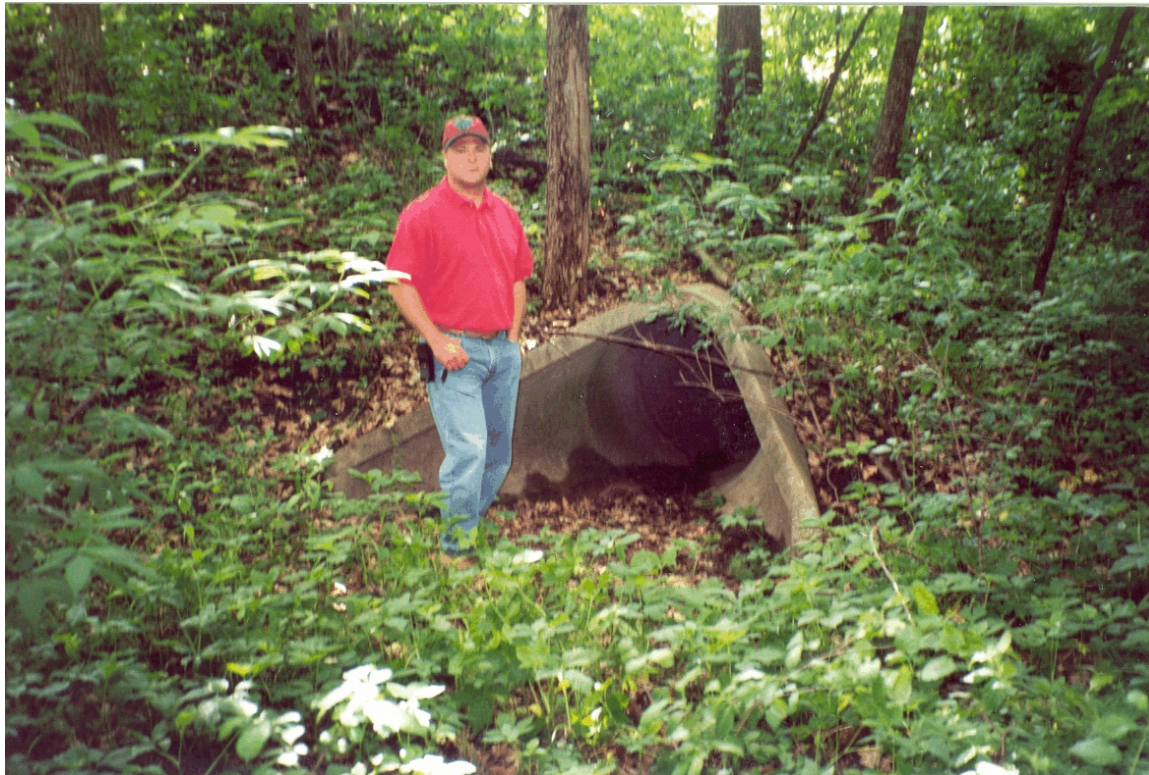
Matt Moore, South Washington Watershed District Administrator, stands by a culvert in subwatershed RL-2, located in the northwest portion of the subwatershed. Not much, if any, runoff from this part of the watershed makes it to Ravine Lake.

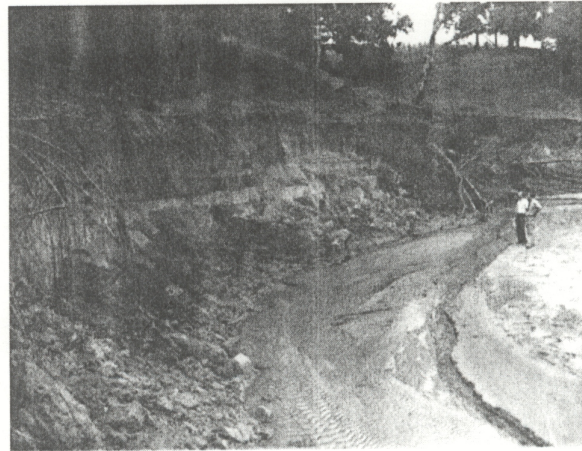
Even streams with low base flow can cause significant bank erosion. (From USDA)

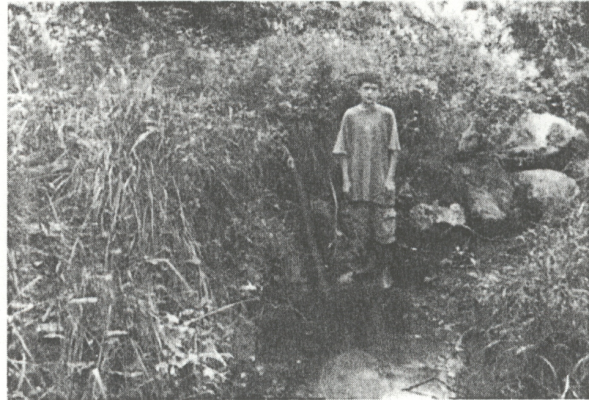
This urban stream suffered damage from overland runoff coming from nearby roof downspouts. Redirecting overland flow will reduce streambank erosion.

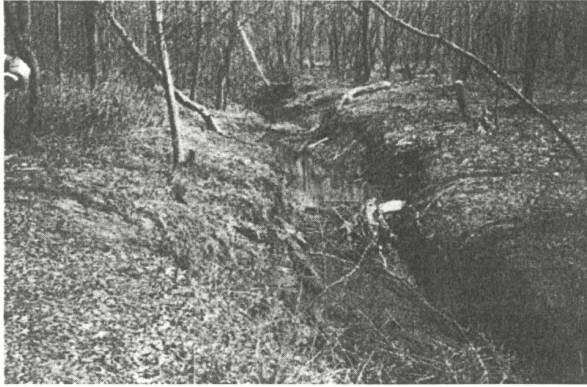
An increase in flow due to an increase in impervious surfaces in this urbanizing watershed was largely responsible for the bank cutting in this situation. The channel needs to be re-meandered to achieve stability. Then the banks can be reshaped and revegetated.

For some stream improvement projects, the first task is to re-meander it using a backhoe or bulldozer. Then, the new curves in the stream should be relatively stable because they are now in equilibrium with the flow. As a result, stabilization has a better chance of success.

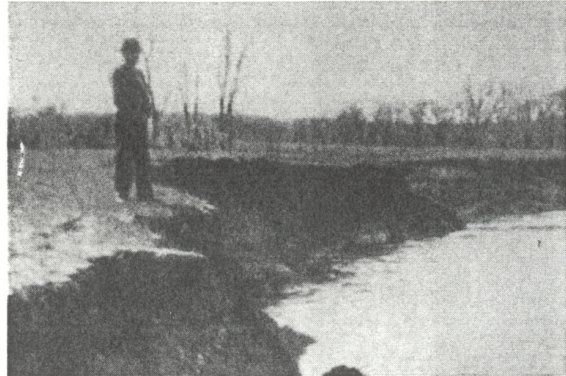
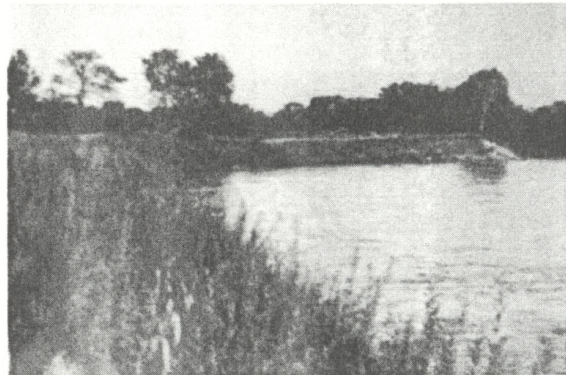
“Streambank erosion control project: (top) Existing conditions in 1937. (bottom) Same bank in 1938. Improvements included protecting toe of slope with riprap, reshaping the bank, brush-matted and planted with willows.” (From Edminster et al., 1949.)

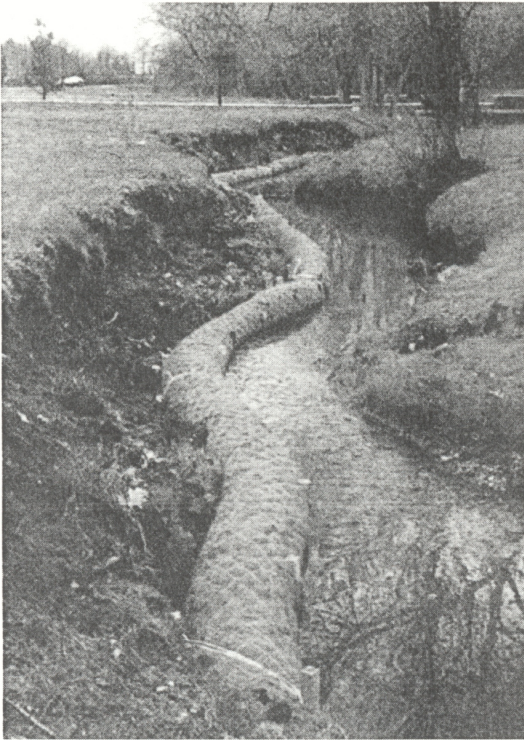
Coir fiber rolls can be used to stabilize the toe of a streambank. Bank reshaping and reseeding will complete the stabilization project. Coir fiber rolls are composed of loose coconut fiber from coconut husks, held together with coir fiber netting. In higher energy environments, rock is used. (From Don Knezick, Pinelands Nursery, Columbus, NJ. With permission.)

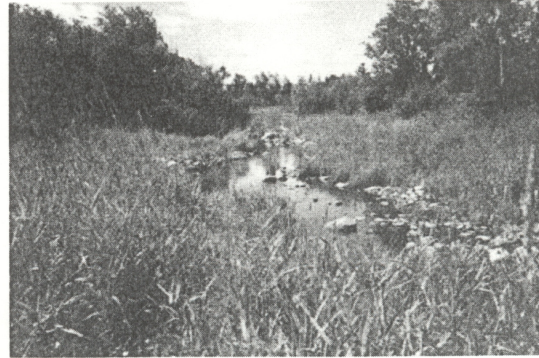
Here is the same stream 1 year later. Vegetation is growing up through the rock, which will actually increase stability.

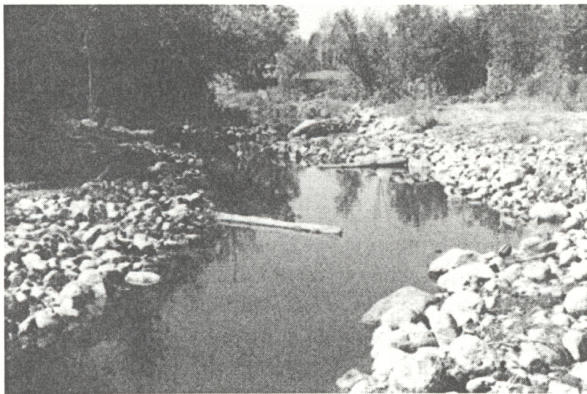
Rock can be used to stabilize the toe of a streambank where there are high flows.

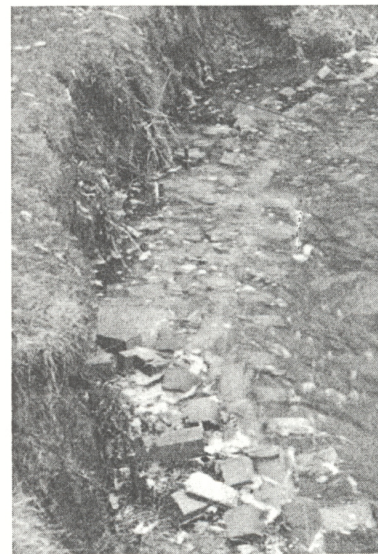
A-jacks interlock and will not roll as easily as rock riprap. Eventually, soil and other materials will fill in behind the A-jacks.

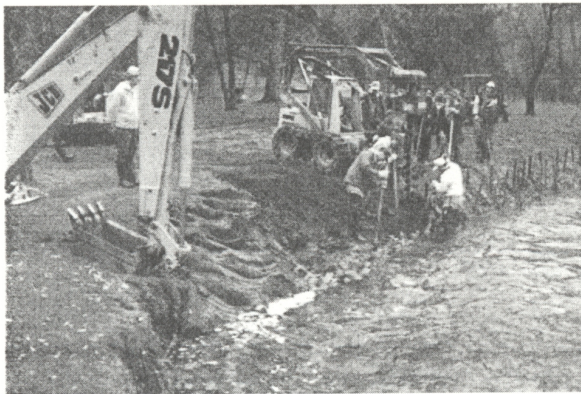
Reshaping the bank can be done by hand or with equipment. In this case, a backhoe is reshaping the streambank, followed by the placement of willow posts. An auger on the end of a bobcat drills holes for the willow posts.

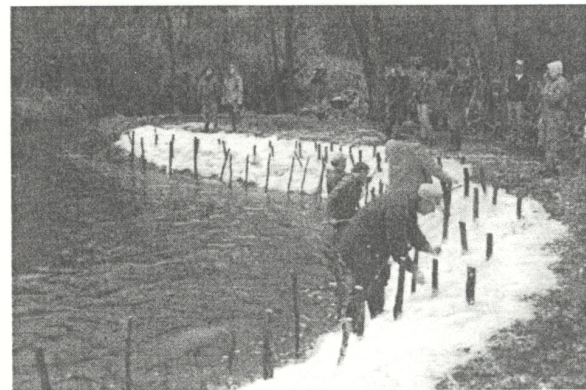
After inserting the willow posts, they can be cut off at 1 to 2 feet above the ground. Erosion control matting is laid down on the reshaped banks to reduce erosion.

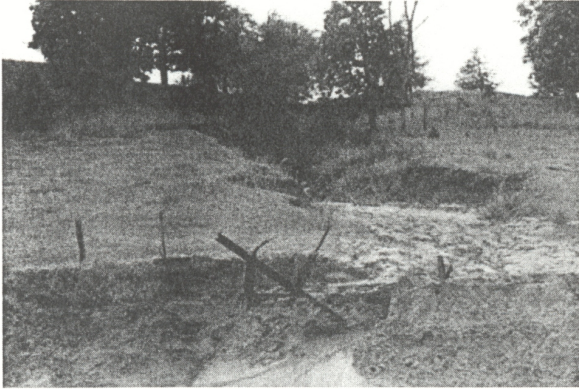
Gully erosion is another form of streambank erosion. The keys to stabilization are to stop head cutting, reduce the gradient, and revegetate.

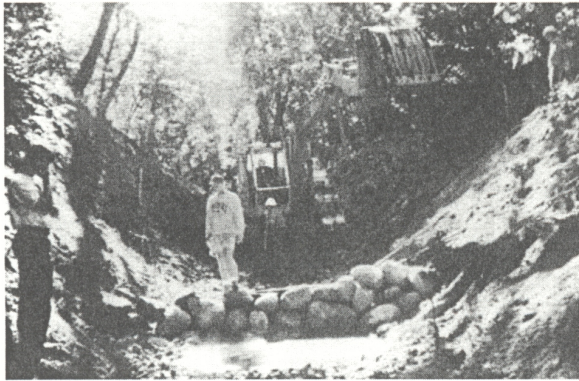
Reducing the gradient in gullies or ravines reduces the erosive force of the water flows. Grade control structures such as this rock weir reduce flow velocities and allow a streambank to reestablish vegetation and stabilize. The rock weir is constructed in the shape of an arc with the high point oriented upstream.

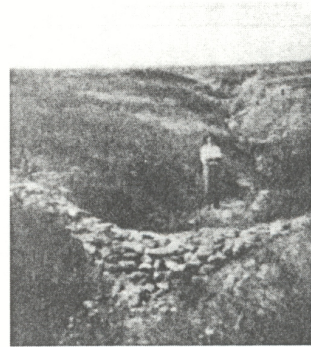
"Series of loose rock dams in a farm gully." (From Ayres, Q.C., Soil and Erosion Control, McGraw-Hill, New York, 1936.)

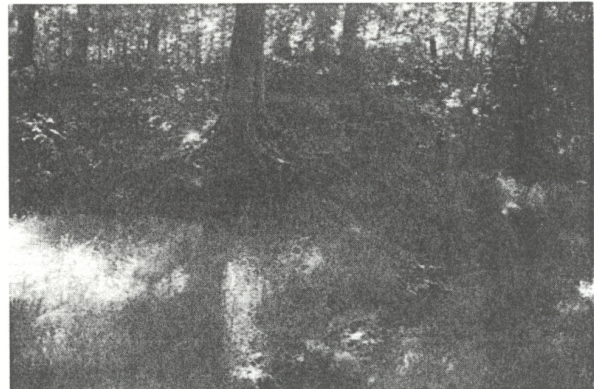
Removing some of the overlying dense forest canopy in gullies or ravines allows sunlight to penetrate to the ravine soils and reestablish ground cover.

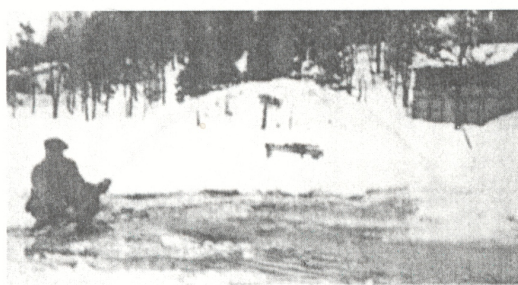
Winter aeration efforts in the 1930s attempted to re-aerate a portion of the lake volume. The same basic approach is used today. (From Hubbs, C.L. and Eschmeyer, R.W., *The Improvement of Lakes for Fishing, Bulletin of the Institute for Fisheries Research (Michigan Department of Conservation)*, No. 2, University of Michigan, Ann Arbor, 1937.)

The objective of a winter aeration project is not to aerate the entire lake, but rather to set up an oxygen-rich refuge in part of the lake to allow fish to survive the ice-covered days until breakup. As a rule of thumb, at least 10% of the volume of the lake should be aerated to prevent winterkill. When the ice breaks up, the wind-mixing action quickly re-aerates the entire lake.

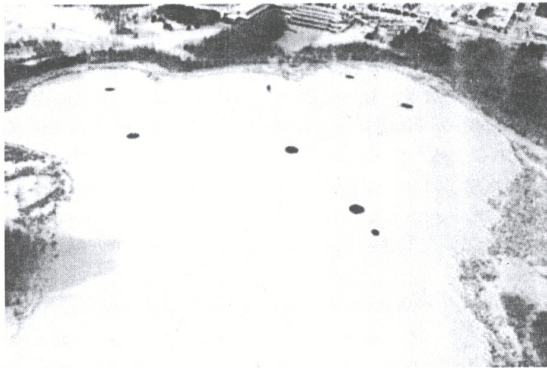
Winter diffuser aeration system operating on a 75-acre lake. An aerial view shows seven diffuser heads spread around the lake with the intent of aerating small pockets in the lake. (From H.B. Huller, Company Nature Reserve, Vadnais Heights, MN.)

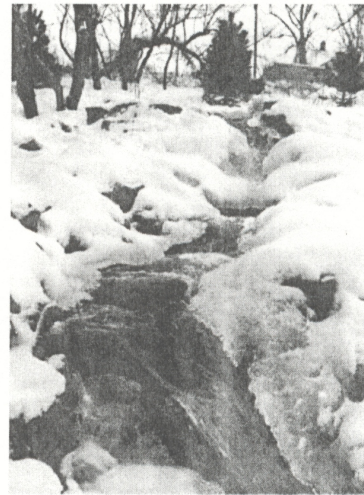
Reaeration occurs as water tumbles down the hillside. There is some open water at the discharge site.

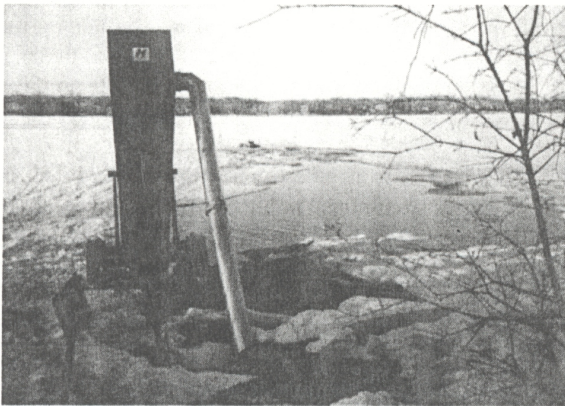
Lake water goes in at the top of the baffle and cascades back into the lake. (From City of Lakeville, Minnesota.)

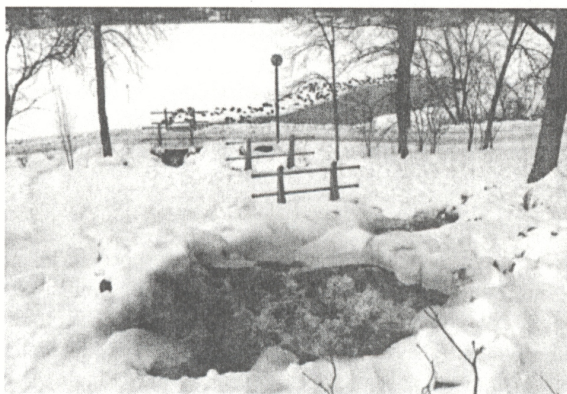
When the pump-and-baffle system is built into a hillside and uses natural rock for baffles, it mimics a bubbling brook. It looks natural and is a permanent setup, but can cost \$30,000 or more.

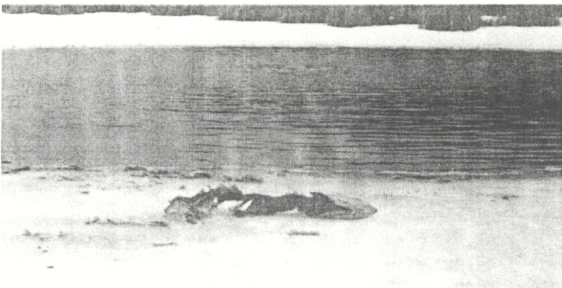
There are no guarantees that winter aeration will work in every case. Early ice-up and heavy snows will produce severe winterkill conditions. In the lake above, winter aeration did not keep dissolved oxygen levels high enough, and there was a fishkill, resulting in a fish buffet for area wildlife.

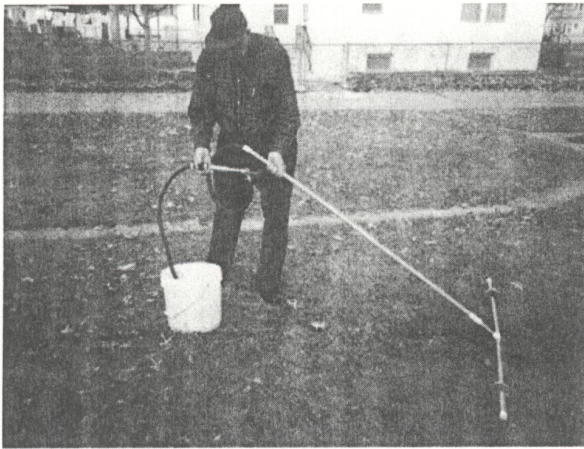
For small lakes or ponds, a distribution system for a buffered alum application can be constructed from PVC pipe. The buffered alum is mixed into a slurry in a pail and pumped through the manifold into the lake.

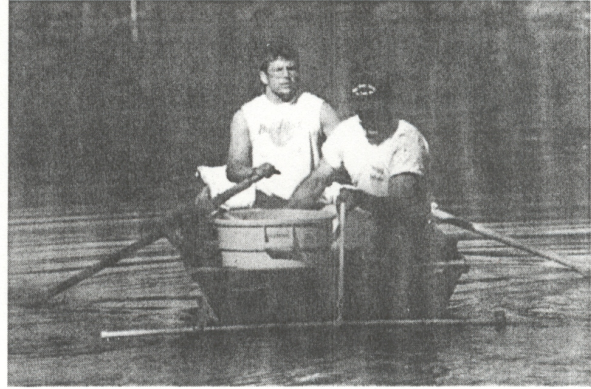
One person directs the boat, and another pumps the buffered alum into the water.

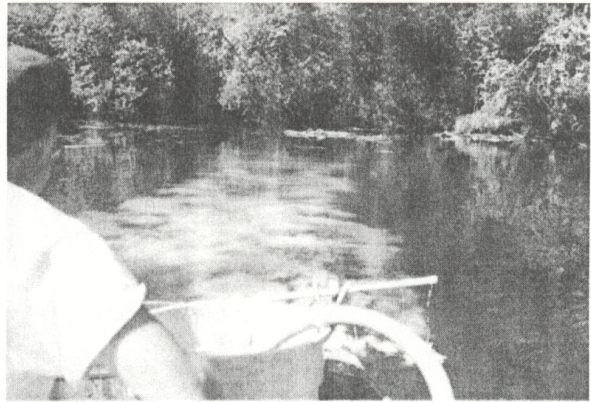
The alum floc settles out of the water column in a couple of hours.

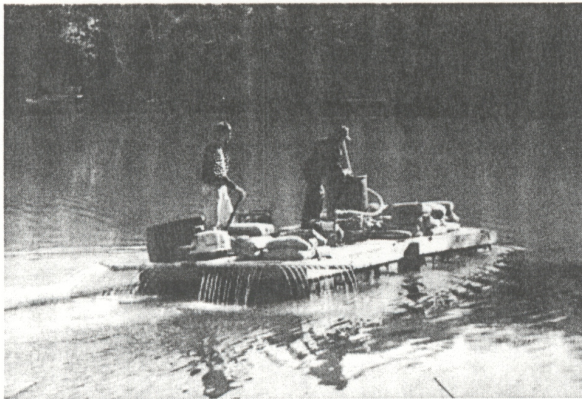
For alum applications in ponds over 4 acres in size, a scaled-up delivery system will be more efficient. Here, a commercial applicator mixes dry alum with lake water to make a slurry that is then pumped through a manifold in the rear of the alum barge.
