Prepared by: Emmons & Olivier Resources, Inc.
for the Lower St. Croix Watershed Management Organization

Trout Brook Management Plan

May 6, 2009
Revised - May 14, 2009

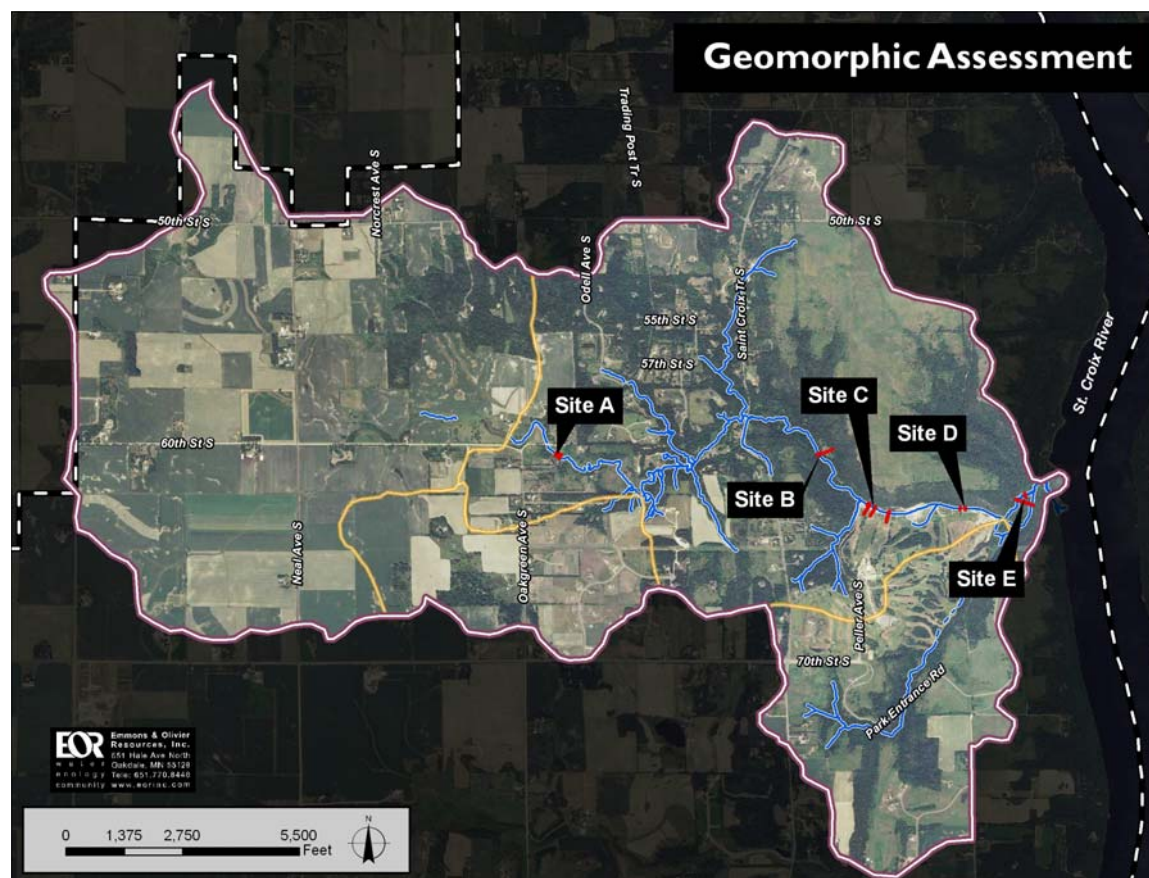
Figure 4.1 – Location of geomorphic assessment

Upon thorough reconnaissance of all perennial flow reaches of Trout Brook, five plausible unique reaches were identified and assessed using the Rosgen classification system. Just downstream of 60th Street, Site A is representative of the headwater

flowage. Site B, located within Afton State Park, is typical of Trout Brook between St. Croix Trail and Afton Alps. Sites C and D, both within Afton Alps, are unique from the rest of the system. Site E, again within Afton State Park is influenced by and located within the St. Croix floodplain. Sites locations are identified in figure 4.1 and a summary of the assessments can be found in figures 4.2 – 4.6

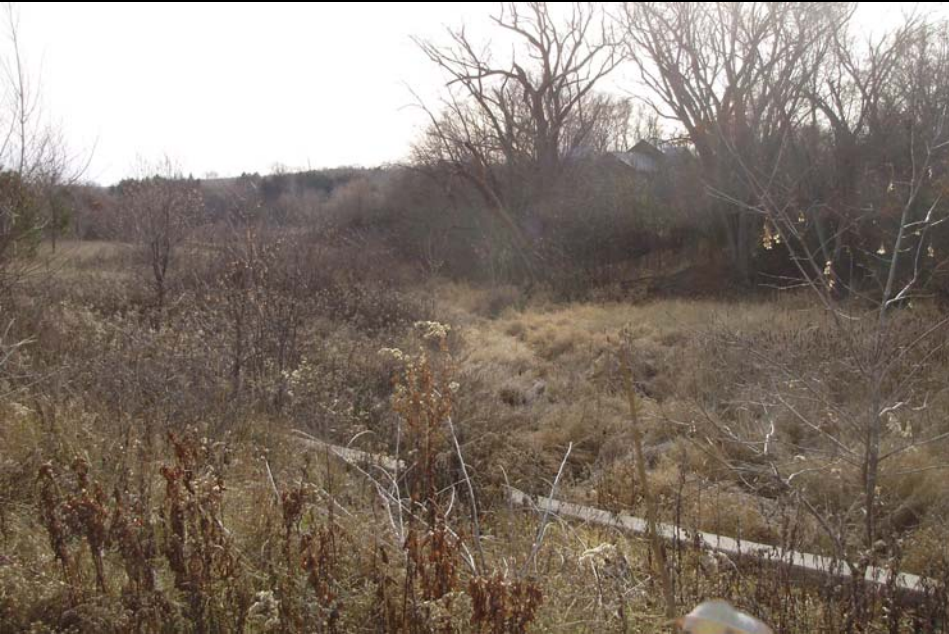
Figure 4.2 – Summary of site 'A' assessment

REACH 'A' SUMMARY				
Stream: Trout Brook				
Watershed: LSCWMO				
Location: Denmark Township (D.S. of Trading Post Trail)				
State: MN				
County: Washington				
Date: November 18, 2008				
Observers: John Barry, Mike Majeski				
Channel type: C4c-				
Drainage area (sq.mi.): 3.2				
Dimension		typical	min	max
floodplain:	width flood prone area (ft)	73.5	63.2	83.7
riffle-run:	x-area bankfull (sq.ft.)	8.8	7.4	10.1
	width bankfull (ft)	18.5	14.5	22.5
	mean depth (ft)	0.47	0.4	0.5
	max depth (ft)	1.8	1.7	1.9
	hydraulic radius (ft)	0.4		
Dimensionless ratios		typical	min	max
	width depth ratio	39.0	28.2	50.1
	entrenchment ratio	4.0	3.4	4.5
	riffle max depth ratio	3.8	3.6	3.9
Pattern		typical	min	max
	stream length (ft)	256.5		
	valley length (ft)	215.0		
	Sinuosity	1.19		
Profile		typical	min	max
	channel slope (%)	0.94		
Channel Materials	Channel			
	D50 (mm)	2.8	---	---
Reference Image

Sites A and E are relatively stable with limited areas of instability and/or bank failure (accelerated erosion), often the result of human disturbance and impact. Located within the floodplain of the St. Croix River, site E is directly influenced by this flowage. Site B, also relatively stable, is over-wide (relative to its stream type) with regular occurrence and has poor riffle-pool definition due to sand embeddedness. Sites C and D have been directly altered (realigned) in the late 1960's and/or early 70's. These human-made reaches exhibit very poor habitat and relative instability. Site C is grossly over-wide with no discernable bank and pool-riffle definition. A 'B' stream has formed within the entrench channel of Site D. This ditch-like channel is confining the stream and subsequently provides poor habitat.

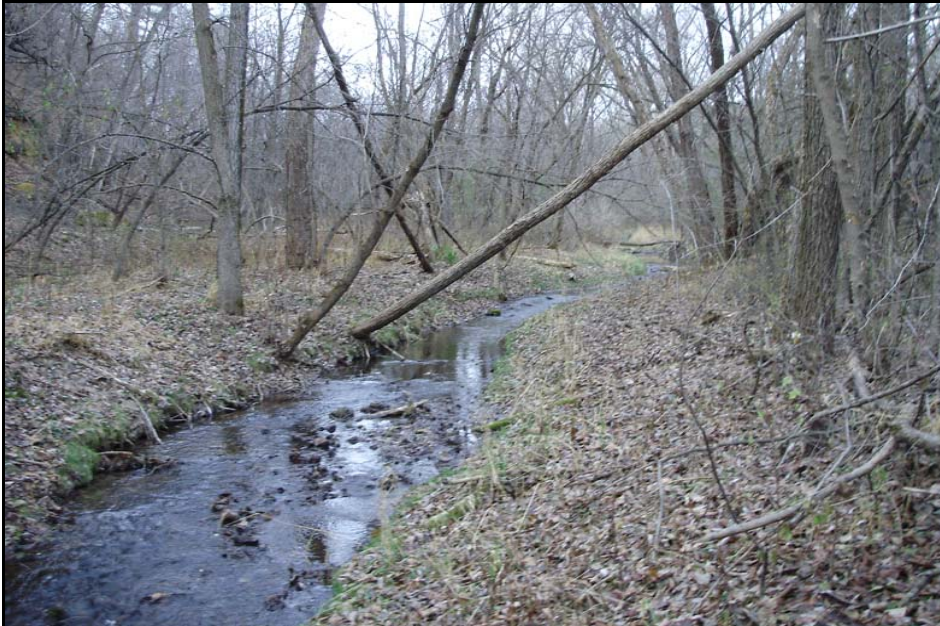
Figure 4.3 – Summary of site 'B' assessment

REACH 'B' SUMMARY				
Stream:	Trout Brook			
Watershed:	LSCWMO			
Location:	Denmark Township (Afton State Park)			
State:	MN			
County:	Washington			
Date:	November 18, 2008			
Observers:	John Barry, Mike Majeski			
Channel type:	C4			
Drainage area (sq.mi.):	6			
Dimension		typical	min	max
floodplain:	width flood prone area (ft)	283.0	---	---
riffle-run:	x-area bankfull (sq.ft.)	18.1	---	---
	width bankfull (ft)	13.2	---	---
	mean depth (ft)	1.37	---	---
	max depth (ft)	1.9	---	---
	hydraulic radius (ft)	1.3	---	---
Dimensionless ratios		typical	min	max
	width depth ratio	9.7	---	---
	entrenchment ratio	21.4	---	---
	riffle max depth ratio	1.4	---	---
Pattern		typical	min	max
	stream length (ft)	294.7		
	valley length (ft)	279.8		
	Sinuosity	1.05		
Profile		typical	min	max
	channel slope (%)	1.2		
Channel Materials		Channel		
	D50 (mm)	6.9	---	---
Reference Image

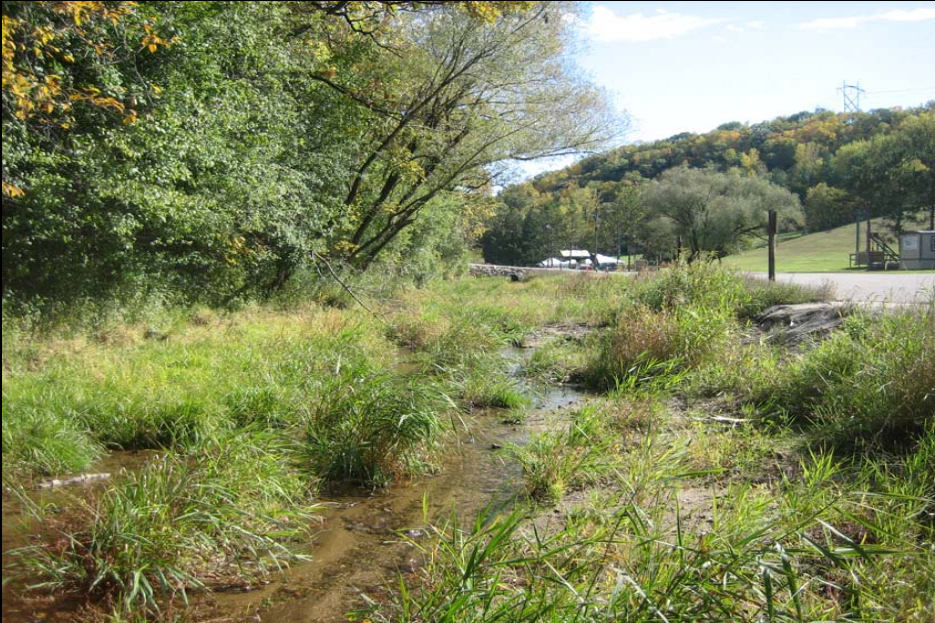
Figure 4.4 – Summary of site 'C' assessment

REACH 'C' SUMMARY				
Stream:	Trout Brook			
Watershed:	LSCWMO			
Location:	Denmark Township (Afton Alps)			
State:	MN			
County:	Washington			
Date:	November 14, 2008			
Observers:	John Barry, Mike Majeski			
Channel type:	B4a			
Drainage area (sq.mi.):	6.2			
Dimension		typical	min	max
floodplain:	width flood prone area (ft)	34.7	31.9	36.9
riffle-run:	x-area bankfull (sq.ft.)	18.0	16.0	19.9
	width bankfull (ft)	27.2	23.2	33.5
	mean depth (ft)	0.66	0.6	0.7
	max depth (ft)	1.3	1.1	1.4
	hydraulic radius (ft)	0.7		
Dimensionless ratios		typical	min	max
	width depth ratio	41.0	33.6	56.3
	entrenchment ratio	1.3	1.2	1.4
	riffle max depth ratio	1.9	1.7	2.2
Pattern		typical	min	max
	stream length (ft)	764.6		
	valley length (ft)	733.6		
	Sinuosity	1.04		
Profile		typical	min	max
	channel slope (%)	0.76		
Channel Materials	Channel			
	D50 (mm)	9.4	---	---
Reference Image

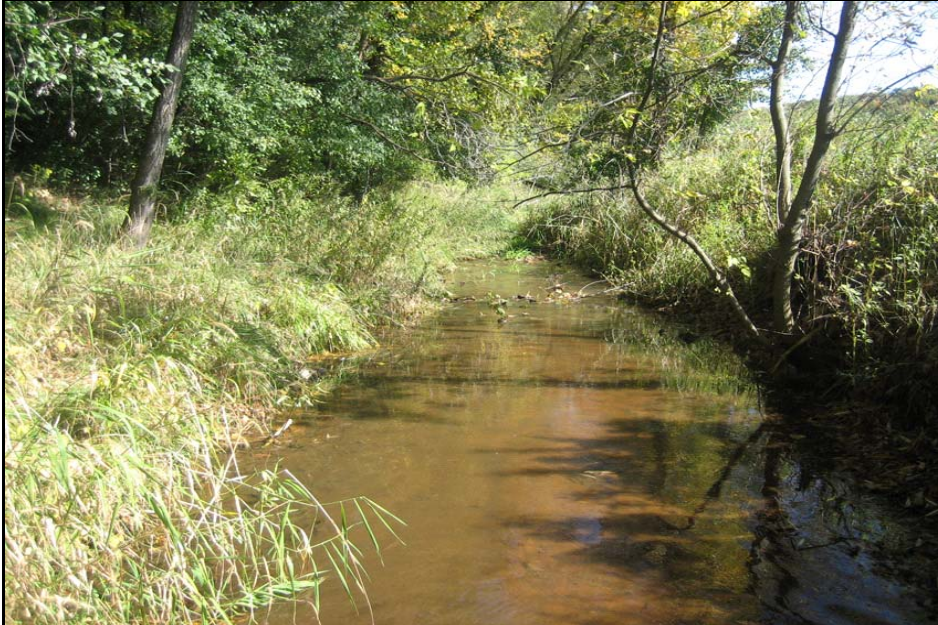
Figure 4.5 – Summary of site 'D' assessment

REACH 'D' SUMMARY				
Stream:		Trout Brook		
Watershed:		LSCWMO		
Location:		Denmark Township (Afton Alps)		
State:		MN		
County:		Washington		
Date:		November 14, 2008		
Observers:		John Barry, Mike Majeski		
Channel type:		B4a		
Drainage area (sq.mi.):		6.2		
Dimension		typical	min	max
floodplain:	width flood prone area (ft)	24.6	23.5	25.7
riffle-run:	x-area bankfull (sq.ft.)	21.2	18.9	23.5
	width bankfull (ft)	17.3	16.8	17.8
	mean depth (ft)	1.23	1.1	1.4
	max depth (ft)	2.2	2.1	2.2
	hydraulic radius (ft)	1.1		
Dimensionless ratios		typical	min	max
	width depth ratio	14.1	12.0	16.7
	entrenchment ratio	1.4	1.4	1.5
	riffle max depth ratio	1.8	1.7	1.8
Pattern		typical	min	max
	stream length (ft)	352.8		
	valley length (ft)	349.7		
	Sinuosity	1.01		
Profile		typical	min	max
	channel slope (%)	0.48		
Channel Materials		Channel		
	D50 (mm)	6.9	---	---
Reference Image

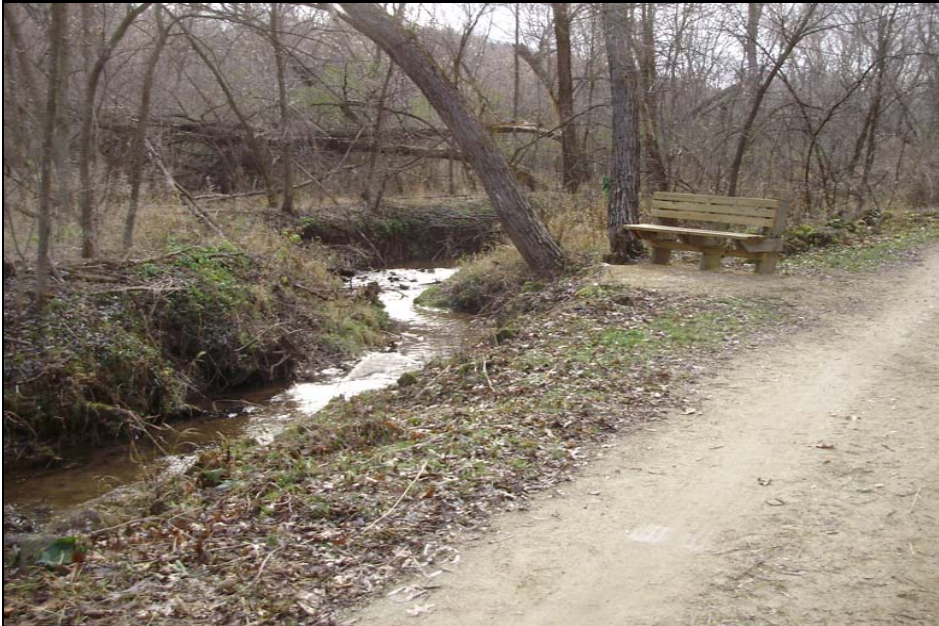
Figure 4.6 – Summary of site 'E' assessment

REACH 'E' SUMMARY				
Stream: Trout Brook				
Watershed: LSCWMO				
Location: Denmark Township (Afton State Park)				
State: MN				
County: Washington				
Date: November 17, 2008				
Observers: John Barry, Mike Majeski				
Channel type: C4				
Drainage area (sq.mi.): 8.4				
Dimension		typical	min	max
floodplain:	width flood prone area (ft)	387.4	---	---
riffle-run:	x-area bankfull (sq.ft.)	24.3	---	---
	width bankfull (ft)	17.0	---	---
	mean depth (ft)	1.43	---	---
	max depth (ft)	2.4	---	---
	hydraulic radius (ft)	1.3		
Dimensionless ratios		typical	min	max
	width depth ratio	11.9	---	---
	entrenchment ratio	22.8	---	---
	riffle max depth ratio	1.7	---	---
Pattern		typical	min	max
	stream length (ft)	387.2		
	valley length (ft)	230.6		
	Sinuosity	1.68		
Profile		typical	min	max
	channel slope (%)	0.46		
Channel Materials		Channel		
	D50 (mm)	2.8	---	---
Reference Image

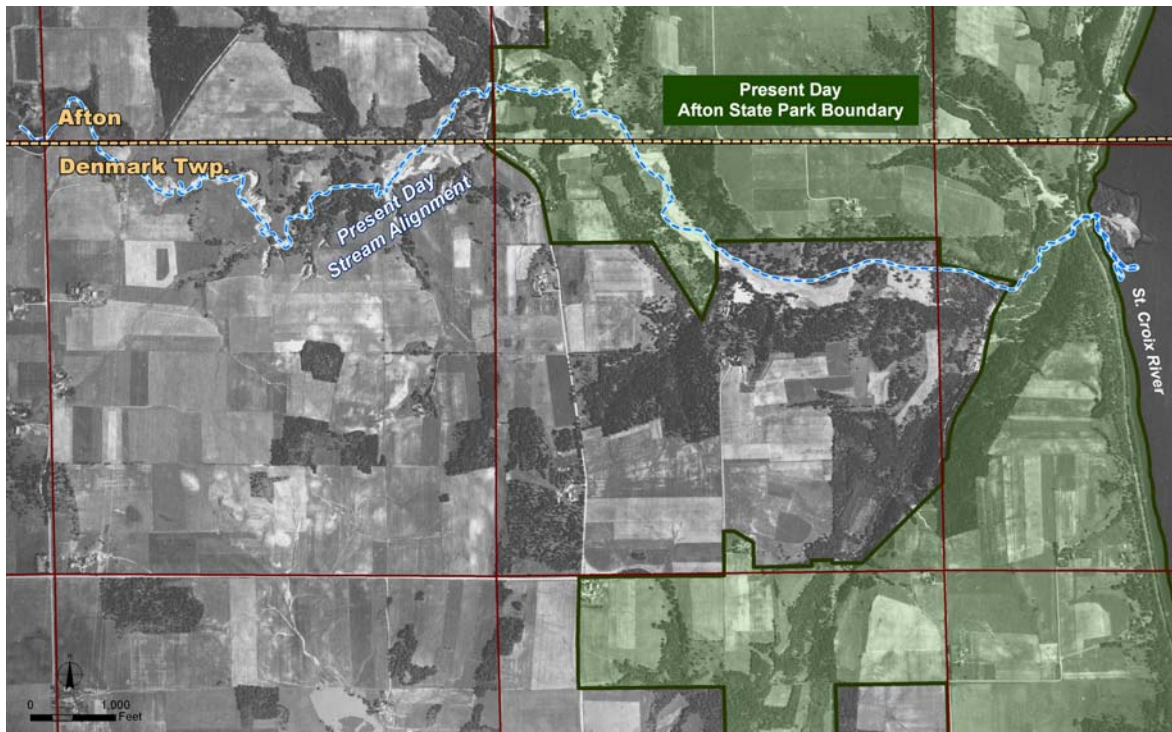
Figure 5.1 – 1938 aerial of Trout Brook

Significant disturbances have occurred within the basin over the last 125 years and subsequently Trout Brook has been responding to these changes. Typically major disturbances, such as conversion of a forested landscape to agriculture production, which has occurred in this basin, result in stream instability and an evolutionary response to coincide with the changes in hydrology and/or sediment delivery. As evident in the 1938 aerial photography (see figure 5.1), the earliest photography of this area, the conversion of forest to agriculture has already occurred. This date precedes the soil conservation movement and soil erosion and downstream sedimentation is very evident. Extreme soil loss in the headwaters was deposited in the lower gradient reaches of present day Afton Alps and Afton State Park. Due to overwhelming sediment loads these reaches likely aggraded, which is supported by the lack of vegetation and presence of braided channels.

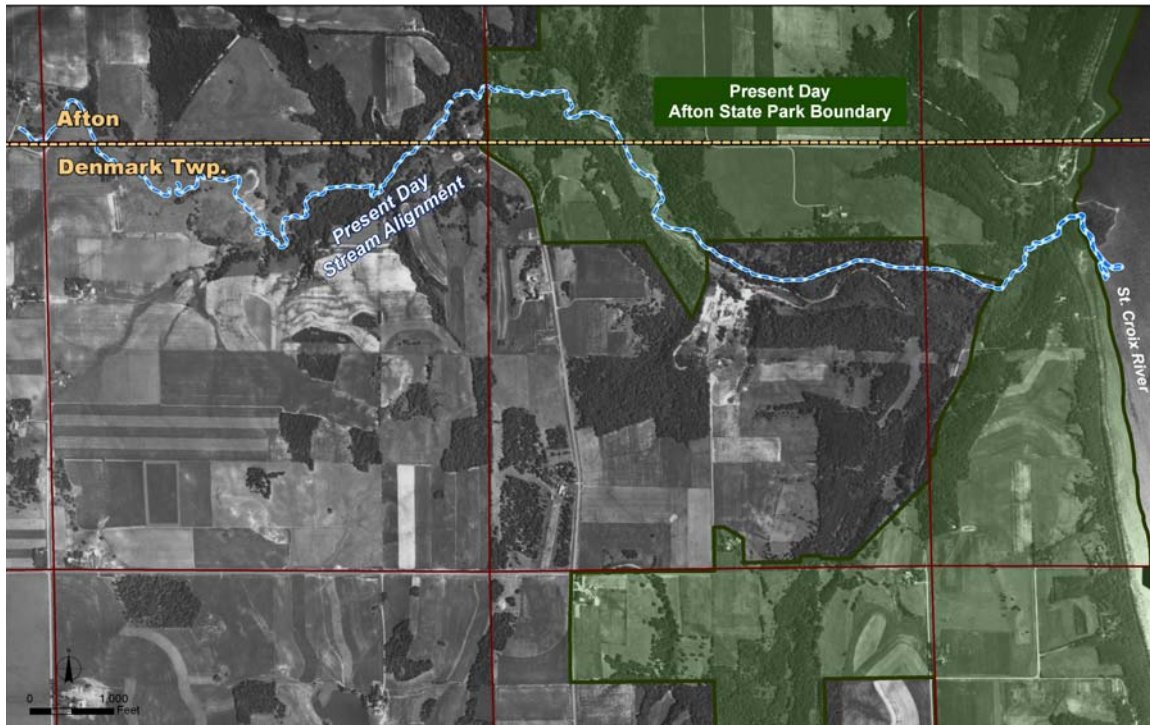
Figure 5.2 – 1964 aerial of Trout Brook

By 1964 (see figure 5.2) significant soil conservation practices are in place (as evident in the contour farming) and Trout Brook is responded to a reduction in sediment delivery. In response a more defined steam channel is apparent and riparian plant species began colonizing the floodplain of these same lower gradient reaches of present day Afton Alps and Afton State Park. Afton Alps is in its infancy at this time.

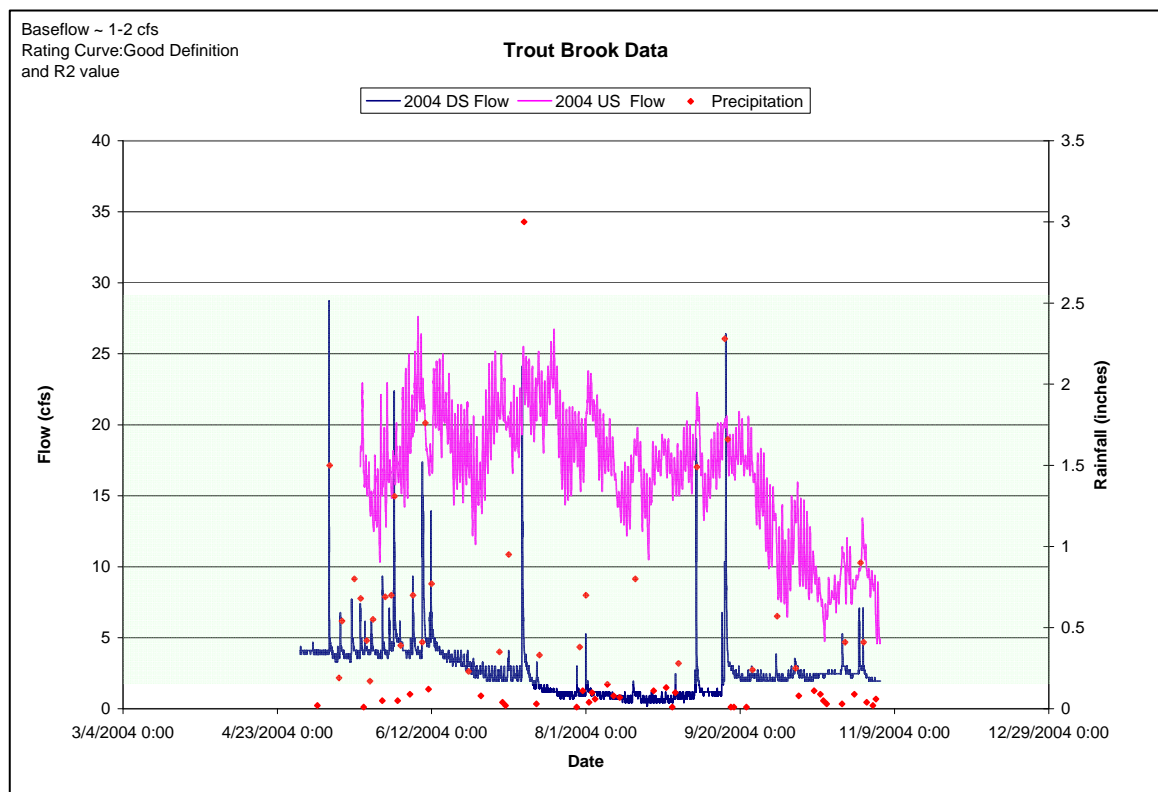
Figure 5.4 – 2004 Trout Brook flow data

The Washington Conservation District conducted automated stream-flow measurements near the mouth of Trout Brook in 2004, 2005 and 2006. This data was analyzed and calibrated by Emmons and Olivier Resources, Inc. Typical base flows ranged from extended weeks around 4.5cfs to extended weeks less than 1cfs. Fourteen precipitation related spikes exceeding 15cfs were witnessed over the 3 years and three events exceeding 30cfs were recorded over this period of record. A summary of the flow data can be found in Figures 5.4 – 5.6.

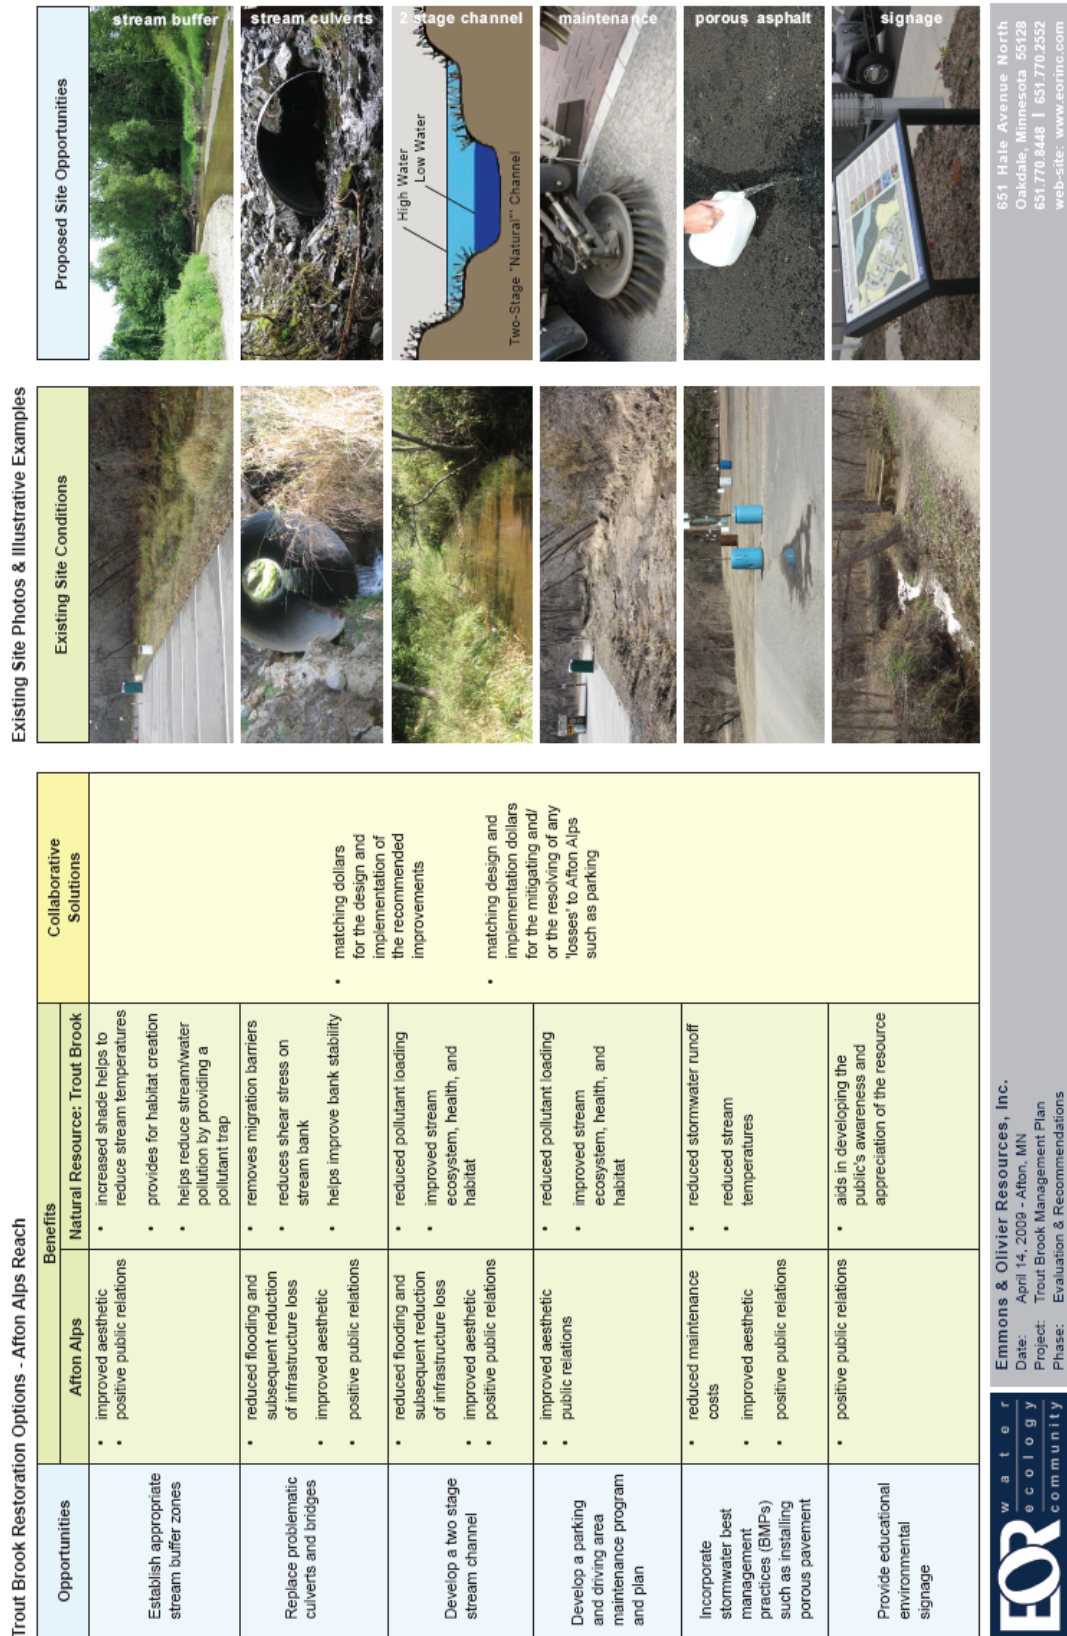
Figure 6.1 – Specific recommendations for Afton Alps Reach

Improving the reach of Trout Brook through Afton Alps is essential to improving this resource. The reach is the most degraded reach of the system, but it holds the greatest potential, as the majority of the base flow is daylighted within this reach. Historic infrastructure encroachment and manipulation of the floodplain will pose challenges to any improvement, but solutions do exist that benefit the resource and Afton Alps. It is understood that since improvements benefit the community, matching public funding will likely be necessary to implement most solutions. It is also understood that some solutions may limit certain business operations and therefore concessions and/or collaborative partnerships may need to be made to balance the give-and-take necessary to improve the resource. The viable recommendations in figure 6.1, which benefit both the land owner and the resource, were explored with Afton Alps and LSCWMO managers.

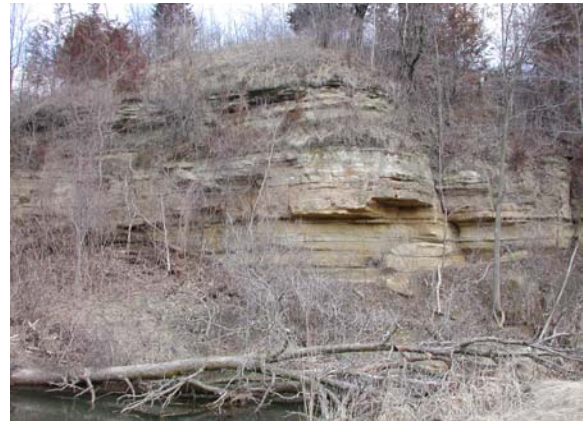
Bedrock outcrop of the St. Lawrence and Franconia Formation along Trout Brook in TRB-2.

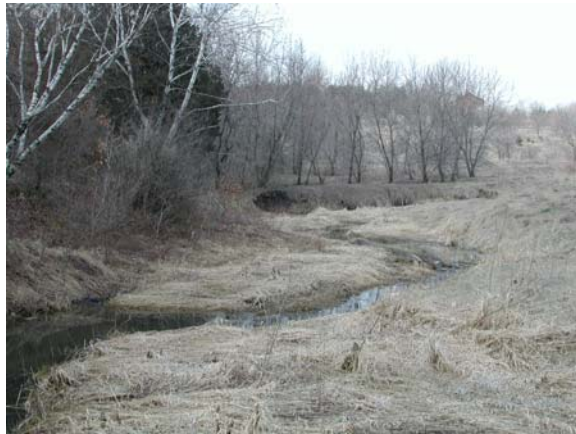
Trout Brook perennial stream channel as it enters Denmark Township, Section 4, T. 27N, R.20W.

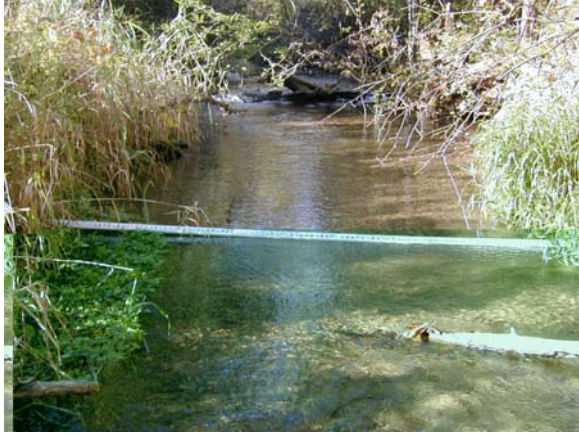
Stream Width: Stream widths were measured at points along the perennial Trout Brook. The width of the stream was measured at bank full, which is higher than the low or base flow water level, and the water level during the mapping period. This feature was mapped to provide some base information regarding stream characteristics.

Stream width was measured at various locations of the perennial stream.

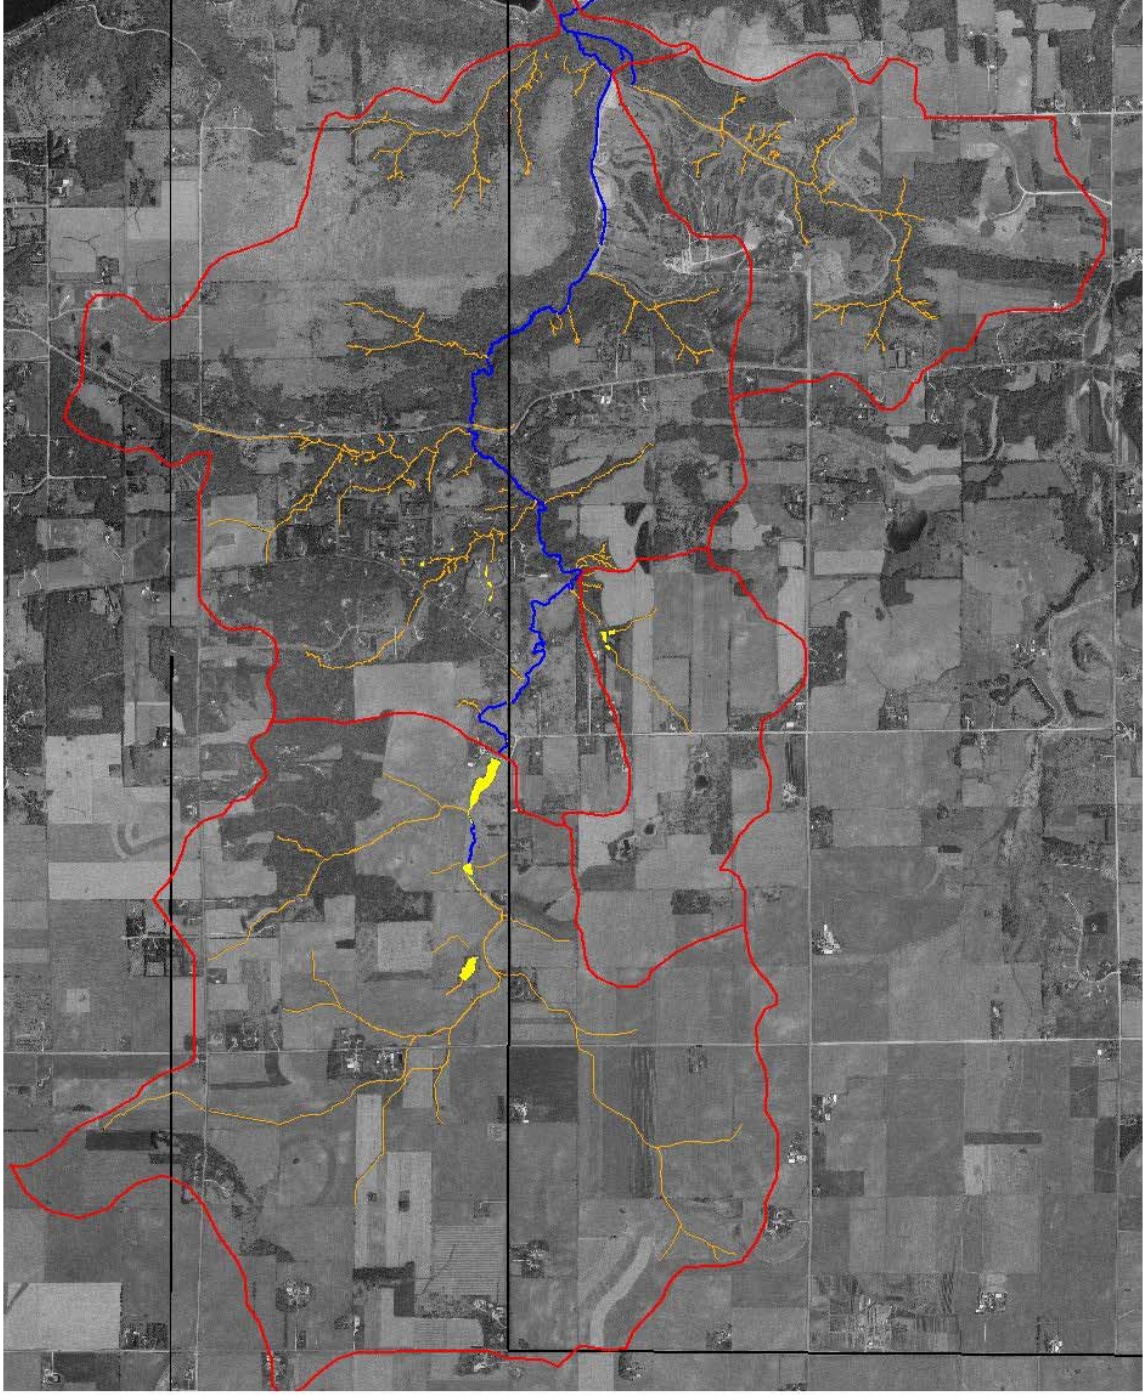
Figure 6e

Streambank Erosion: Streambank erosion was observed and mapped along perennial and intermittent reaches of Trout Brook. Streambank erosion **condition and size** tended to be moderate. **See Figure 6e.**

**Trout Brook Watershed
Stream Bank Erosion Sites**
