Prepared by: Emmons & Olivier Resources, Inc.
for the Lower St. Croix Watershed Management Organization

Trout Brook Management Plan

May 6, 2009
Revised - May 14, 2009

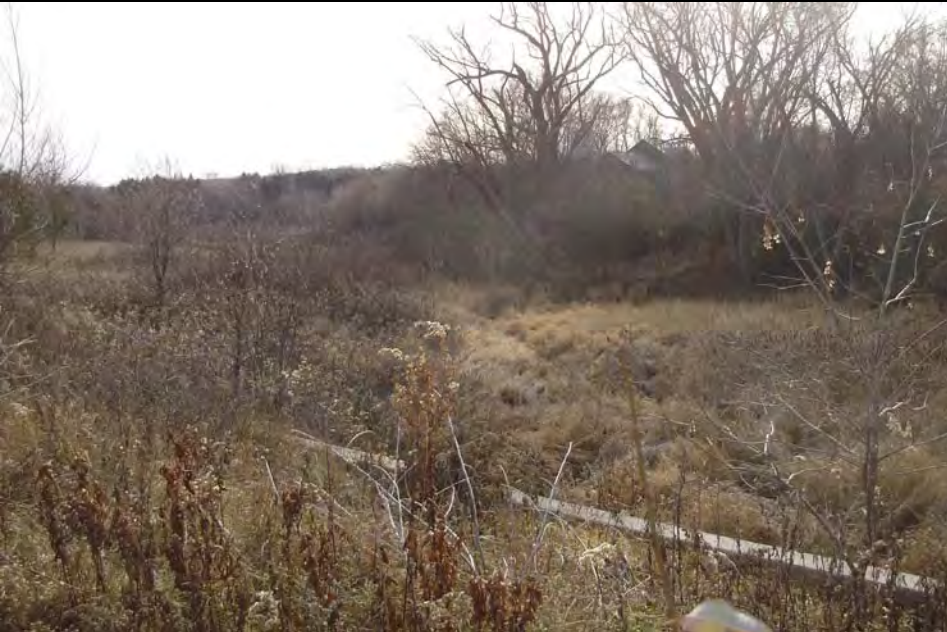
Figure 4.2 – Summary of site 'A' assessment

REACH 'A' SUMMARY				
Stream: Trout Brook				
Watershed: LSCWMO				
Location: Denmark Township (D.S. of Trading Post Trail)				
State: MN				
County: Washington				
Date: November 18, 2008				
Observers: John Barry, Mike Majeski				
Channel type: C4c-				
Drainage area (sq.mi.): 3.2				
Dimension		typical	min	max
floodplain:	width flood prone area (ft)	73.5	63.2	83.7
riffle-run:	x-area bankfull (sq.ft.)	8.8	7.4	10.1
	width bankfull (ft)	18.5	14.5	22.5
	mean depth (ft)	0.47	0.4	0.5
	max depth (ft)	1.8	1.7	1.9
	hydraulic radius (ft)	0.4		
Dimensionless ratios		typical	min	max
	width depth ratio	39.0	28.2	50.1
	entrenchment ratio	4.0	3.4	4.5
	riffle max depth ratio	3.8	3.6	3.9
Pattern		typical	min	max
	stream length (ft)	256.5		
	valley length (ft)	215.0		
	Sinuosity	1.19		
Profile		typical	min	max
	channel slope (%)	0.94		
Channel Materials	Channel			
	D50 (mm)	2.8	---	---
Reference Image

Sites A and E are relatively stable with limited areas of instability and/or bank failure (accelerated erosion), often the result of human disturbance and impact. Located within the floodplain of the St. Croix River, site E is directly influenced by this flowage. Site B, also relatively stable, is over-wide (relative to its stream type) with regular occurrence and has poor riffle-pool definition due to sand embeddedness. Sites C and D have been directly altered (realigned) in the late 1960's and/or early 70's. These human-made reaches exhibit very poor habitat and relative instability. Site C is grossly over-wide with no discernable bank and pool-riffle definition. A 'B' stream has formed within the entrench channel of Site D. This ditch-like channel is confining the stream and subsequently provides poor habitat.

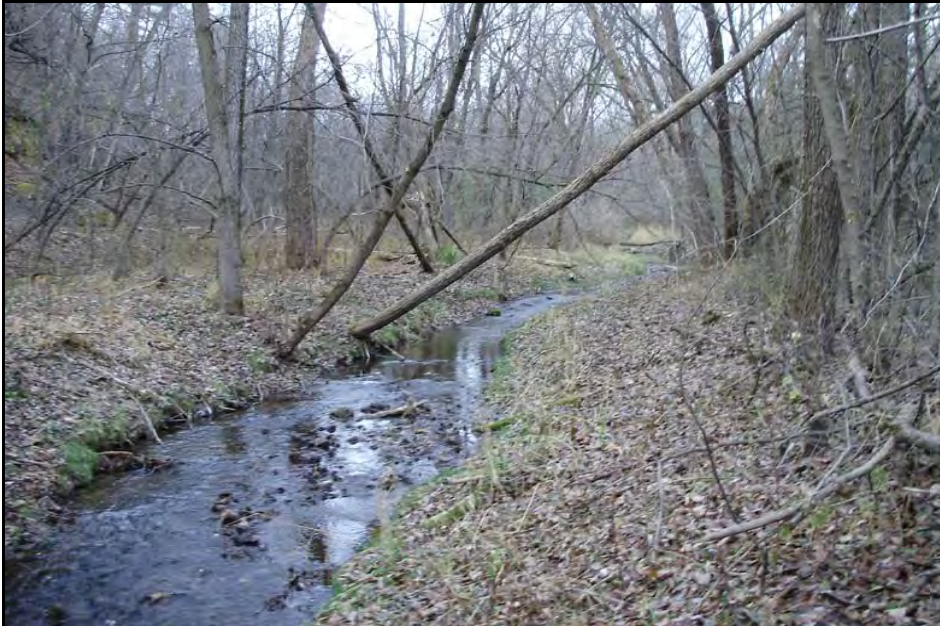
Figure 4.3 – Summary of site 'B' assessment

REACH 'B' SUMMARY				
Stream:	Trout Brook			
Watershed:	LSCWMO			
Location:	Denmark Township (Afton State Park)			
State:	MN			
County:	Washington			
Date:	November 18, 2008			
Observers:	John Barry, Mike Majeski			
Channel type:	C4			
Drainage area (sq.mi.):	6			
Dimension		typical	min	max
floodplain:	width flood prone area (ft)	283.0	---	---
riffle-run:	x-area bankfull (sq.ft.)	18.1	---	---
	width bankfull (ft)	13.2	---	---
	mean depth (ft)	1.37	---	---
	max depth (ft)	1.9	---	---
	hydraulic radius (ft)	1.3		
Dimensionless ratios		typical	min	max
	width depth ratio	9.7	---	---
	entrenchment ratio	21.4	---	---
	riffle max depth ratio	1.4	---	---
Pattern		typical	min	max
	stream length (ft)	294.7		
	valley length (ft)	279.8		
	Sinuosity	1.05		
Profile		typical	min	max
	channel slope (%)	1.2		
Channel Materials		Channel		
	D50 (mm)	6.9	---	---
Reference Image

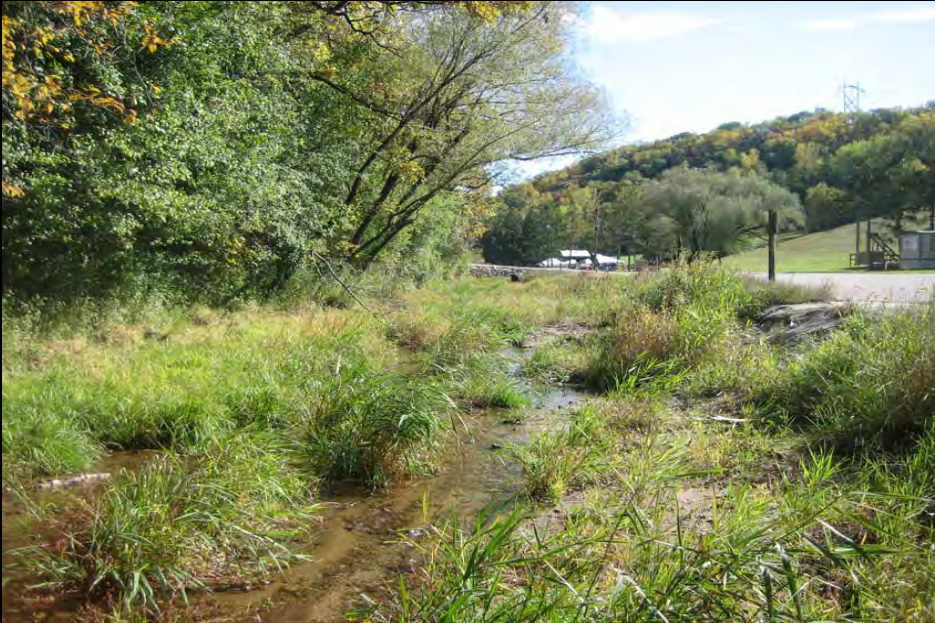
Figure 4.4 – Summary of site 'C' assessment

REACH 'C' SUMMARY				
Stream:	Trout Brook			
Watershed:	LSCWMO			
Location:	Denmark Township (Afton Alps)			
State:	MN			
County:	Washington			
Date:	November 14, 2008			
Observers:	John Barry, Mike Majeski			
Channel type:	B4a			
Drainage area (sq.mi.):	6.2			
Dimension		typical	min	max
floodplain:	width flood prone area (ft)	34.7	31.9	36.9
riffle-run:	x-area bankfull (sq.ft.)	18.0	16.0	19.9
	width bankfull (ft)	27.2	23.2	33.5
	mean depth (ft)	0.66	0.6	0.7
	max depth (ft)	1.3	1.1	1.4
	hydraulic radius (ft)	0.7		
Dimensionless ratios		typical	min	max
	width depth ratio	41.0	33.6	56.3
	entrenchment ratio	1.3	1.2	1.4
	riffle max depth ratio	1.9	1.7	2.2
Pattern		typical	min	max
	stream length (ft)	764.6		
	valley length (ft)	733.6		
	Sinuosity	1.04		
Profile		typical	min	max
	channel slope (%)	0.76		
Channel Materials	Channel			
	D50 (mm)	9.4	---	---
Reference Image

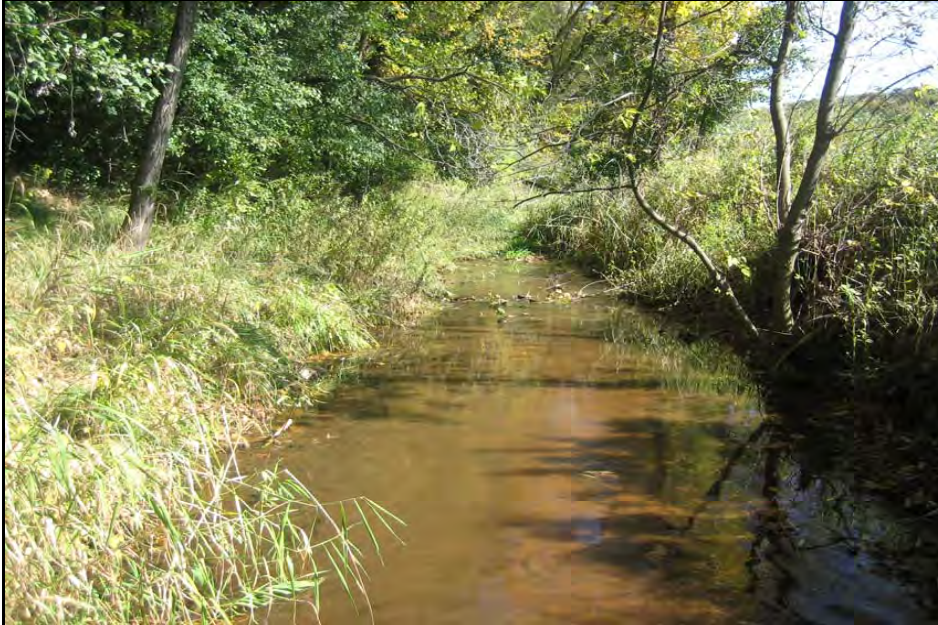
Figure 4.5 – Summary of site 'D' assessment

REACH 'D' SUMMARY				
Stream:		Trout Brook		
Watershed:		LSCWMO		
Location:		Denmark Township (Afton Alps)		
State:		MN		
County:		Washington		
Date:		November 14, 2008		
Observers:		John Barry, Mike Majeski		
Channel type:		B4a		
Drainage area (sq.mi.):		6.2		
Dimension		typical	min	max
floodplain:	width flood prone area (ft)	24.6	23.5	25.7
riffle-run:	x-area bankfull (sq.ft.)	21.2	18.9	23.5
	width bankfull (ft)	17.3	16.8	17.8
	mean depth (ft)	1.23	1.1	1.4
	max depth (ft)	2.2	2.1	2.2
	hydraulic radius (ft)	1.1		
Dimensionless ratios		typical	min	max
	width depth ratio	14.1	12.0	16.7
	entrenchment ratio	1.4	1.4	1.5
	riffle max depth ratio	1.8	1.7	1.8
Pattern		typical	min	max
	stream length (ft)	352.8		
	valley length (ft)	349.7		
	Sinuosity	1.01		
Profile		typical	min	max
	channel slope (%)	0.48		
Channel Materials		Channel		
	D50 (mm)	6.9	---	---
Reference Image

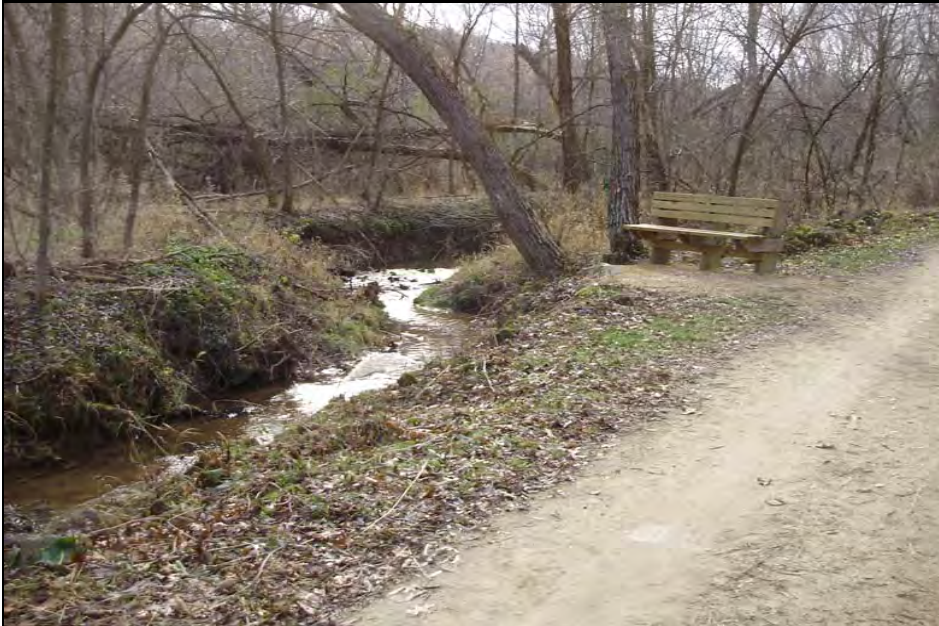
Figure 4.6 – Summary of site 'E' assessment

REACH 'E' SUMMARY				
Stream: Trout Brook				
Watershed: LSCWMO				
Location: Denmark Township (Afton State Park)				
State: MN				
County: Washington				
Date: November 17, 2008				
Observers: John Barry, Mike Majeski				
Channel type: C4				
Drainage area (sq.mi.): 8.4				
Dimension		typical	min	max
floodplain:	width flood prone area (ft)	387.4	---	---
riffle-run:	x-area bankfull (sq.ft.)	24.3	---	---
	width bankfull (ft)	17.0	---	---
	mean depth (ft)	1.43	---	---
	max depth (ft)	2.4	---	---
	hydraulic radius (ft)	1.3		
Dimensionless ratios		typical	min	max
	width depth ratio	11.9	---	---
	entrenchment ratio	22.8	---	---
	riffle max depth ratio	1.7	---	---
Pattern		typical	min	max
	stream length (ft)	387.2		
	valley length (ft)	230.6		
	Sinuosity	1.68		
Profile		typical	min	max
	channel slope (%)	0.46		
Channel Materials		Channel		
	D50 (mm)	2.8	---	---
Reference Image

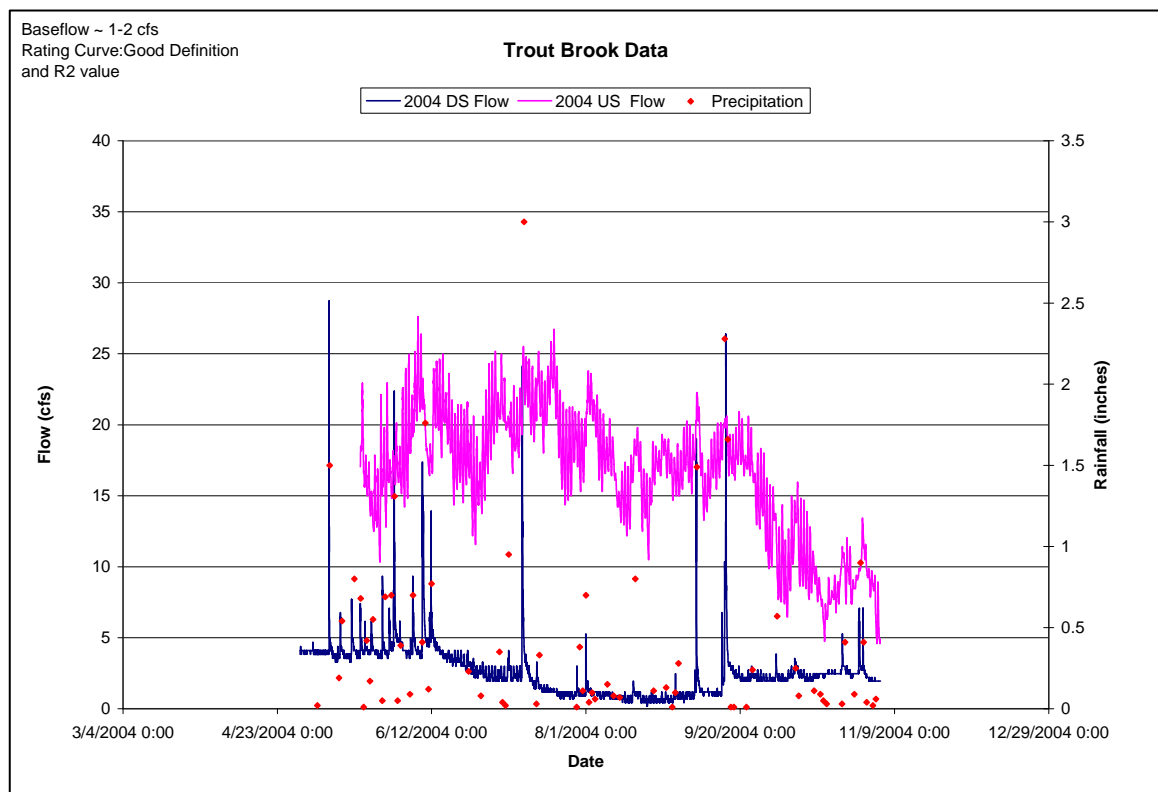
Figure 5.4 – 2004 Trout Brook flow data

The Washington Conservation District conducted automated stream-flow measurements near the mouth of Trout Brook in 2004, 2005 and 2006. This data was analyzed and calibrated by Emmons and Olivier Resources, Inc. Typical base flows ranged from extended weeks around 4.5cfs to extended weeks less than 1cfs. Fourteen precipitation related spikes exceeding 15cfs were witnessed over the 3 years and three events exceeding 30cfs were recorded over this period of record. A summary of the flow data can be found in Figures 5.4 – 5.6.

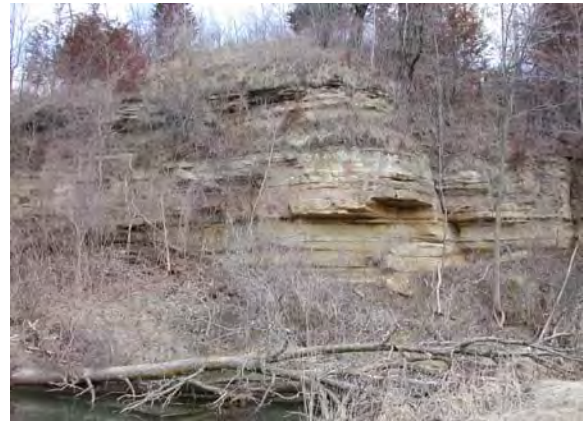
Bedrock outcrop of the St. Lawrence and Franconia Formation along Trout Brook in TRB-2.

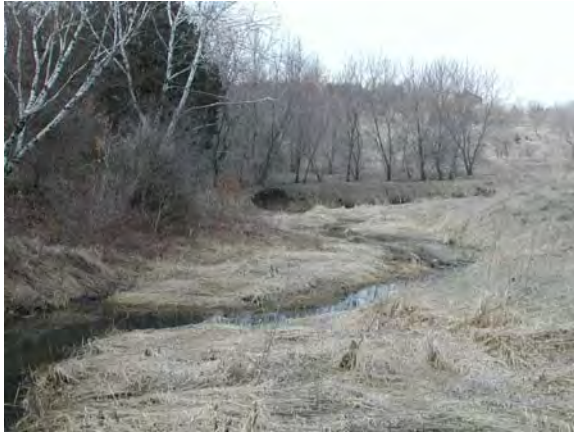
Trout Brook perennial stream channel as it enters Denmark Township, Section 4, T. 27N, R.20W.

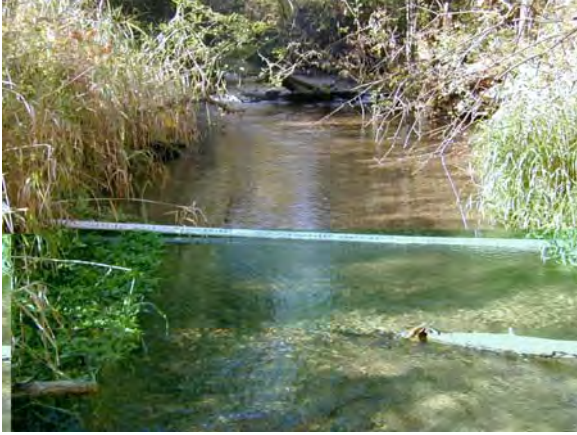
Stream width was measured at various locations of the perennial stream.

Stream Width: Stream widths were measured at points along the perennial Trout Brook. The width of the stream was measured at bank full, which is higher than the low or base flow water level, and the water level during the mapping period. This feature was mapped to provide some base information regarding stream characteristics.
