# ENVIRONMENTAL ASSESSMENT WORKSHEET

**1. Project title:** Afton Alps Trout Brook Stream Restoration

The proposed project will realign more than 500 feet of a stream. Therefore, the EAW is mandatory under MN Rules 4410.4300, subpart 26 Stream Diversion.

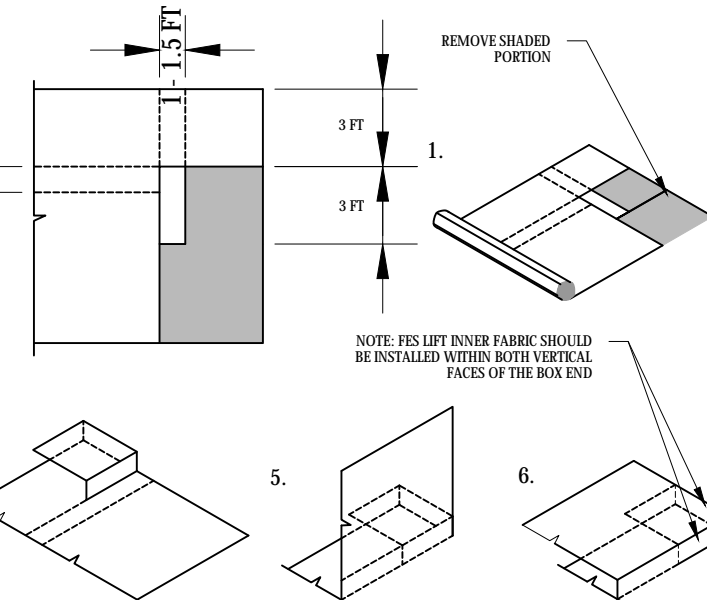
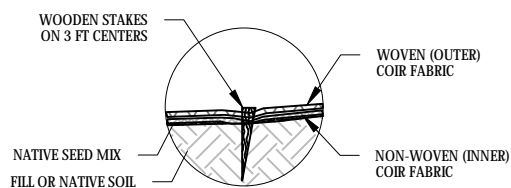
**5 TYP** TOE DETAIL BIODEGRADABLE FABRICS AND STAKES NOT TO SCALE

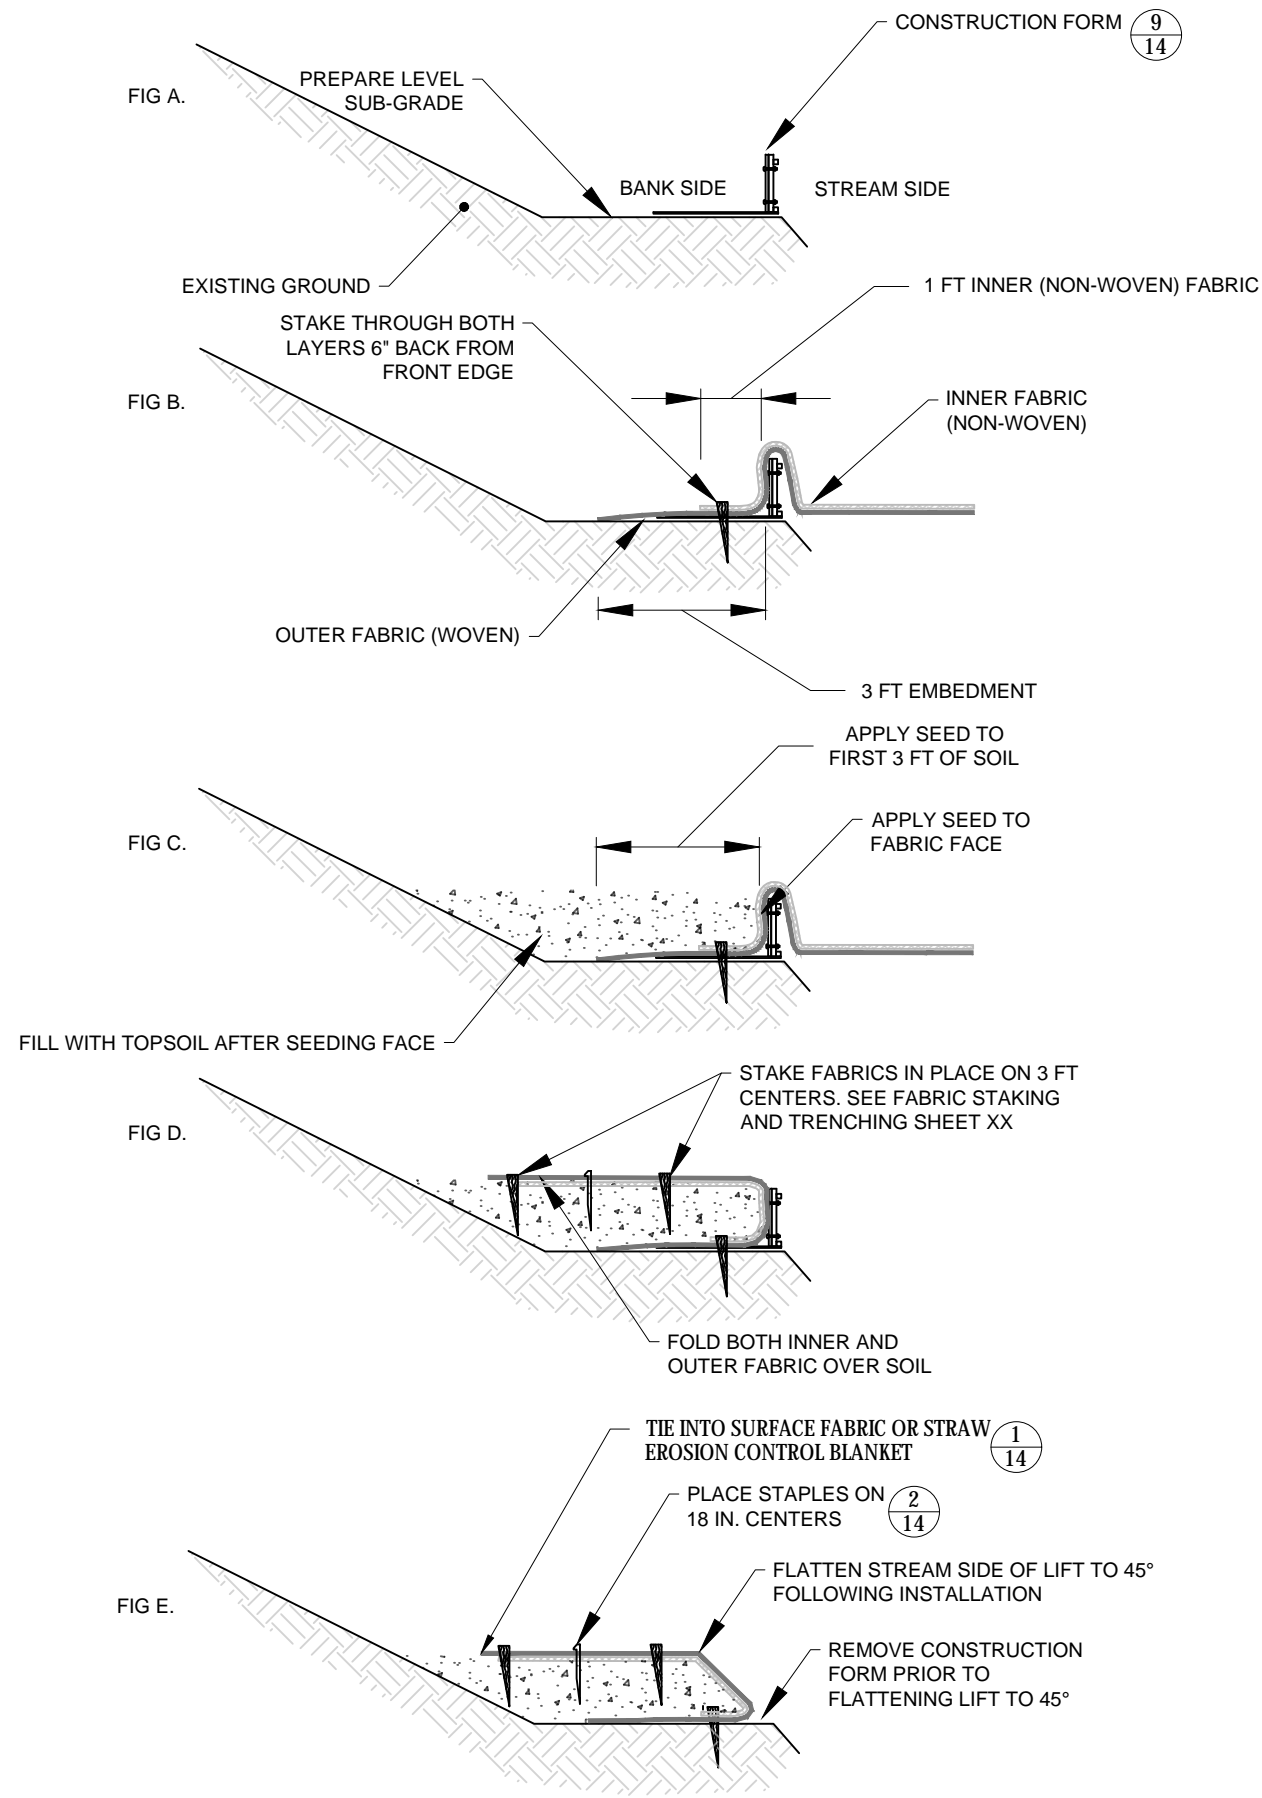
GENERAL INSTRUCTIONS FOR FABRIC ENCAPSULATED LIFTS

1. BANKS MAY BE CONSTRUCTED IN EITHER AN UPSTREAM OR DOWNSTREAM DIRECTION, AS LONG AS THE FABRIC IS OVERLAPPED IN THE PROPER DIRECTION.
2. PLACE A SERIES OF THREE OR MORE FORMS ON THE GROUND SO THAT THE FORMS FOLLOW THE PROPOSED STREAM BANK ALIGNMENT. BUTT THE ENDS OF THE FORMS TIGHTLY TOGETHER.

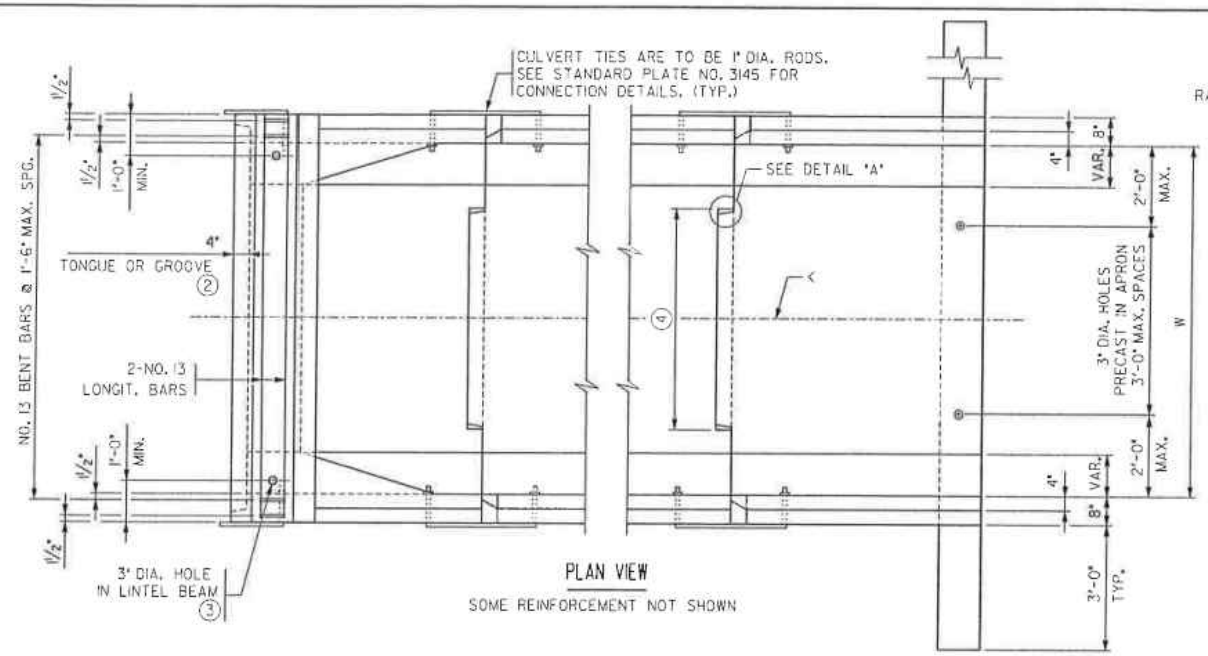
PLAN VIEW  
SOME REINFORCEMENT NOT SHOWN

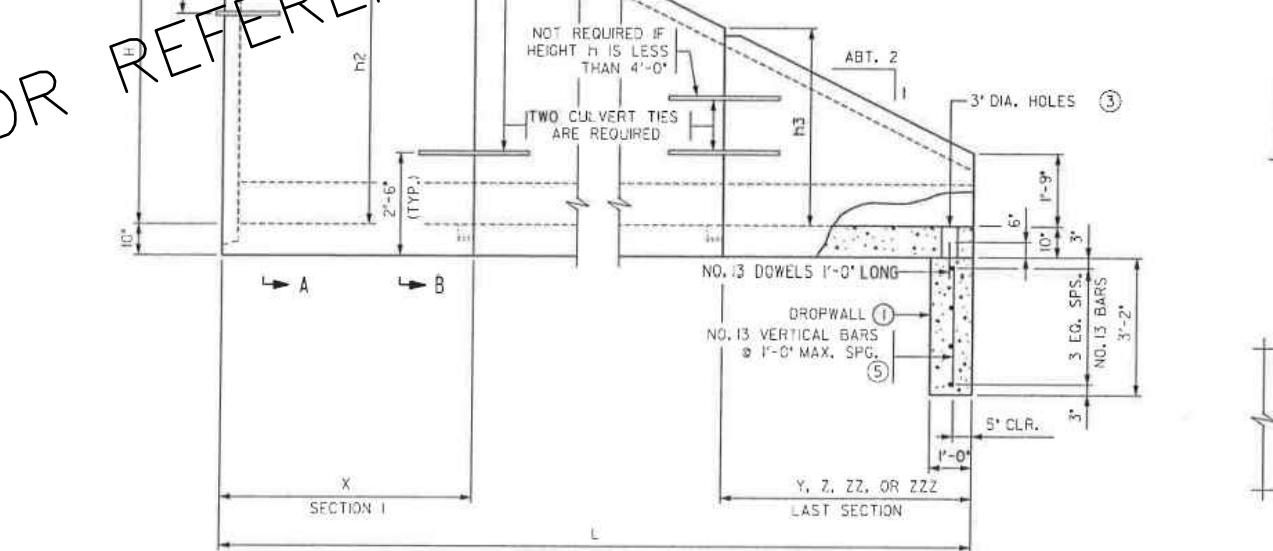
SIDE ELEVATION

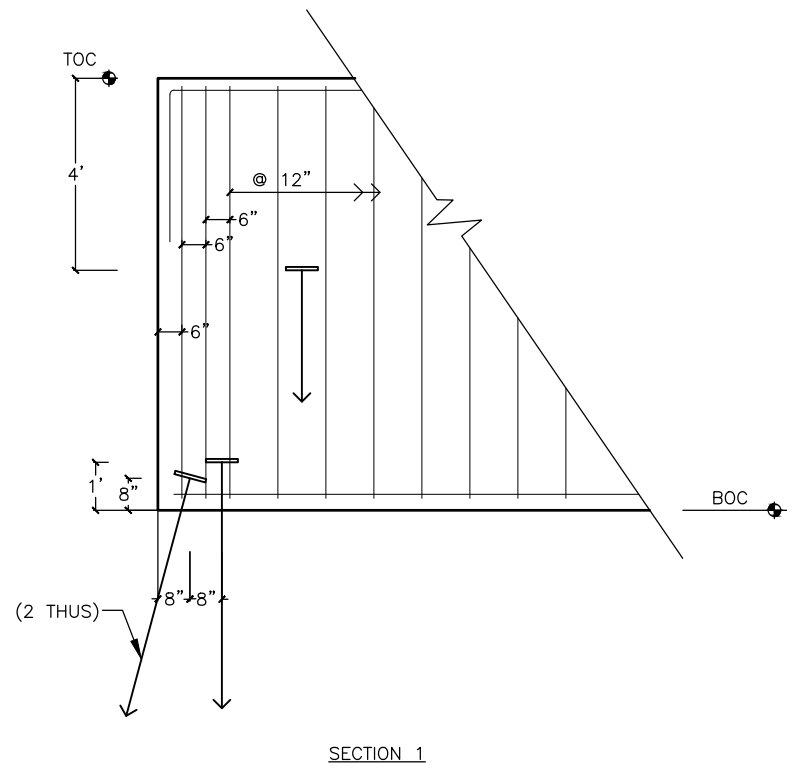
**1 BRIDGE ABUTMENT DETAIL**  
SCALE: 1/2" = 1'

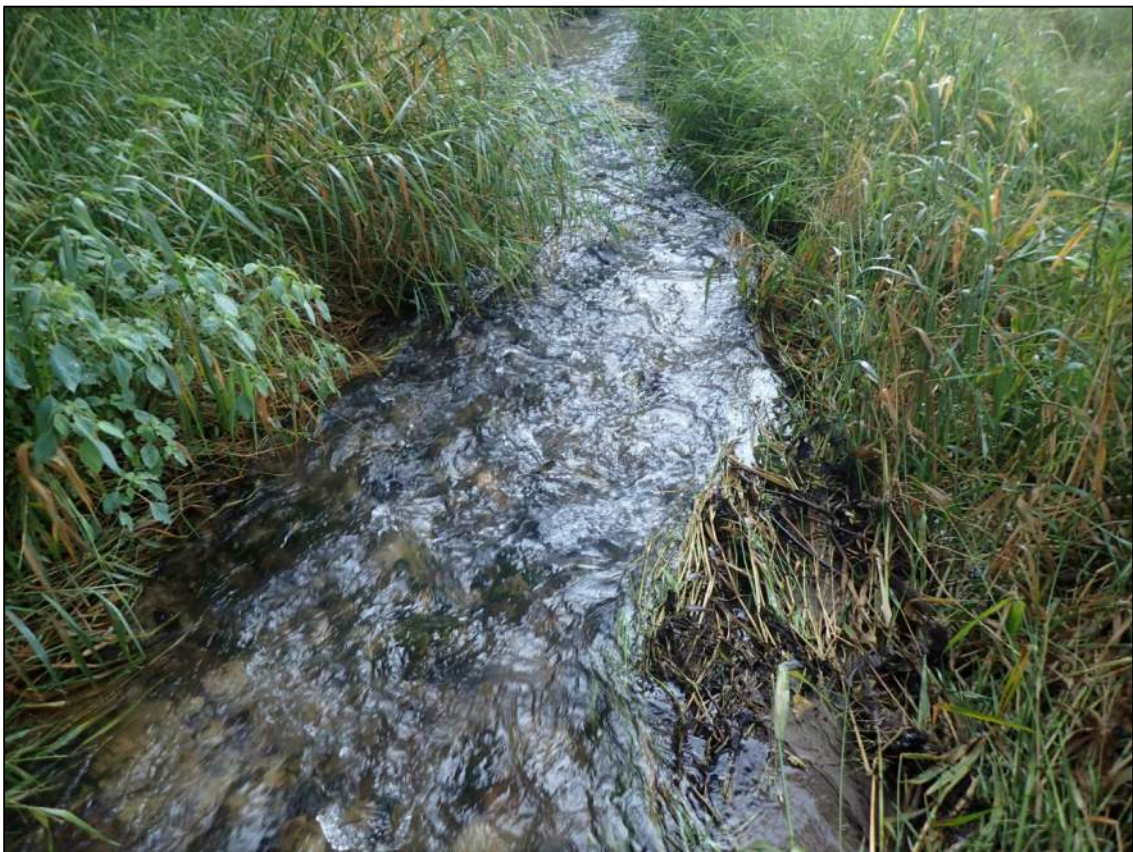
**Photo 2 - Cobble substrate in Trout Brook in Wetland A**

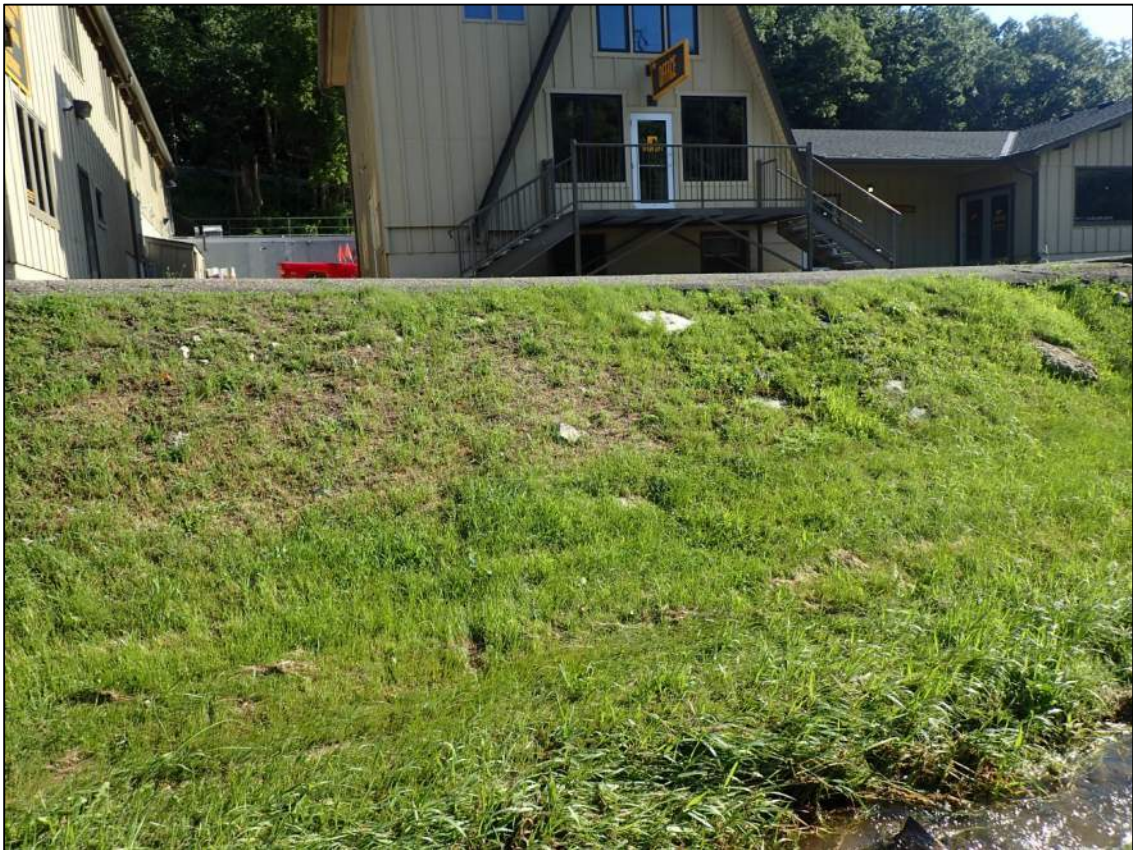
**Photo 4 - Looking north, maintained grass and rip rap on bank of Trout Brook above Wetland B**

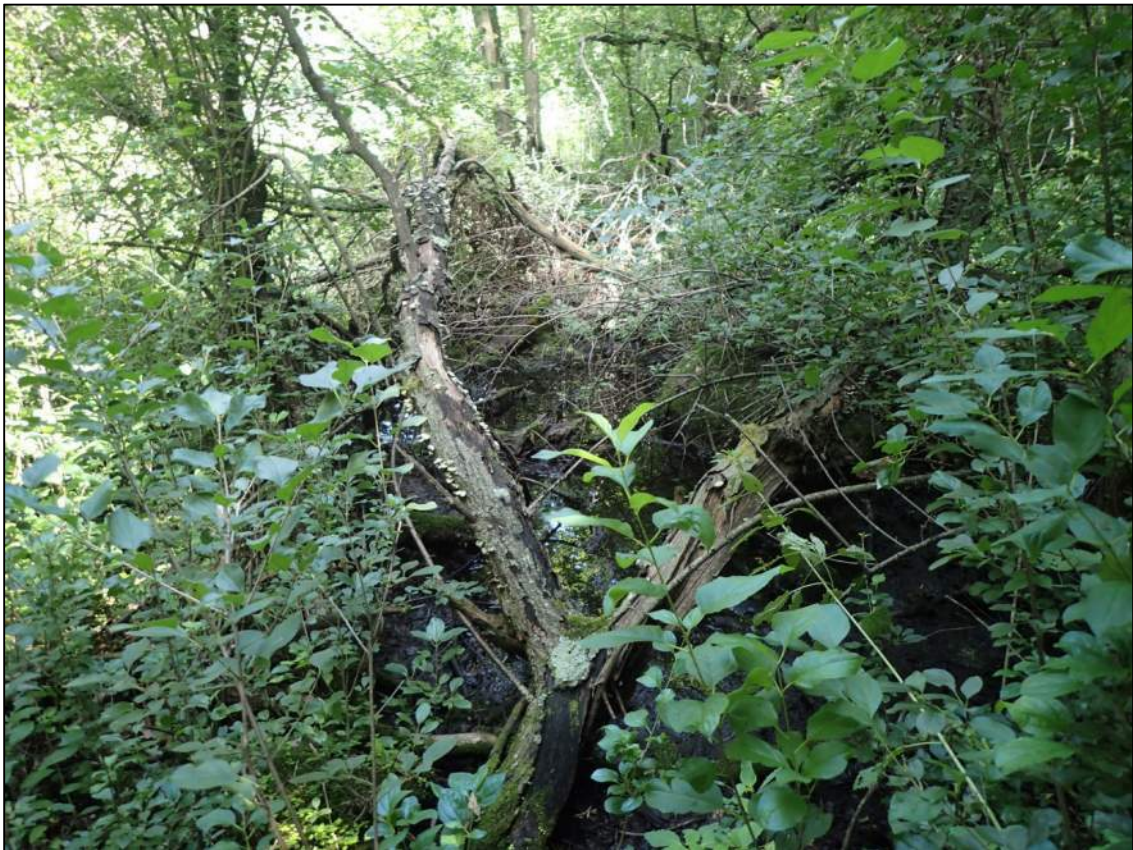
**Photo 6 - Surface saturation in forested Wetland D1**

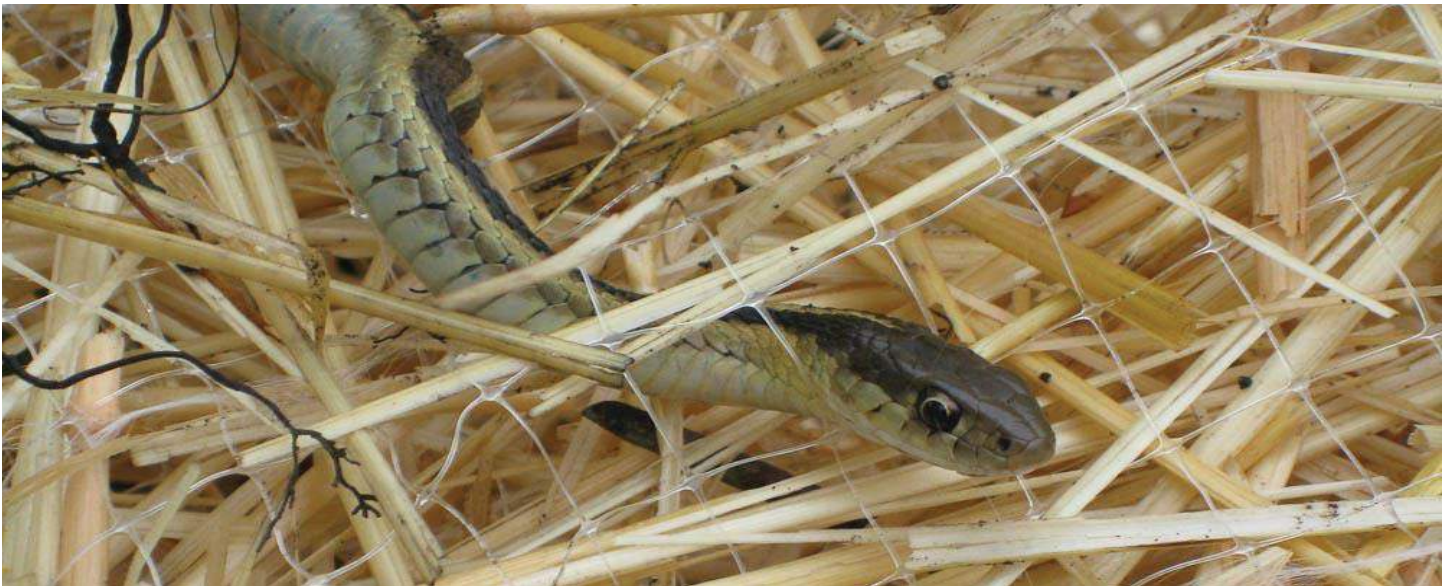
The plastic mesh component of erosion control blanket becomes a net for entrapment.
