SOUTH WASHINGTON WATERSHED DISTRICT

Colby Lake

DNR ID #82-0094	Municipality: Woodbury
Surface Area: 68 Acres	Watershed Area: 2,839 Acres
Mean Depth: 7 feet	Maximum Depth: 11 feet
SWWD Maximum Allowable Phosphorus Load: 0.34 lbs/ac/yr	
SWWD Trophic State Index (TSI) Goal: 70-73

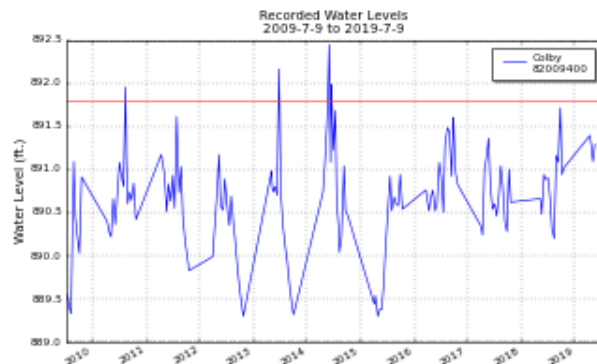
Figure 1: Colby Lake Surface Elevation

The outlet of Colby Lake is controlled by a 10-foot long weir with a crest elevation at 890.30 MSL (NGVD 29) and an ordinary high water level has been established at 891.8 MSL. Since 1980, lake levels have fluctuated by a maximum of 5 feet, averaging to within a foot and a half of the weir elevation (Figure 1).
