# SOUTH WASHINGTON WATERSHED DISTRICT

## Bailey Lake and CDSF

DNR ID #82-0456	Municipality: Woodbury
Surface Area: 61 Acres	Watershed Area: 18,431 Acres
Mean Depth:	Maximum Depth:
SWWD Maximum Allowable Phosphorus Load: maintain existing	
SWWD Trophic State Index (TSI) Goal: NA

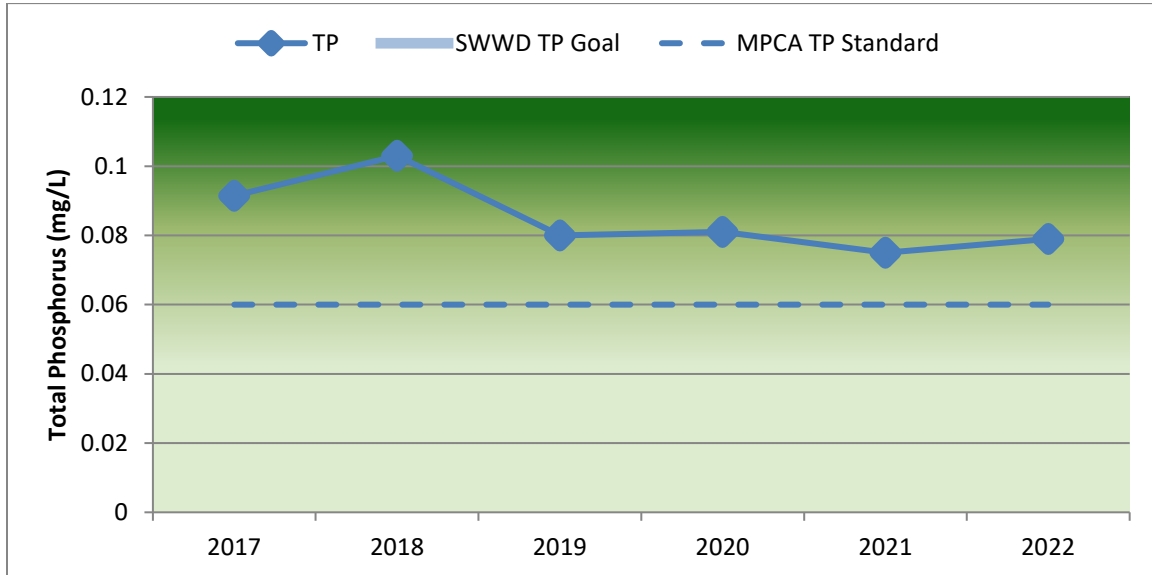
Figure 2: Bailey Lake TP

Bailey Lake is monitored twice per month during the growing season through Met Council’s Citizen Assisted Monitoring Program. Monitoring results since 2017 are shown in Figures 2-4. The data record is limited, but Bailey does not meet state eutrophication standards.

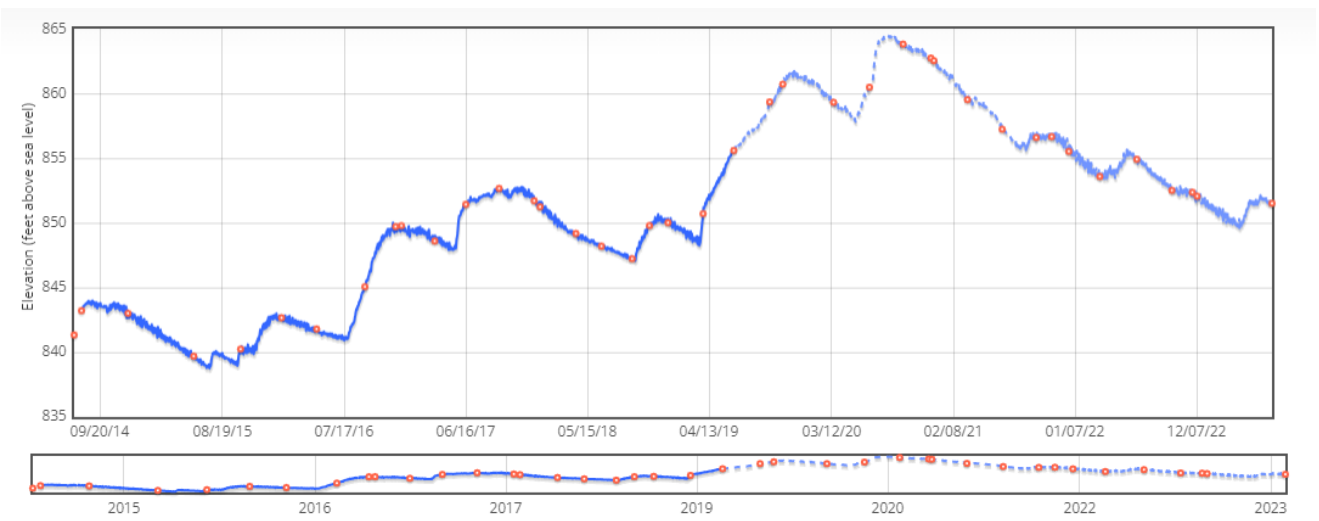
Figure 5: Quaternary Aquifer Elevation

Groundwater levels are monitored continuously by MnDNR at a set of four nested observation wells at CDSF. Results are shown in Figures 5-8. Based on the data, the quaternary, Jordan, and Prairie du Chien aquifers appear to be connected. All three, along with the deeper Tunnel City aquifer were elevated for a number of years but have dropped through the repeated droughts in 2021 and 2022.

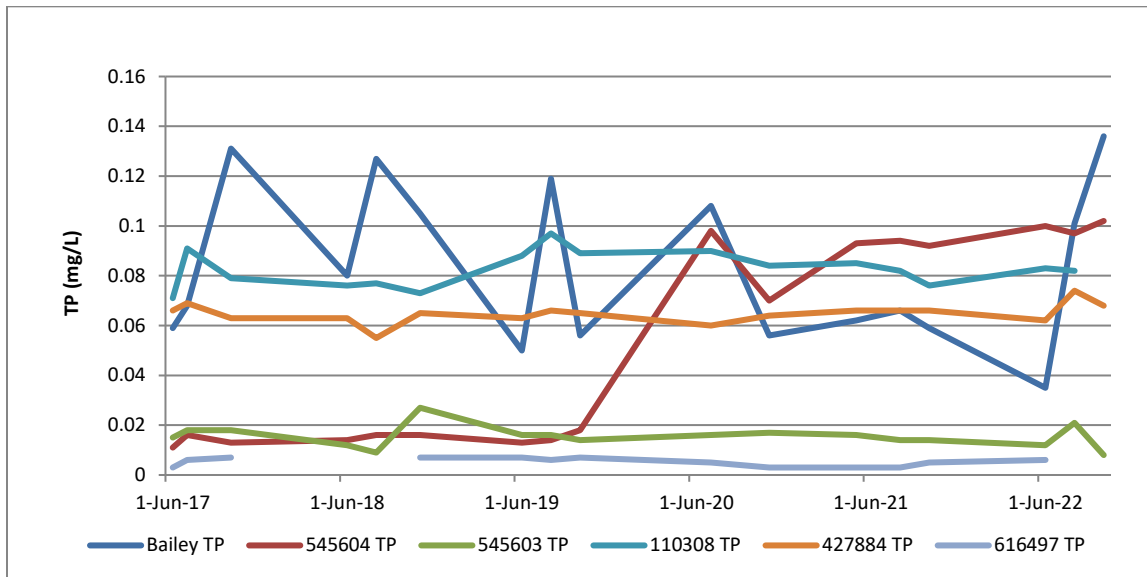
Figure 9: Lake and Groundwater Total Phosphorus Concentrations

MnPCA monitors groundwater quality in the area as part of their ambient groundwater monitoring program. Samples are analyzed for several potential contaminants. Of primary significance due to high surface water/groundwater interaction are nutrients and chloride which are both sourced through Stormwater inflows to Bailey Lake. Figures 9-11 show concentrations of TP, Bromide, and Chloride in Bailey Lake and several area wells. Of greatest concern is high chlorides present at times in both the Lake and some wells. Based on presence of bromide, along with Cl:Br ratios greater than 1000, it is likely that observed chloride is sourced from road deicing material. That relationship is most clear from Bromide concentrations at well 545604 near the lift station from 2020-2023. Groundwater TP concentrations are highest at the two private wells adjacent to the lake.
